Richard Noble  
Bushfire Attack Level (BAL) Compliance Report  
Stage 4 Vivente, Hammond Park

20 August 2020

59211/131,251 (Rev 1)

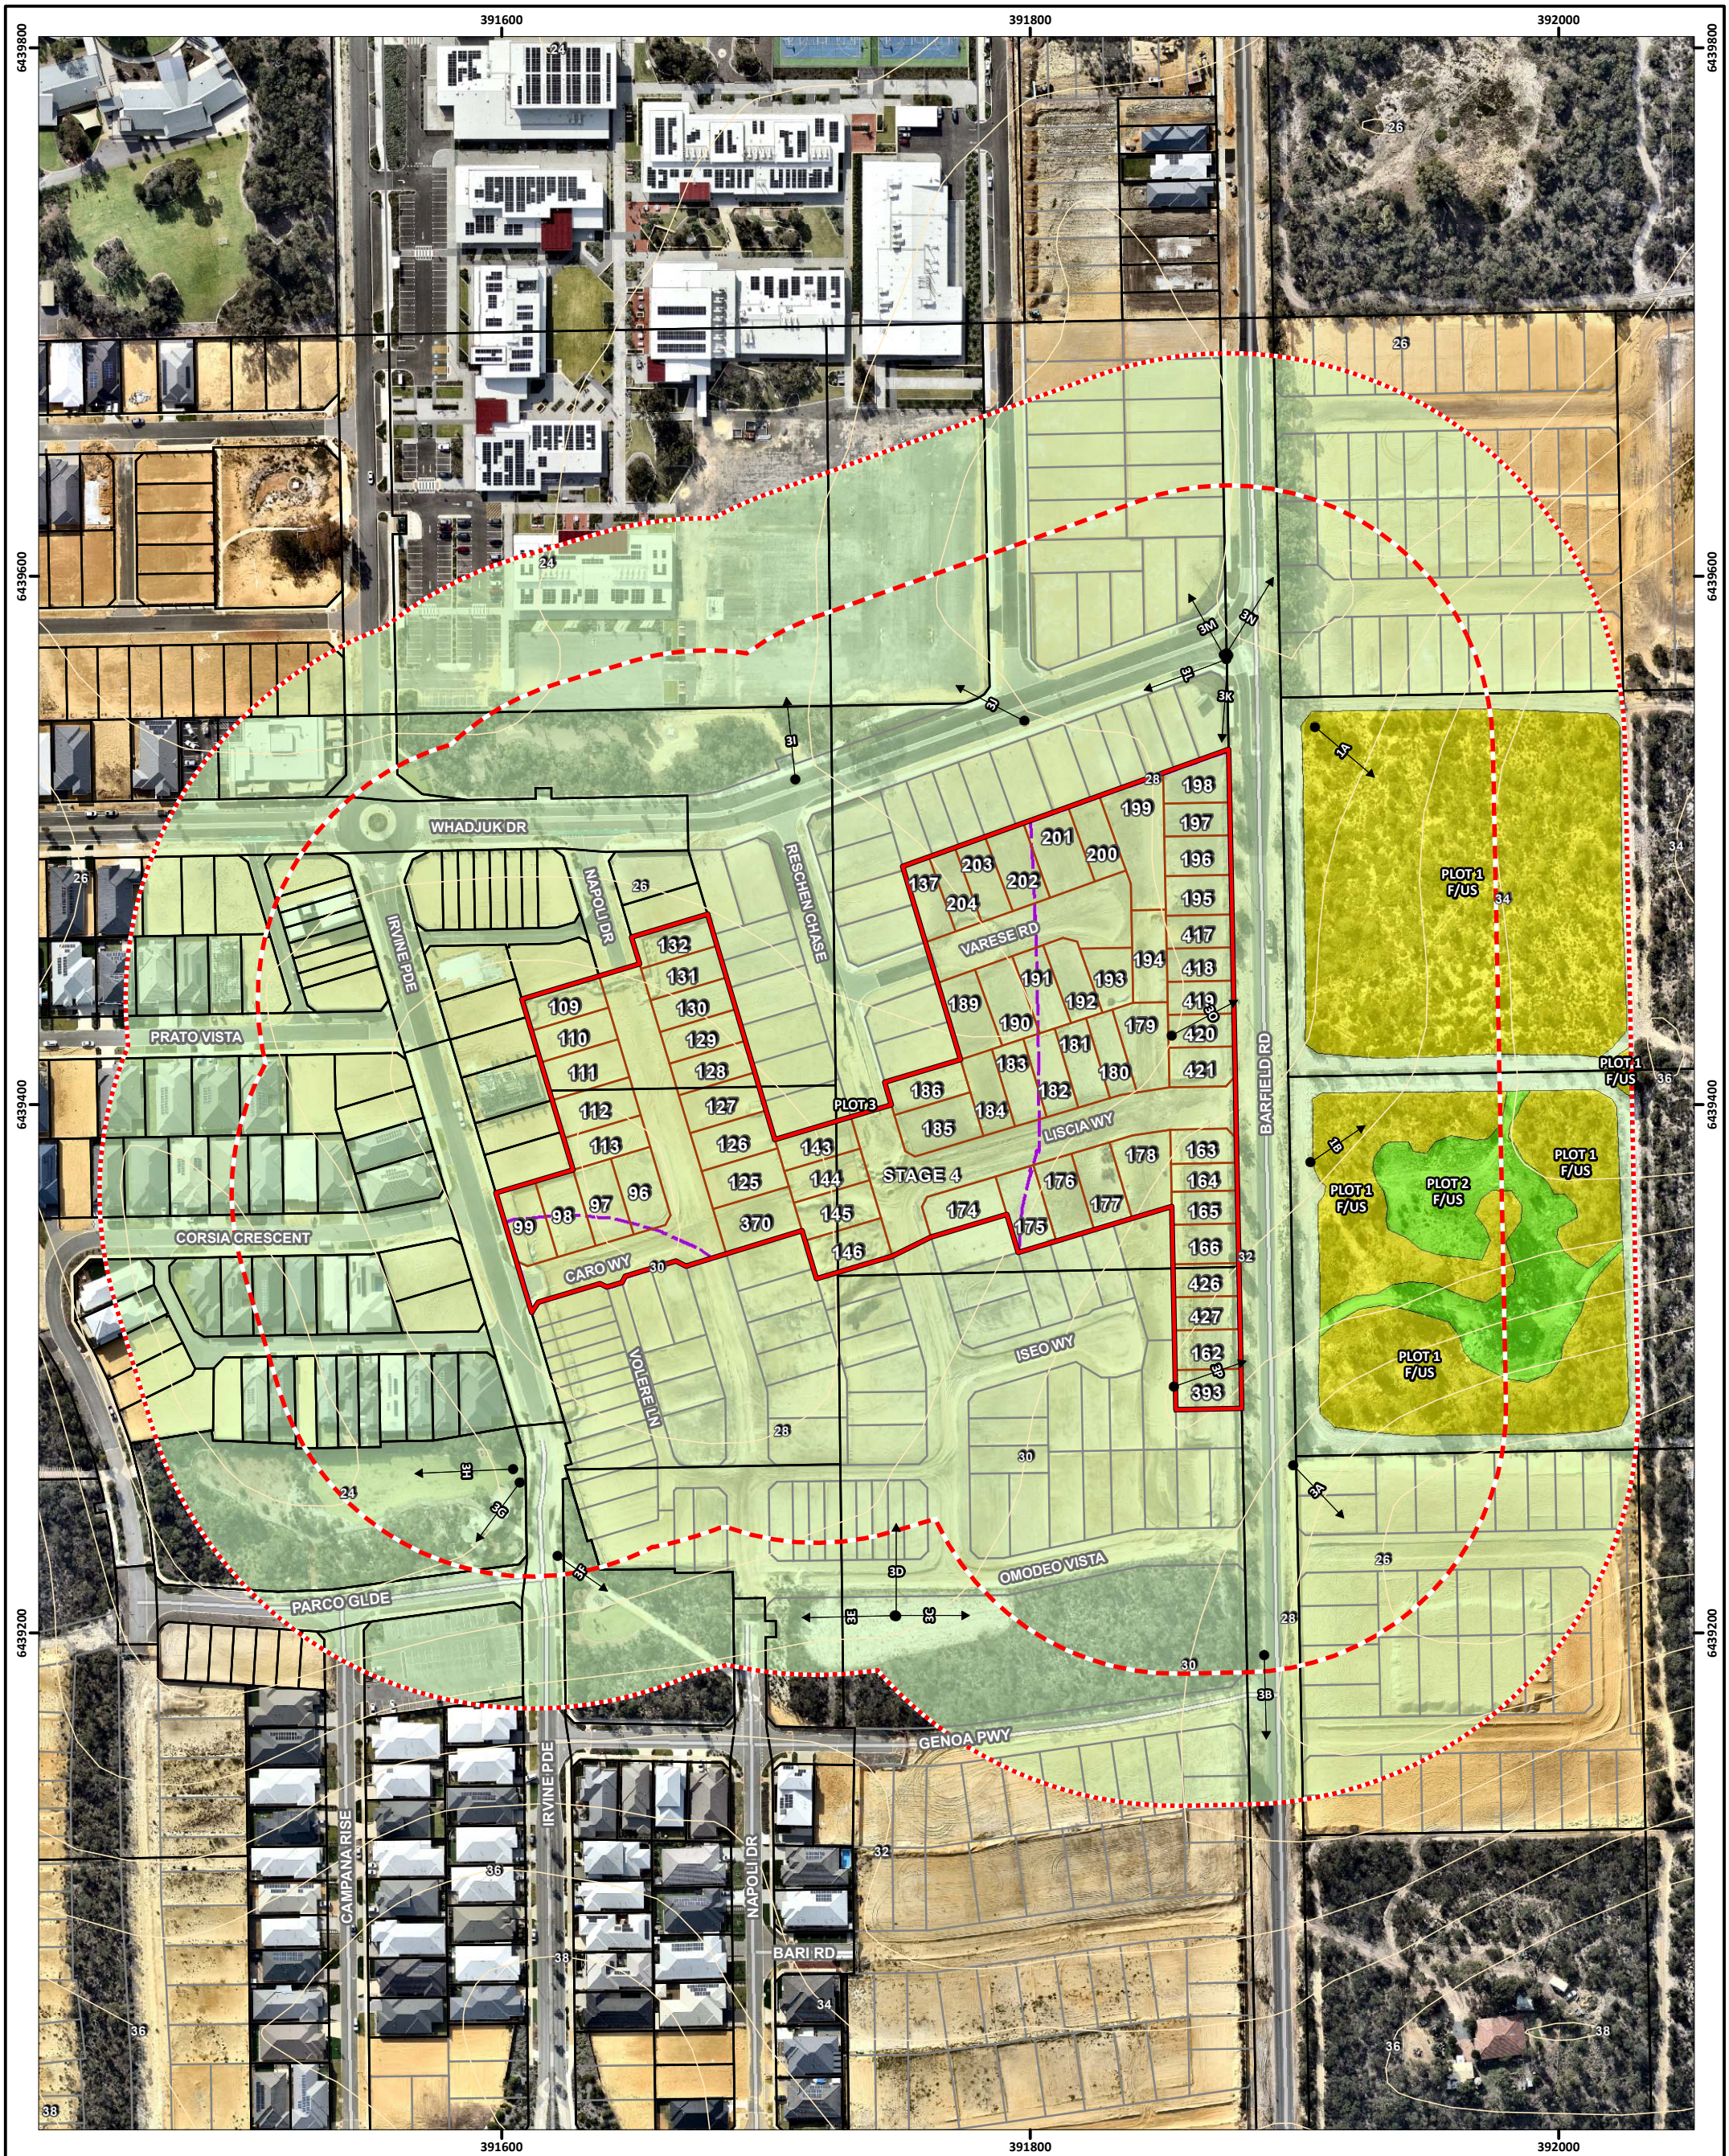
Site observations show that the vegetation classifications align with the post-development vegetation classifications determined by the endorsed BMPs, except for new roadside clearing along Barfield Road, which has reduced the level of Class D scrub along this interface compared to that previously mapped.

Classified vegetation in the form of Class D scrub was identified to the east of the project area within undeveloped rural residential properties. Class G grassland was also identified within a previously cleared area amongst the broader Class D scrub to the east, which is not being managed.

Site observations show that effective slope under the classified vegetation aligns with the effective slopes identified within the endorsed BMPs. Classified vegetation is situated on flat land resulting in an effective slope of flat/upslope (0 degrees) under all classified vegetation within the 150 m assessment area.

Figure 1 illustrates the current post-development vegetation classifications and exclusions observed during the inspection. The vegetation classifications/exclusions and effective slope are summarised in Table 2.

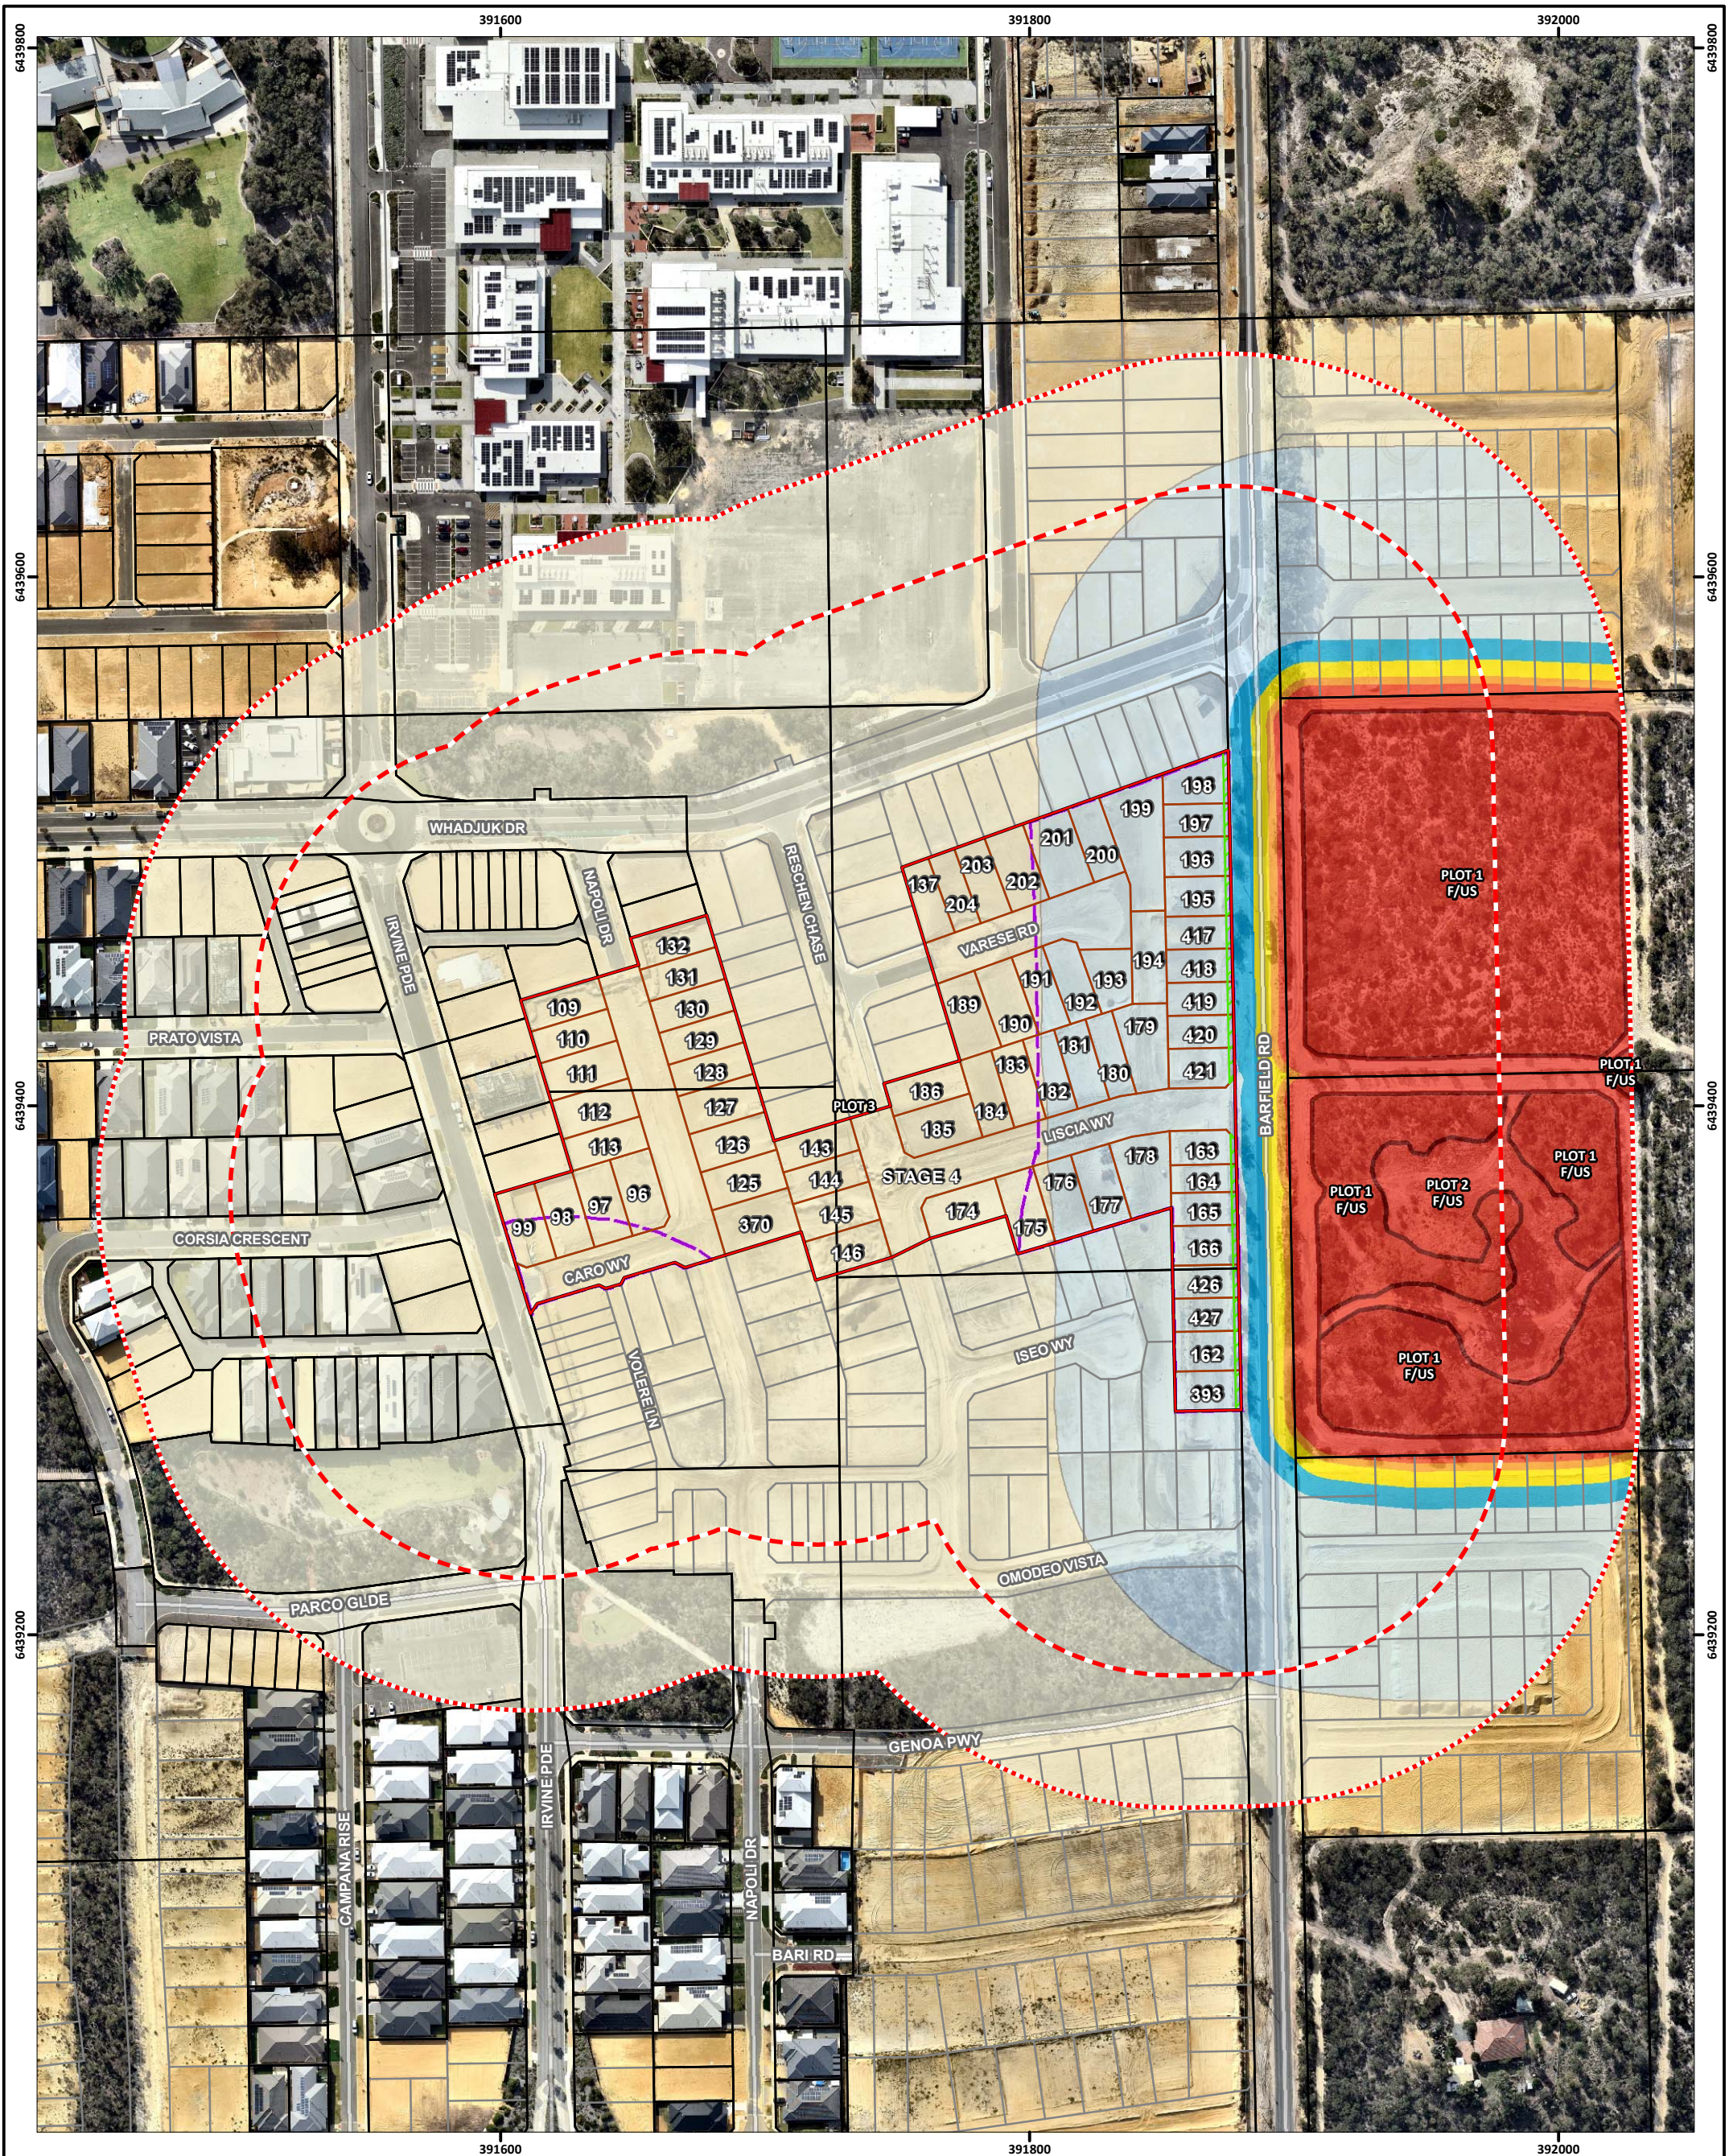
**FIGURE: 2**

Strategen-JBS&G has undertaken a BAL contour assessment in accordance with Method 1 of AS 3959 for the project area (Figure 2). The Method 1 procedure incorporates the following factors:

The BAL contours are based on the current on-ground site conditions confirmed during site assessment and results are detailed in Table 3 and illustrated in Figure 2.

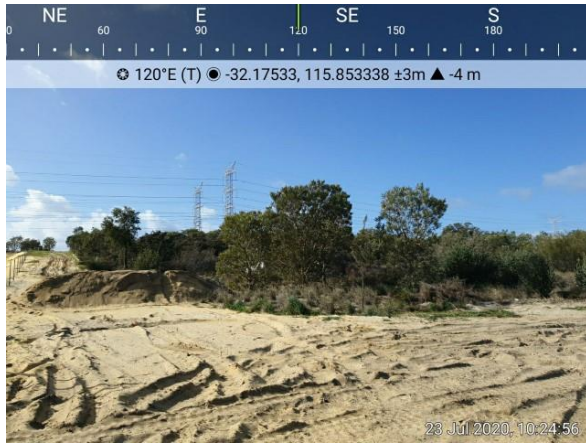
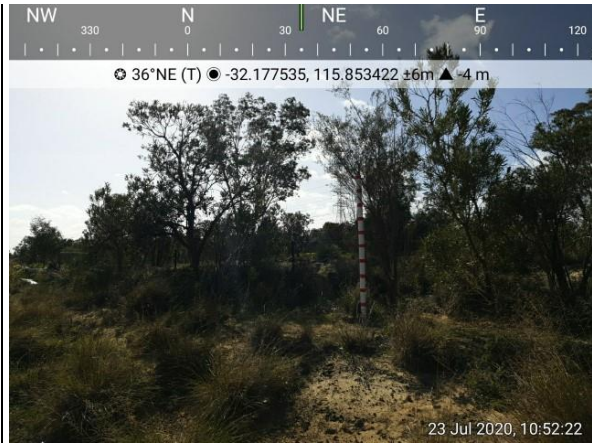
**Photo ID: 1a**

**Plot 1**

**Class D Scrub**

Scrub vegetation predominantly 2-6 m in height with a continuous vertical fuel profile consisting predominantly of low banksias.

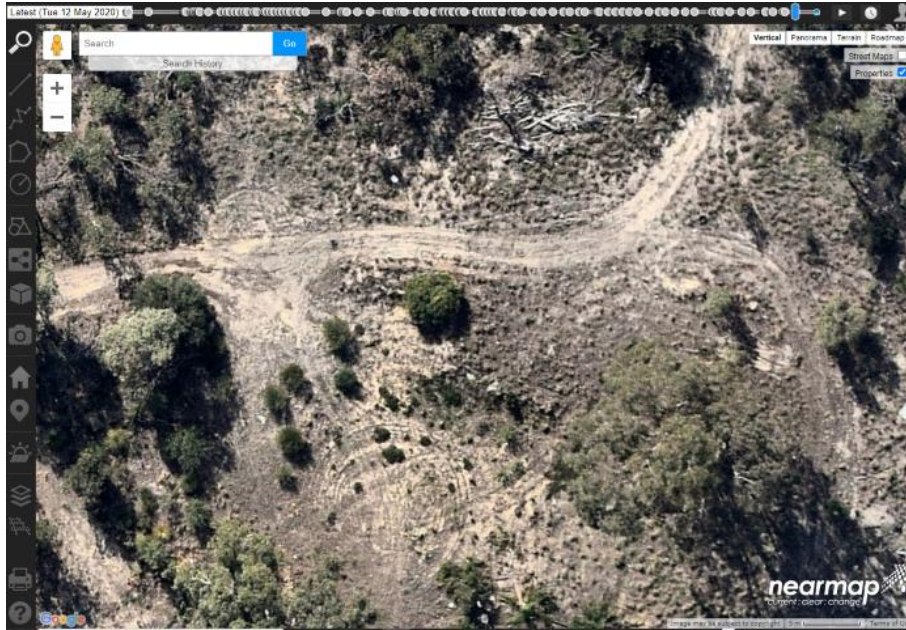
Nearmap aerial imagery (2020)

<b>Plot number</b>	Plot 2
<b>Vegetation classification</b>	Class G Grassland
<b>Description / justification</b>	Unmanaged grassland vegetation greater than 10 cm in height.

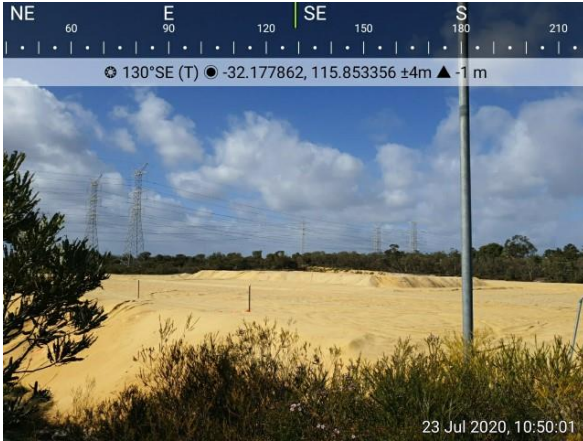
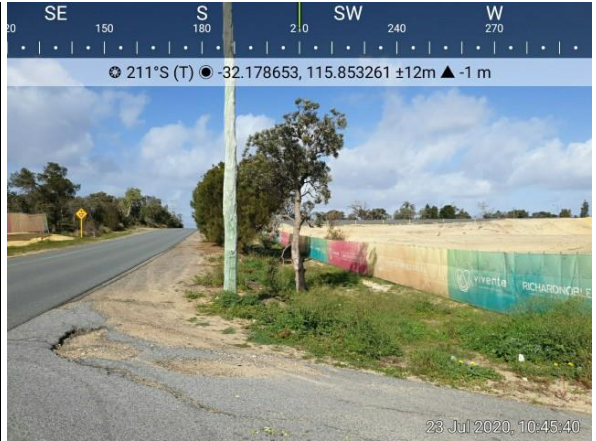
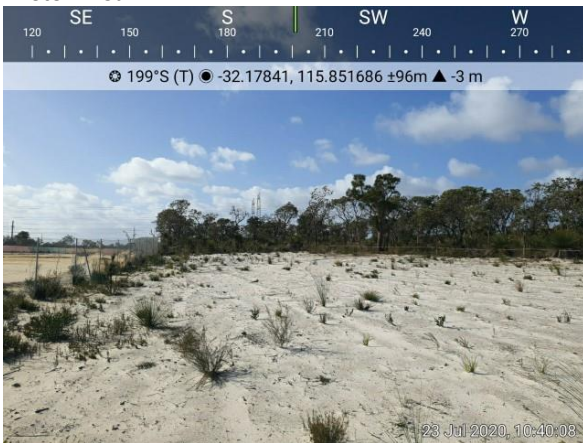
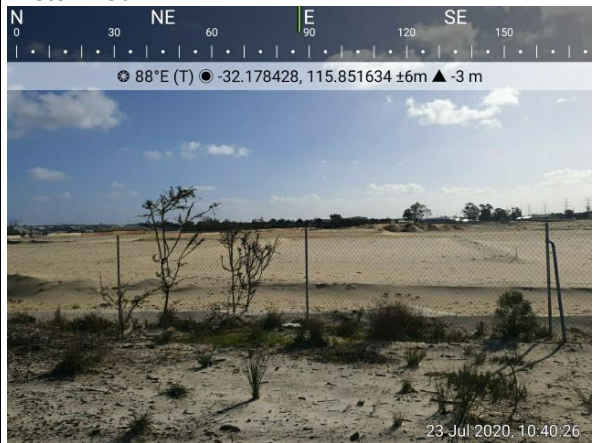
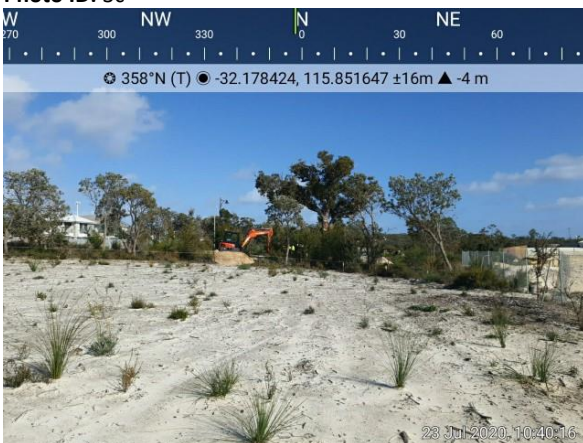
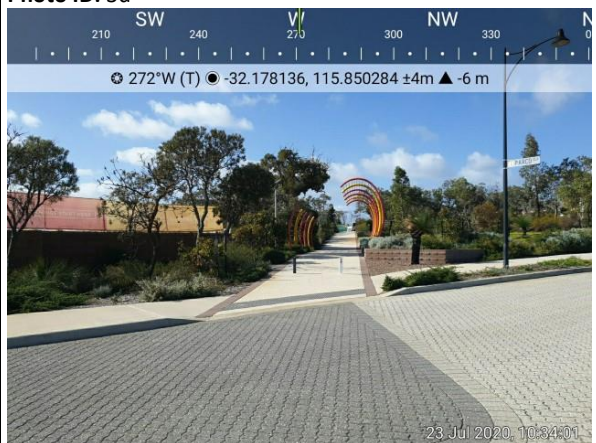
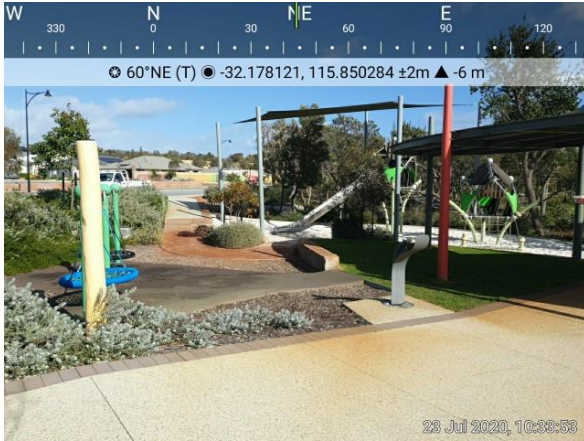
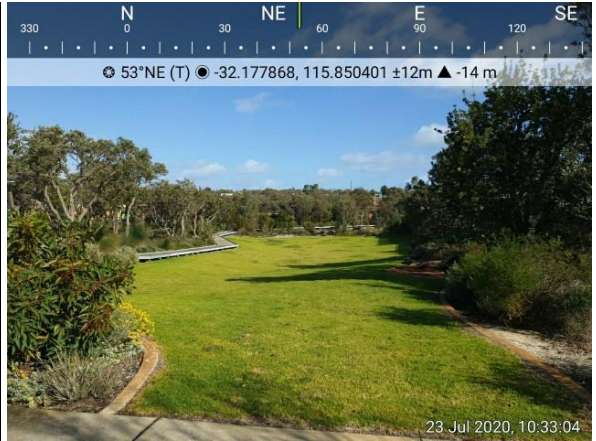
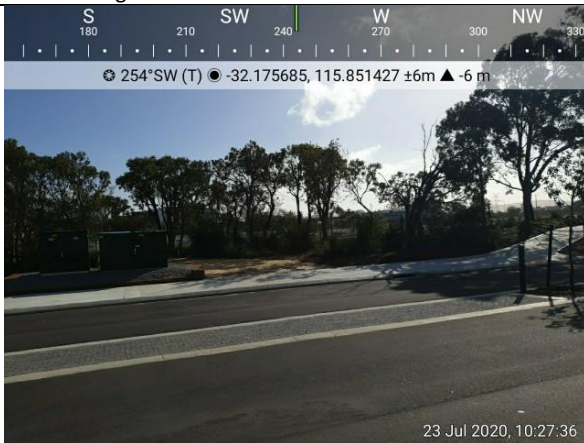
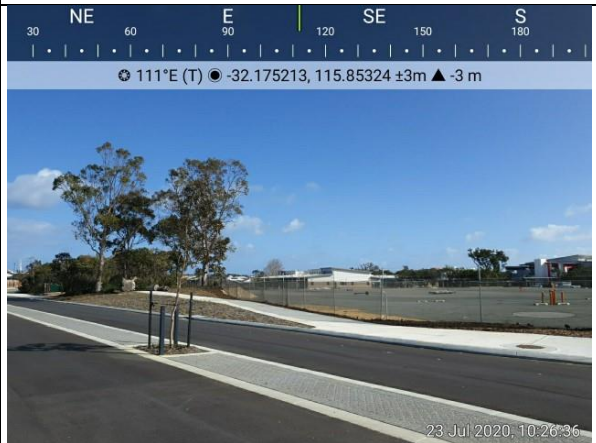
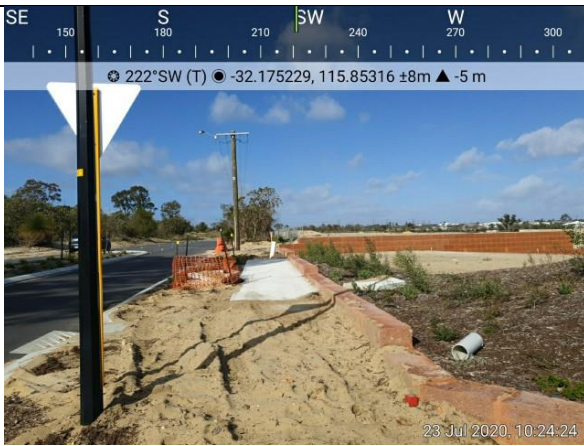
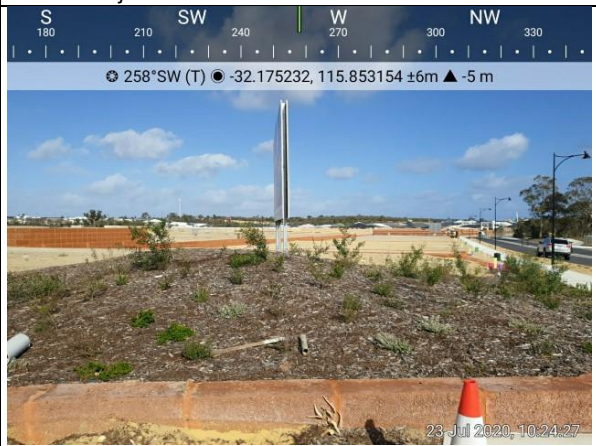
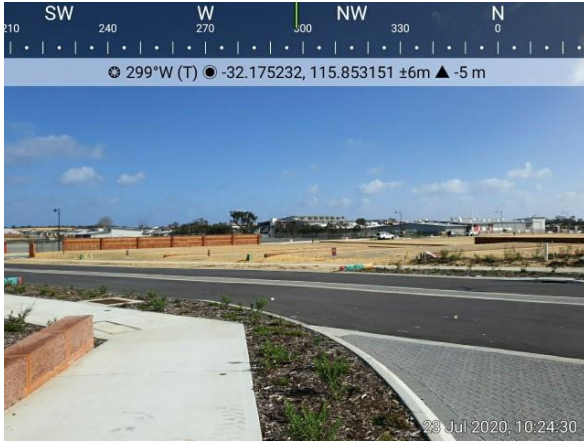
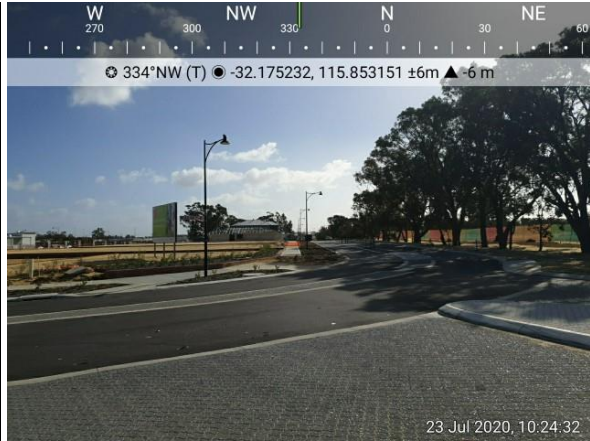
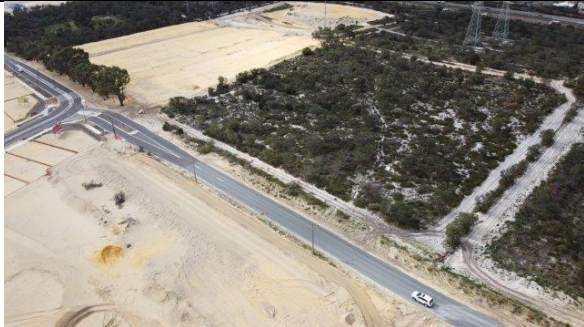
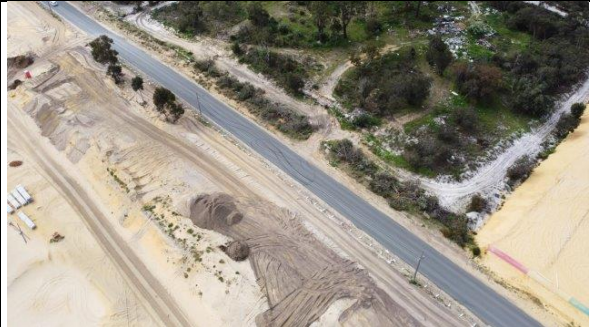
Plot 3

Excluded – Non-vegetated and Low threat (Clause 2.2.3.2 [e] and [f])

Non-vegetated areas (i.e. roads, buildings, cleared vacant lots, driveways, footpaths) and low threat managed vegetation (i.e. mowed grass, slashed staging buffers, managed gardens/POS, etc).
