Project No: RNO18292.01

Bushfire Attack Level (BAL) Compliance Report Stages 2 & 3 Vivente

Site Details			
Address: 45 residential lots within Stages 2A, 2B, 3A and 3B Vivente			
Suburb:	Hammond Park	State:	Western Australia
Local Government Area:	City of Cockburn		
Description of building works:	Class 1a buildings with associated Class 10a building/s		
Report details			
Report/Job number:	RNO18292.01	Report version:	M001 Rev B
Assessment date:	12 June 2018	Report date:	27 July 2018
Report Review Endorsement	Z Cockerill 26 July 2018	BPAD37803	Level 2 Accredited

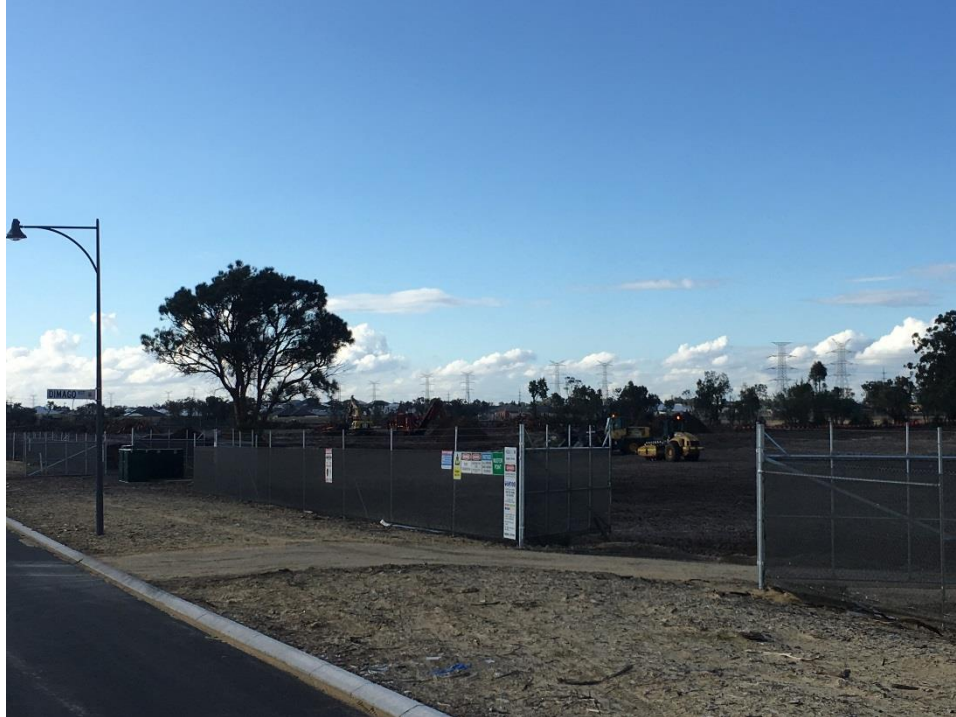
Plot 1:	Excluded – Non-vegetated & Low threat (Clauses 2.2.3.2 [e] and [f])
Photo 1a:	Future school site has recently been cleared.

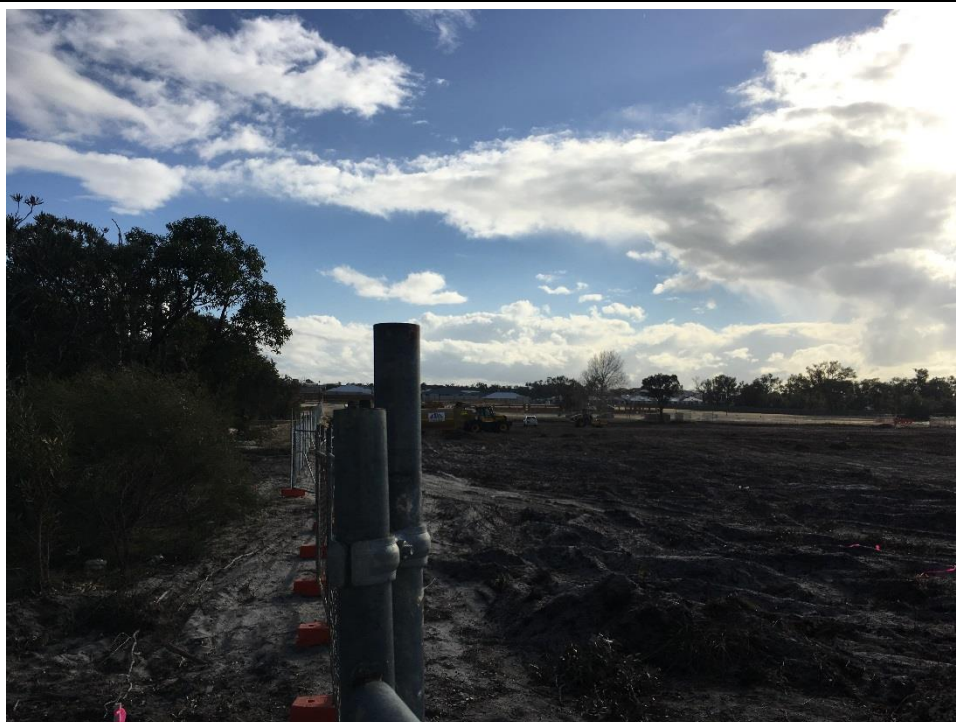
Plot 1:	Excluded – Non-vegetated & Low threat (Clauses 2.2.3.2 [e] and [f])
Photo 1b:	Future school site has recently been cleared.

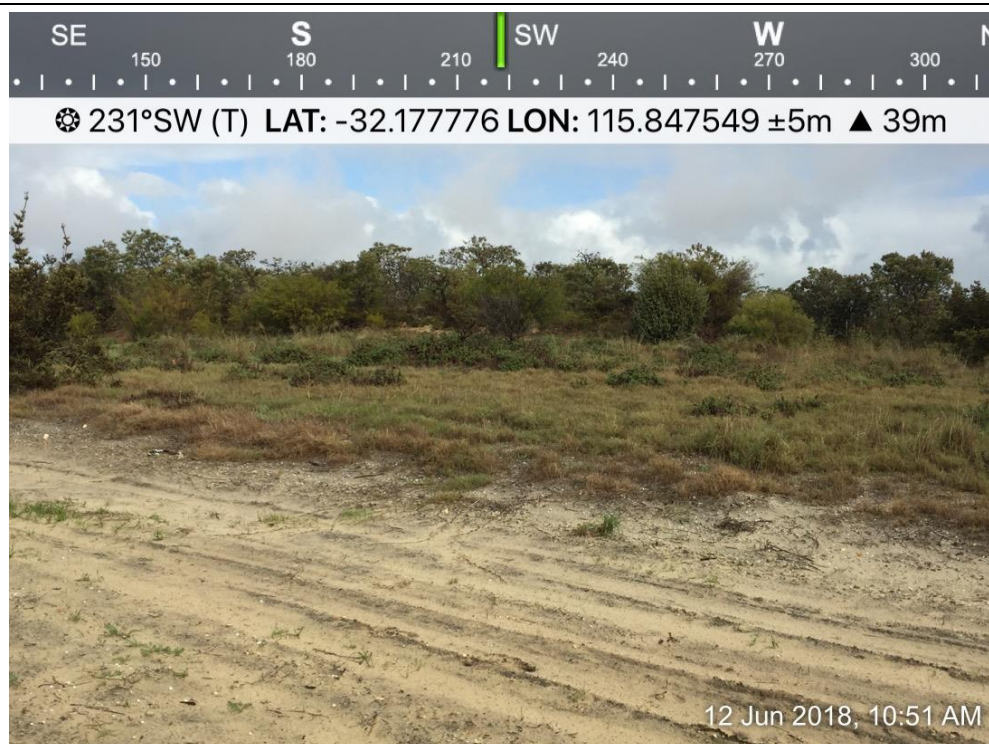
Classified vegetation was observed within Frankland Park (Plot 2) which is situated to the west of Frankland Avenue and the project area. This vegetation has been classified as Class B Woodland.

Plot 2:	Class B Woodland
Photo 2a:	Regenerating banksia woodland vegetation within Frankland Park.

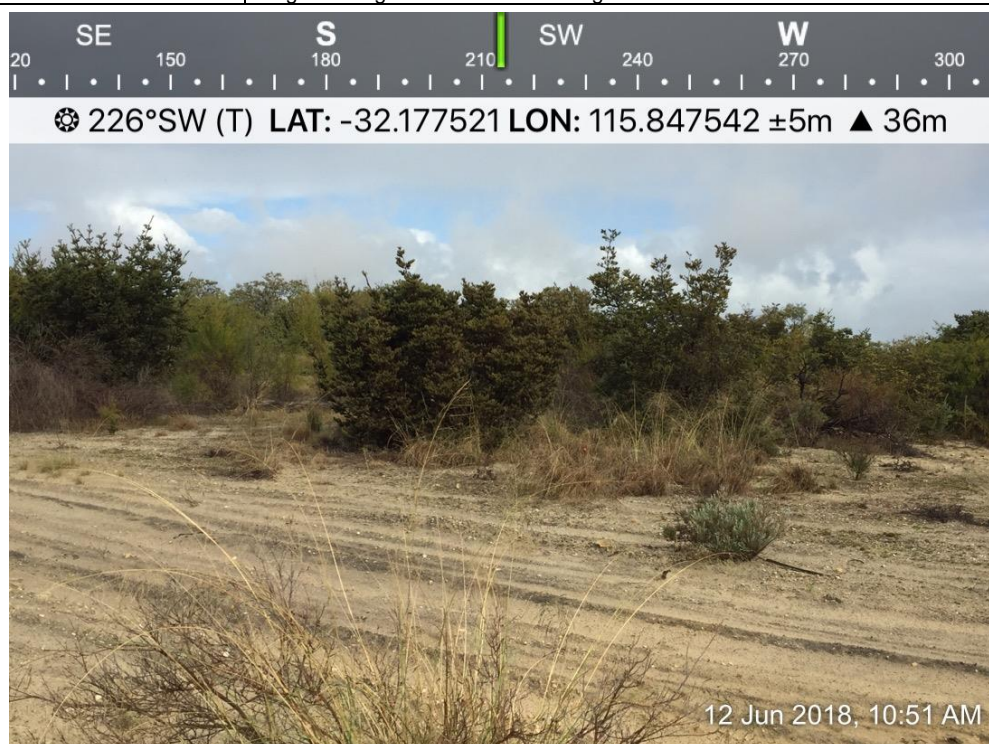
Plot 2:	Class B Woodland
Photo 2b:	Regenerating banksia woodland vegetation within Frankland Park.

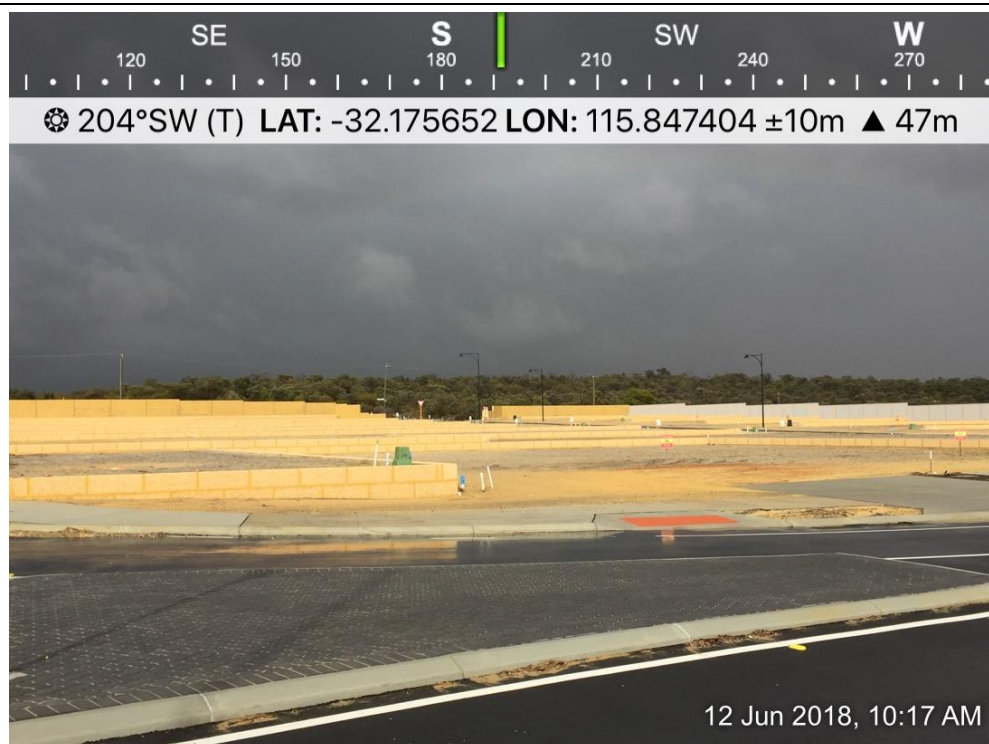
Plot 3:	Excluded – Non-vegetated (Clause 2.2.3.2 [e])
Photo 3a:	Land to west of project area has been cleared to accommodate imminent residential development.

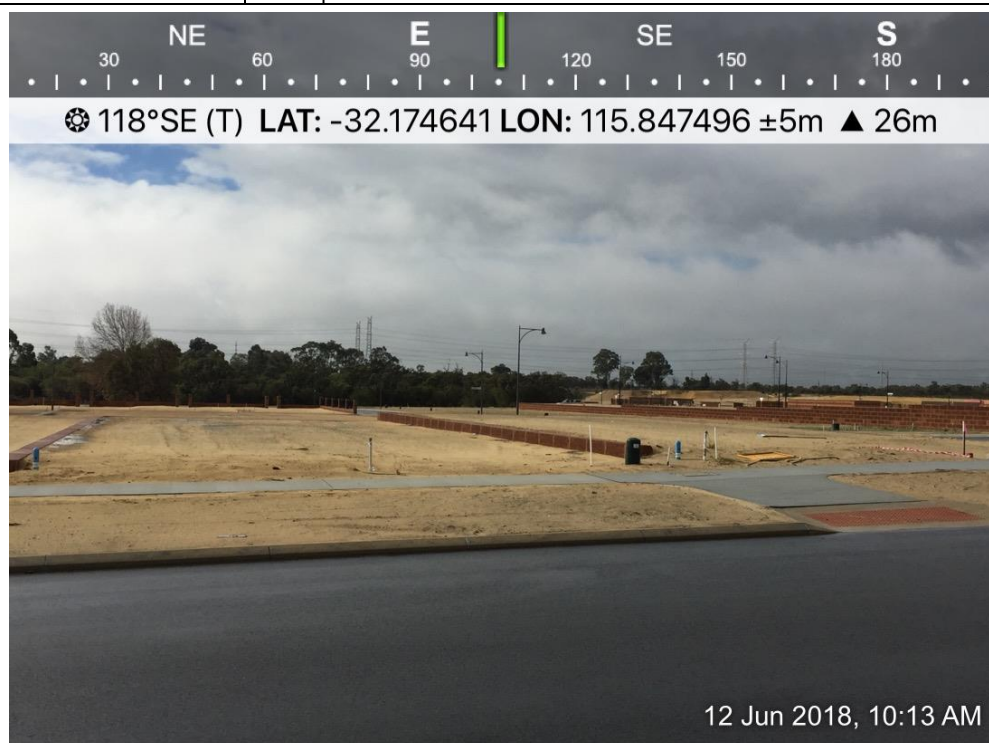
Plot 4:	Excluded – Non-vegetated (Clause 2.2.3.2 [e])
Photo 4a:	Land to north of project area has been cleared to accommodate imminent residential development.

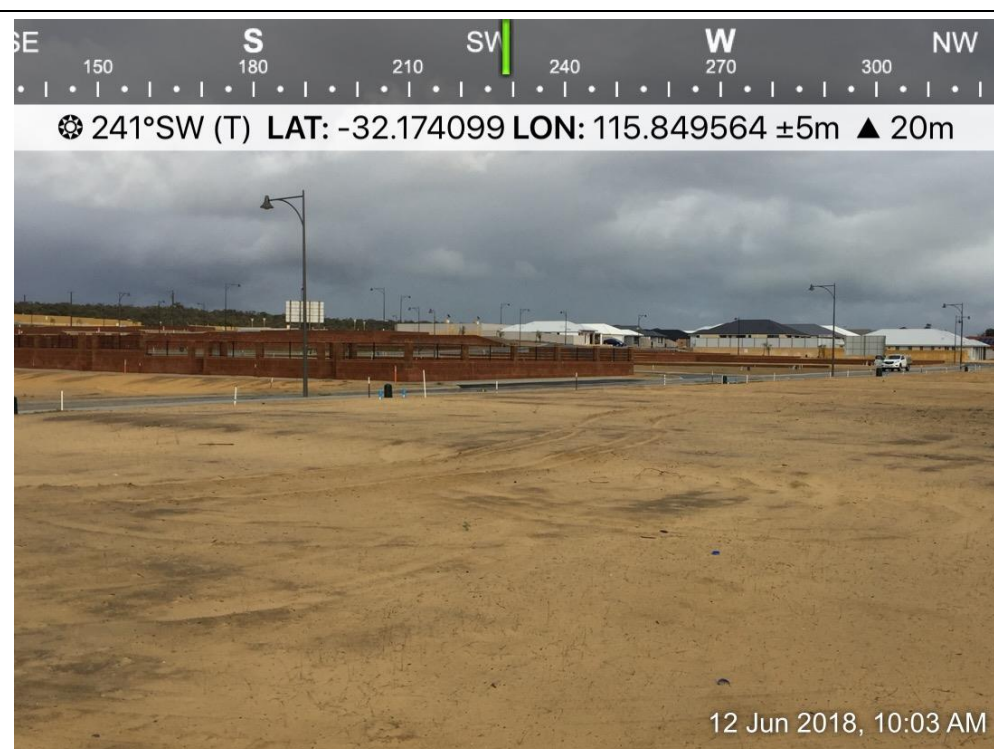
Plot 4:	Excluded – Non-vegetated (Clause 2.2.3.2 [e])
Photo 4b:	Land to north of project area has been cleared to accommodate imminent residential development.

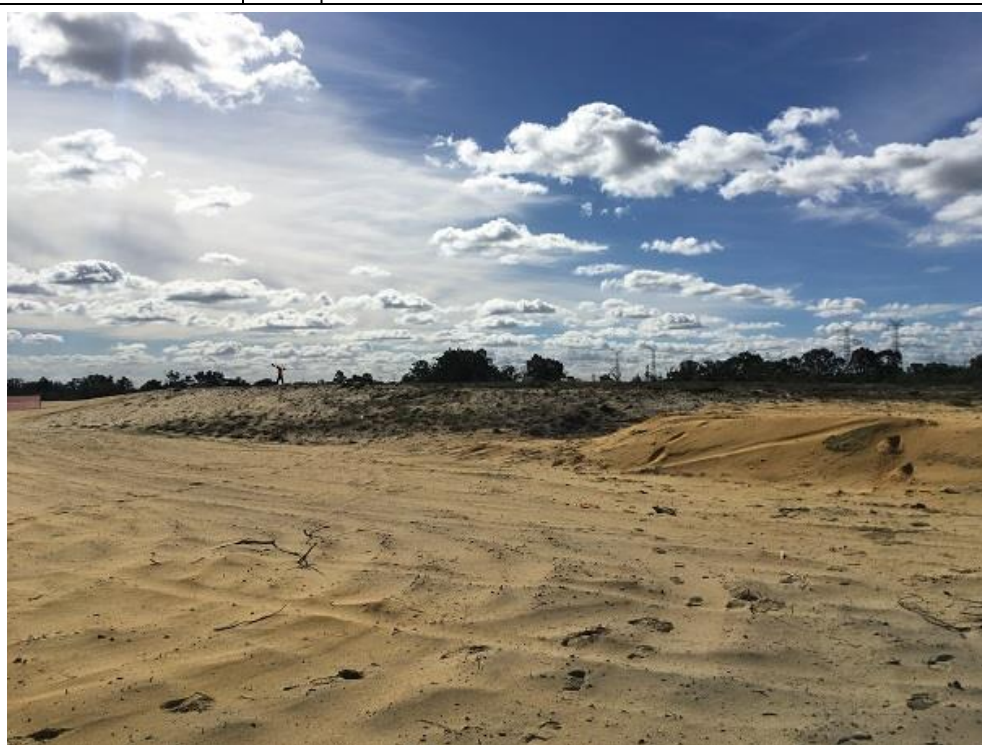
- The 100 m wide low threat staging buffer to the east and south of the subject lots (Plots 4 and 5) has been implemented properly in accordance with the previous BMP prepared over the site and is excluded from classification under a combination of Clauses 2.2.3.2 (e) and (f).

Plot 5:	Excluded – Non-vegetated & Low threat (Clauses 2.2.3.2 [e] and [f])
Photo 5a:	Vacant land within 100 m low threat staging buffer surrounding project area maintained in a low threat state, including all grassland slashed to <100 mm.

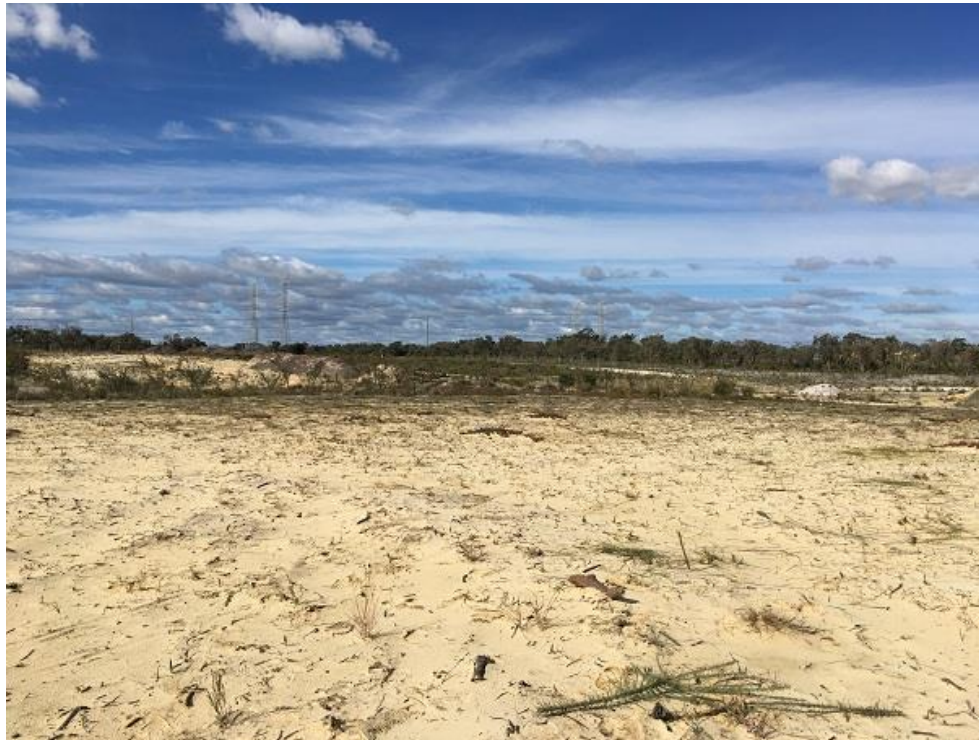
Plot 5:	Excluded – Non-vegetated & Low threat (Clauses 2.2.3.2 [e] and [f])
Photo 5b:	Vacant land within 100 m low threat buffer surrounding project area maintain in a low threat state, including all grassland slashed to <100 mm.

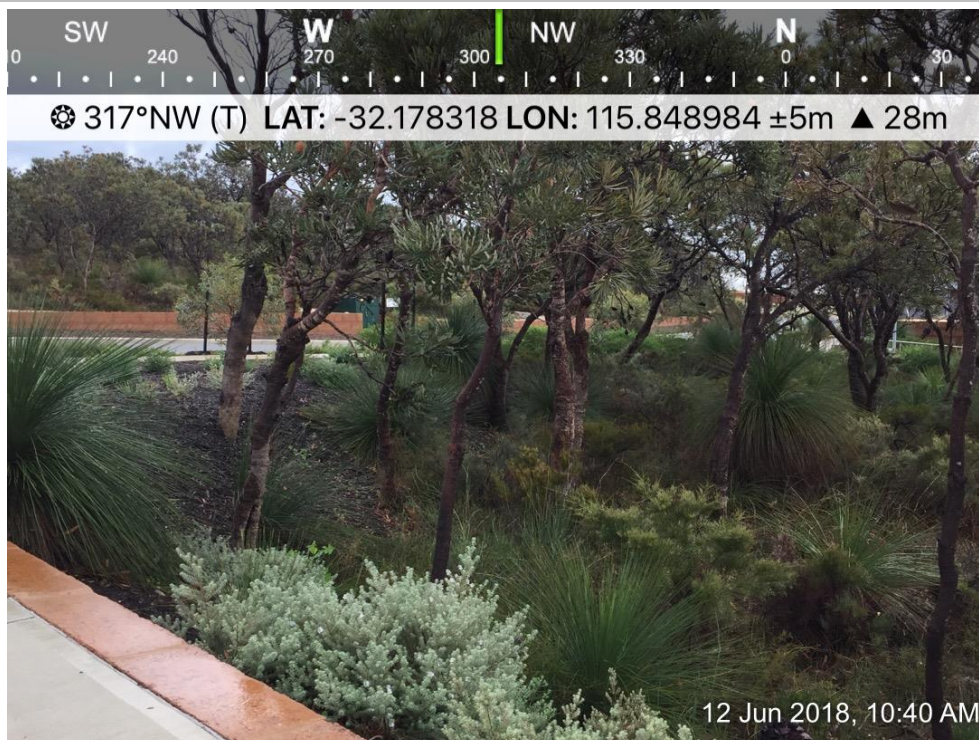
- The five individual POS areas (Plot 6) to the south of the subject lots comprise a combination of active POS (maintained turf and play areas) and retained native vegetation. Strategen is satisfied that the retained vegetation is being maintained in accordance with the previous BMP prepared to support the subdivision (Strategen, 2015). In this regard, the five POS areas have been excluded under Clause 2.2.3.2 (f).

Plot 6:	Excluded – Low threat (Clause 2.2.3.2 [f])
Photo 6a:	Retained vegetation within POS maintained in accordance with the previous BMP (Strategen, 2015).

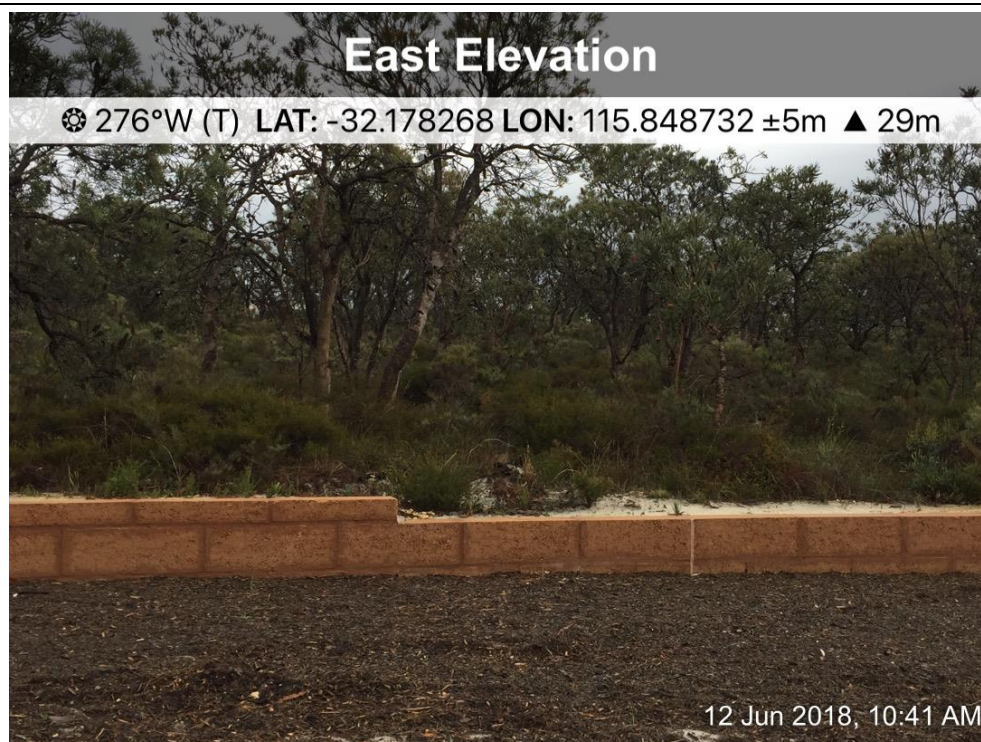
Plot 6:	Excluded – Low threat (Clause 2.2.3.2 [f])
Photo 6b:	Retained vegetation within POS maintained in accordance with the previous BMP (Strategen, 2015).

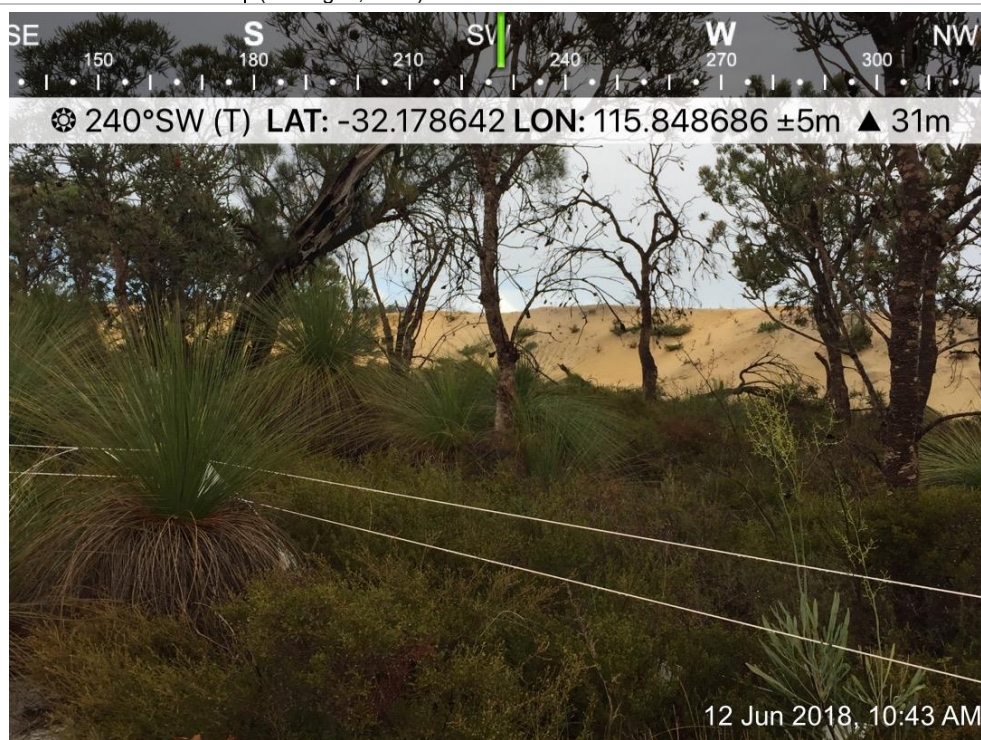
Plot 6:	Excluded – Low threat (Clause 2.2.3.2 [f])
Photo 6c:	Retained vegetation within POS maintained in accordance with the previous BMP (Strategen, 2015).

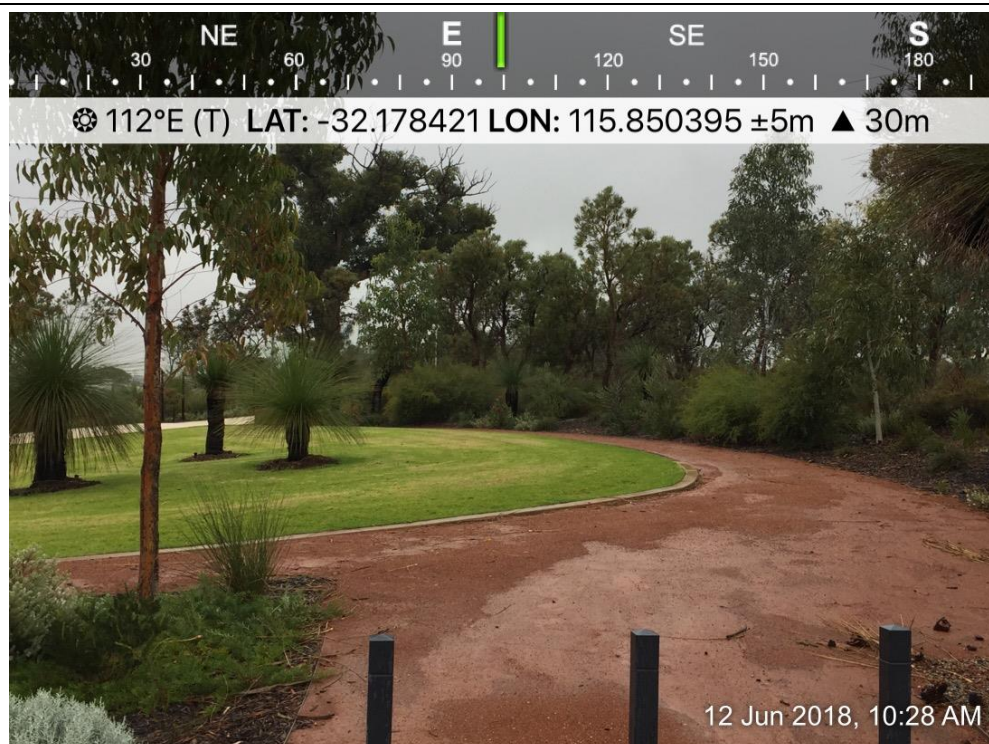
Plot 6:	Excluded – Low threat (Clause 2.2.3.2 [f])
Photo 6d:	Retained vegetation within POS maintained in accordance with the previous BMP (Strategen, 2015).

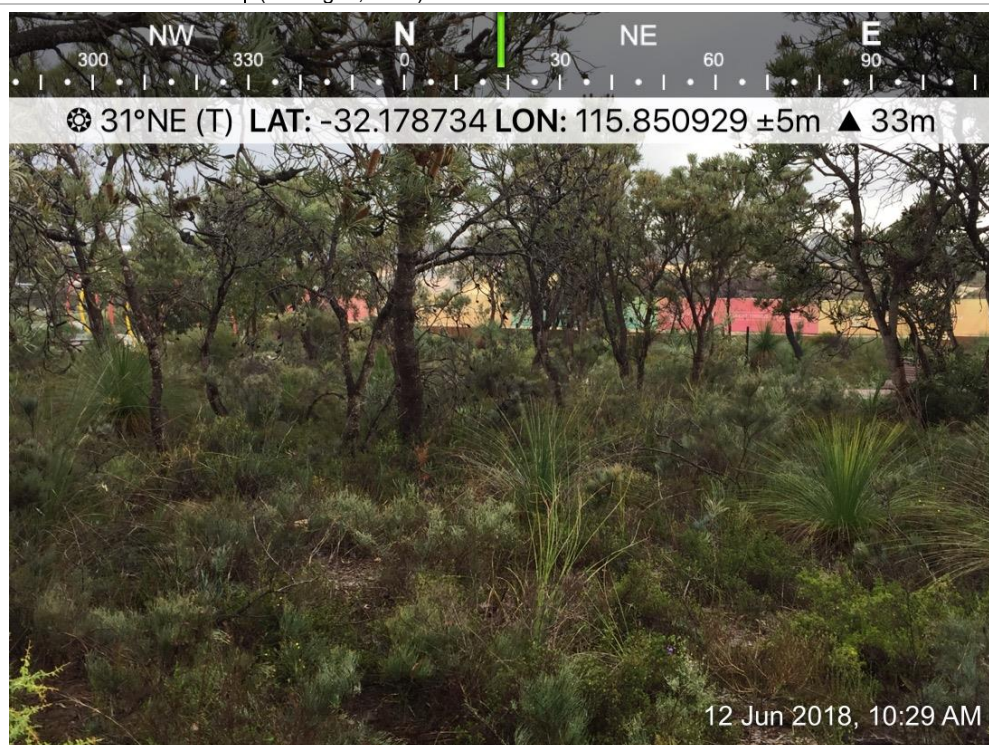
Plot 6:	Excluded – Low threat (Clause 2.2.3.2 [f])
Photo 6e:	Retained vegetation within POS maintained in accordance with the previous BMP (Strategen, 2015).

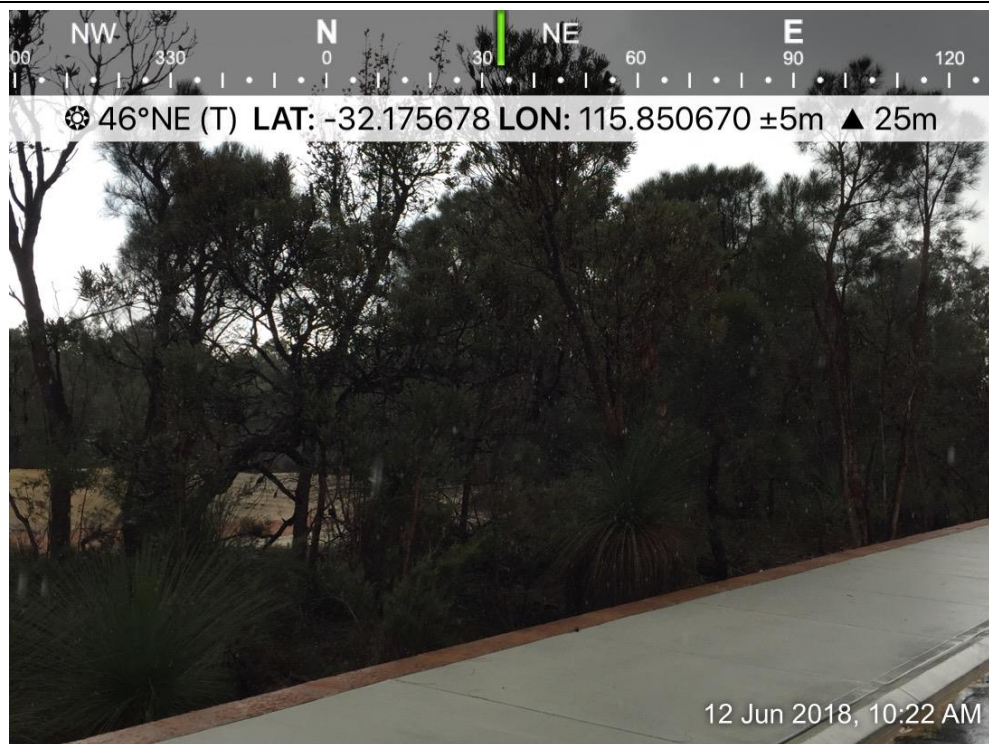
- The northern POS area (Plot 7), directly south of the cleared school site, is excluded in accordance with AS 3959 Clause 2.2.3.2 (c); multiple areas of vegetation less than 0.25 ha in area and not within 20 m of other areas of vegetation being classified or the proposed lots.

Plot 7:	Excluded – Clause 2.2.3.2 [c]
Photo 7a:	Retained vegetation within POS maintained in accordance with the previous BMP (Strategen, 2015) and excluded in accordance with Clause 2.2.3.2 (c) being vegetation less than 0.25 ha in area and not within 20 m of the proposed lots or other vegetation plots.
