Bushfire Attack Level (BAL) Compliance Report Stages 2 & 3 Vivente

Address: 45 residential lots within Stages 2A, 2B, 3A and 3B Vivente

Suburb:	Hammond Park	State:	Western Australia
----------------	--------------	---------------	-------------------

Report/Job number:	RNO18292.01	Report version:	M001 Rev B
Assessment date:	12 June 2018	Report date:	27 July 2018
Report Review Endorsement	Z Cockerill 26 July 2018	BPAD37803	Level 2 Accredited

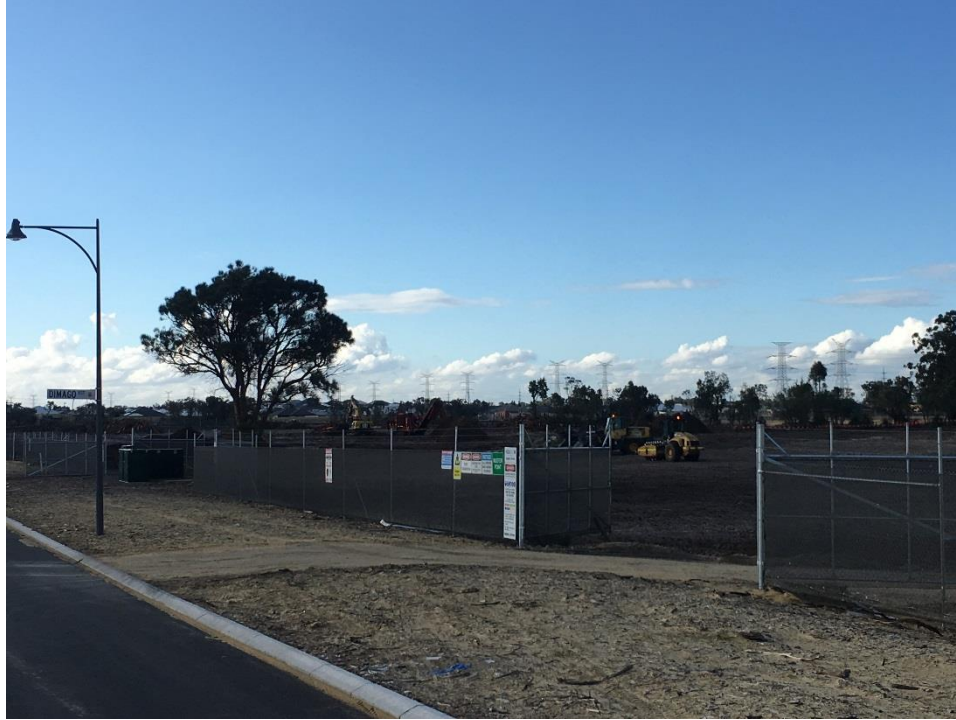
Plot 1:	Excluded – Non-vegetated & Low threat (Clauses 2.2.3.2 [e] and [f])
Photo 1a:	Future school site has recently been cleared.

- Latest Nearmap imagery (dated June 2018) shows classified vegetation occurring northeast of the Stage 3 development area within the future school site (Plot 1) and future POS directly south of the school site (Plot 7). The school site has, however, recently been cleared, the extent of which is shown in Figure 1. The approved Bulk Earthworks Plan included in Appendix 2 shows that there is no classified vegetation to be retained within 150 m of the proposed Stage 2 and 3 lots.

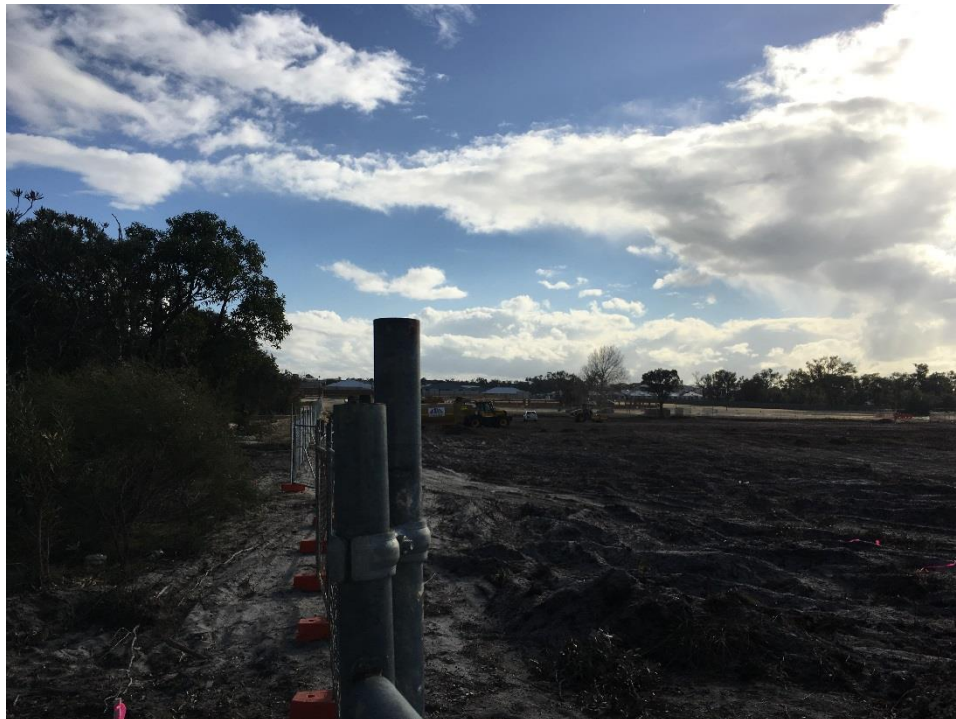
Plot 1:	Excluded – Non-vegetated & Low threat (Clauses 2.2.3.2 [e] and [f])
Photo 1b:	Future school site has recently been cleared.

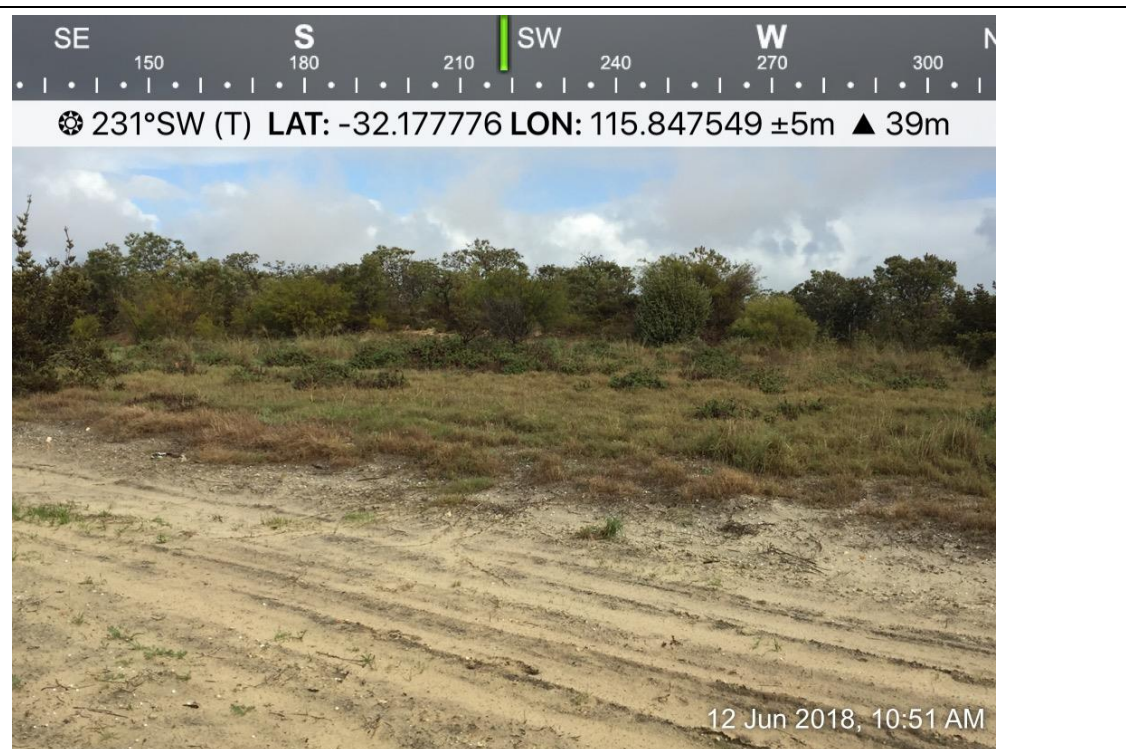
Plot 2:	Class B Woodland
Photo 2a:	Regenerating banksia woodland vegetation within Frankland Park.

Classified vegetation was observed within Frankland Park (Plot 2) which is situated to the west of Frankland Avenue and the project area. This vegetation has been classified as Class B Woodland.

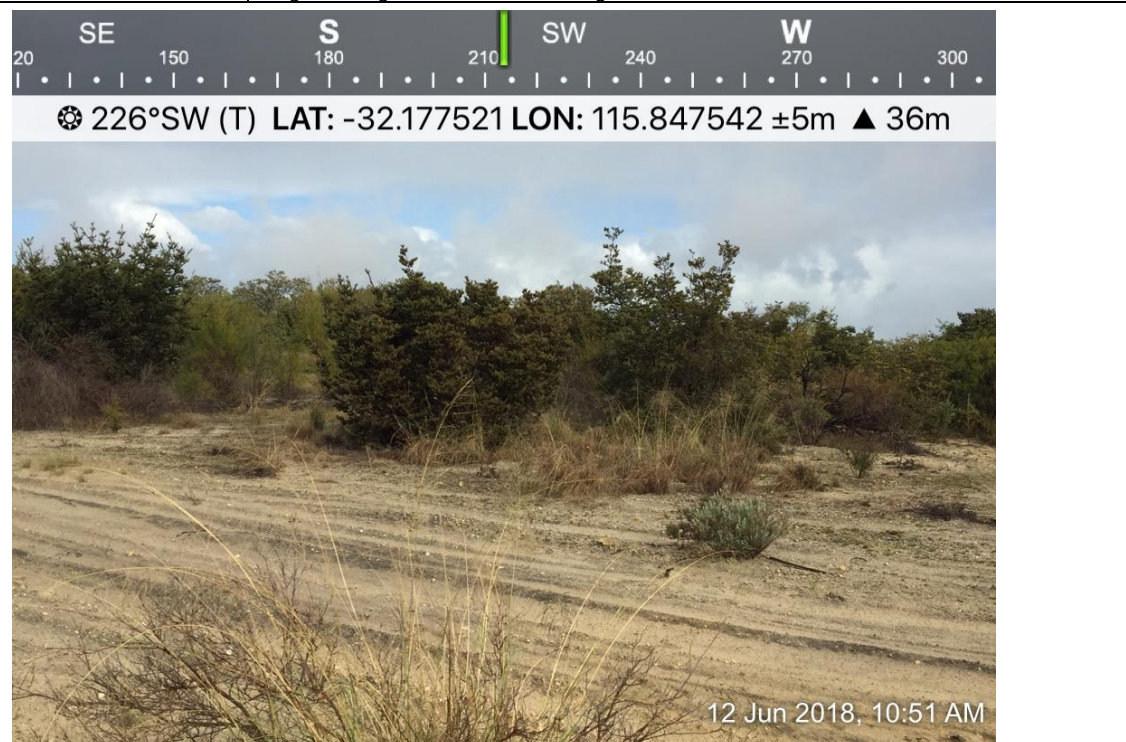
Plot 2:	Class B Woodland
Photo 2b:	Regenerating banksia woodland vegetation within Frankland Park.

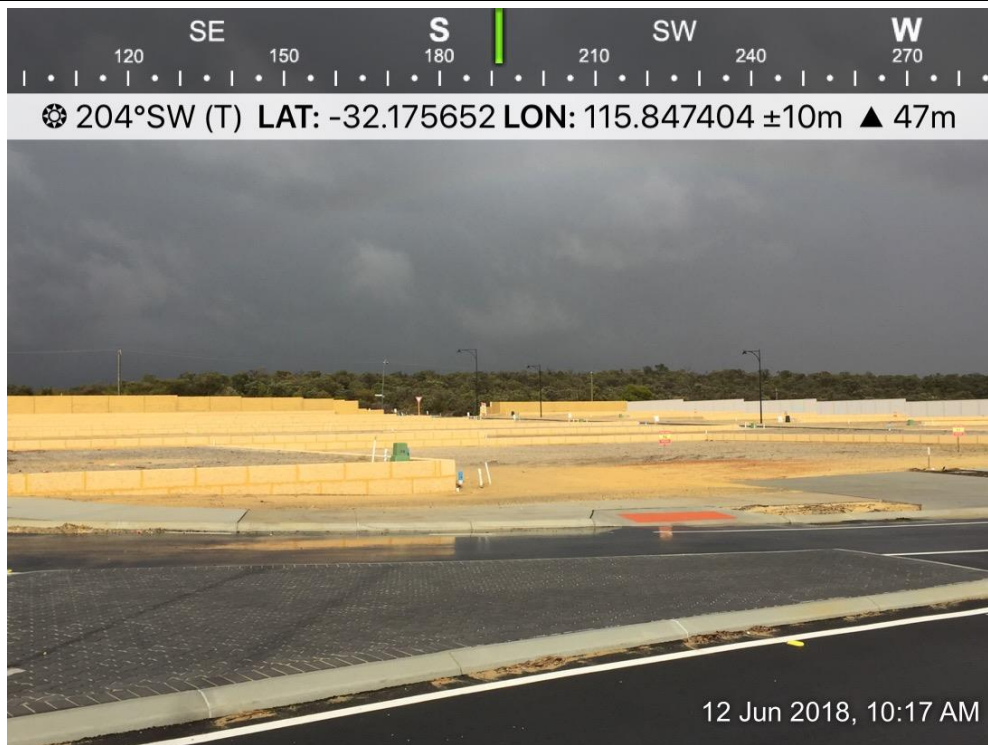
Plot 3:	Excluded – Non-vegetated (Clause 2.2.3.2 [e])
Photo 3a:	Land to west of project area has been cleared to accommodate imminent residential development.

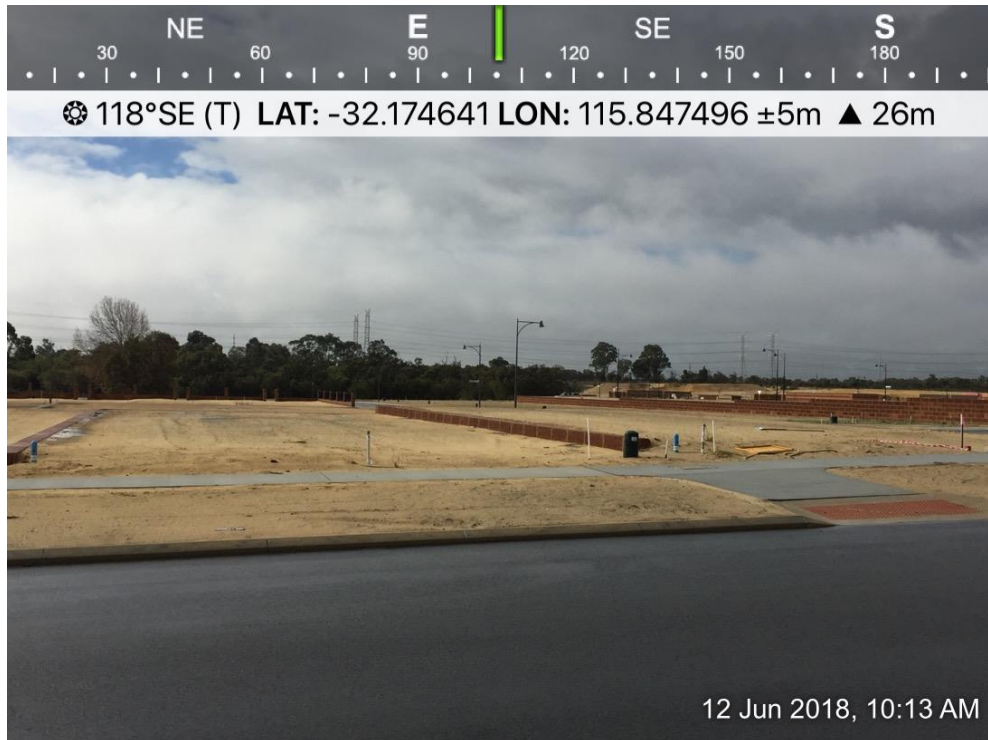
Plot 4:	Excluded – Non-vegetated (Clause 2.2.3.2 [e])
Photo 4a:	Land to north of project area has been cleared to accommodate imminent residential development.

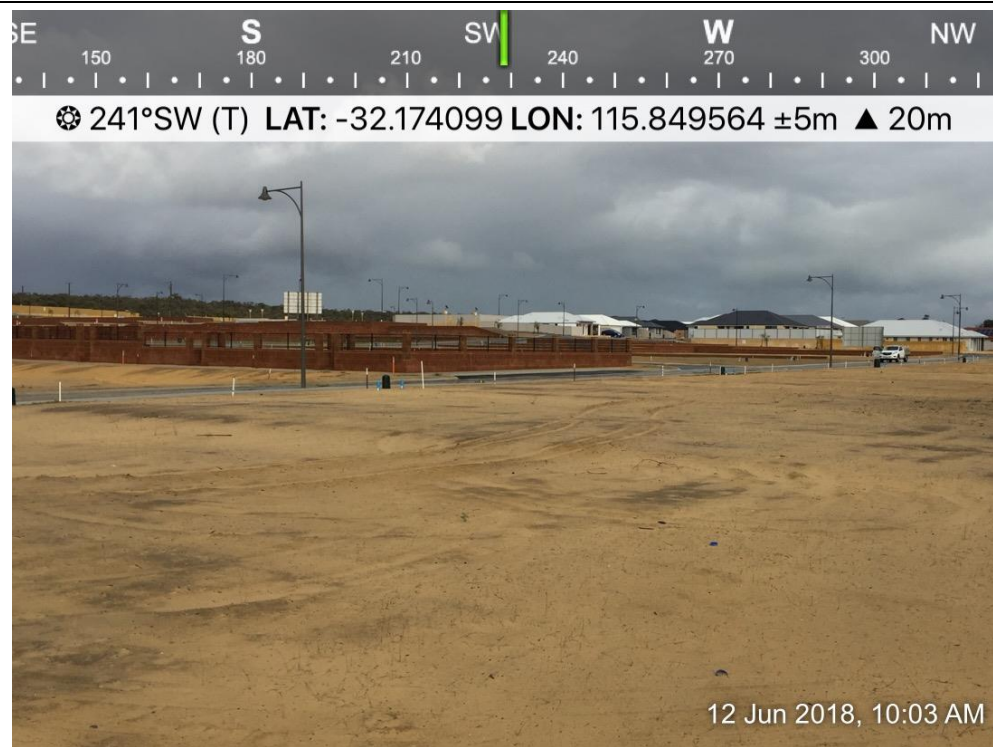
Plot 4:	Excluded – Non-vegetated (Clause 2.2.3.2 [e])
Photo 4b:	Land to north of project area has been cleared to accommodate imminent residential development.

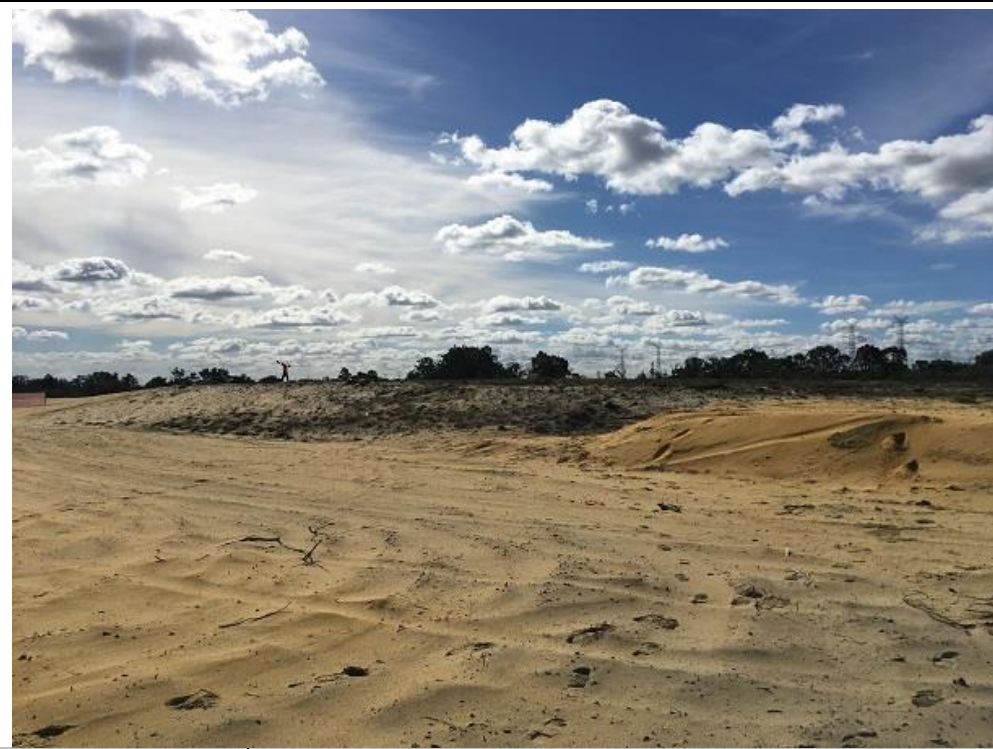
Plot 5:	Excluded – Non-vegetated & Low threat (Clauses 2.2.3.2 [e] and [f])
Photo 5a:	Vacant land within 100 m low threat staging buffer surrounding project area maintained in a low threat state, including all grassland slashed to <100 mm.

- The 100 m wide low threat staging buffer to the east and south of the subject lots (Plots 4 and 5) has been implemented properly in accordance with the previous BMP prepared over the site and is excluded from classification under a combination of Clauses 2.2.3.2 (e) and (f).

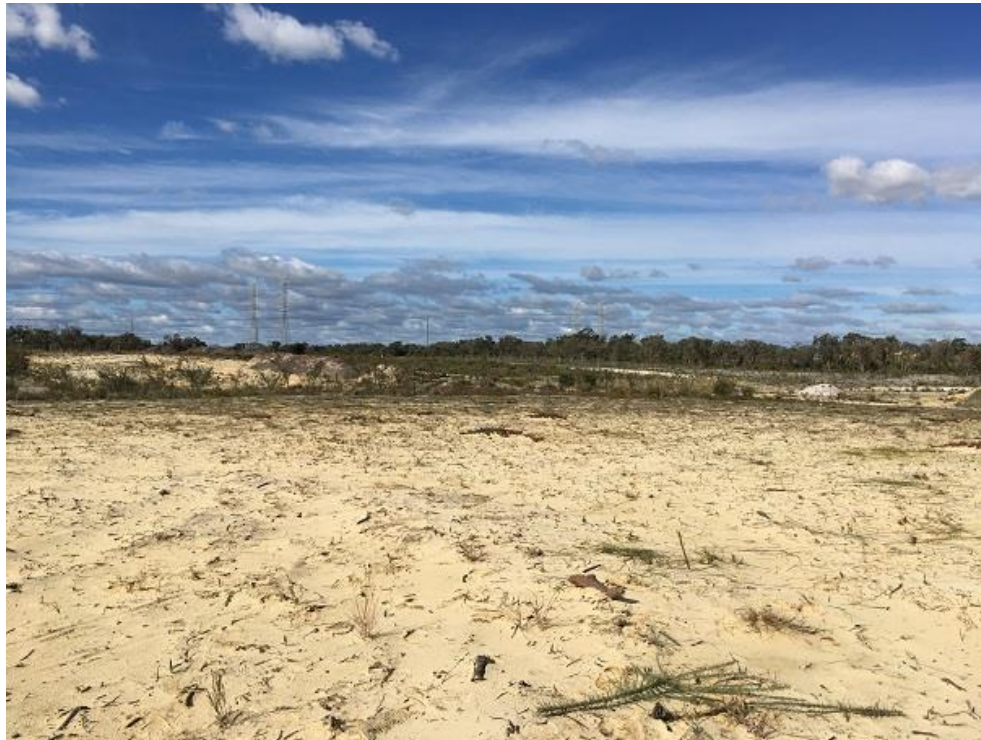
Plot 5:	Excluded – Non-vegetated & Low threat (Clauses 2.2.3.2 [e] and [f])
Photo 5b:	Vacant land within 100 m low threat buffer surrounding project area maintain in a low threat state, including all grassland slashed to <100 mm.

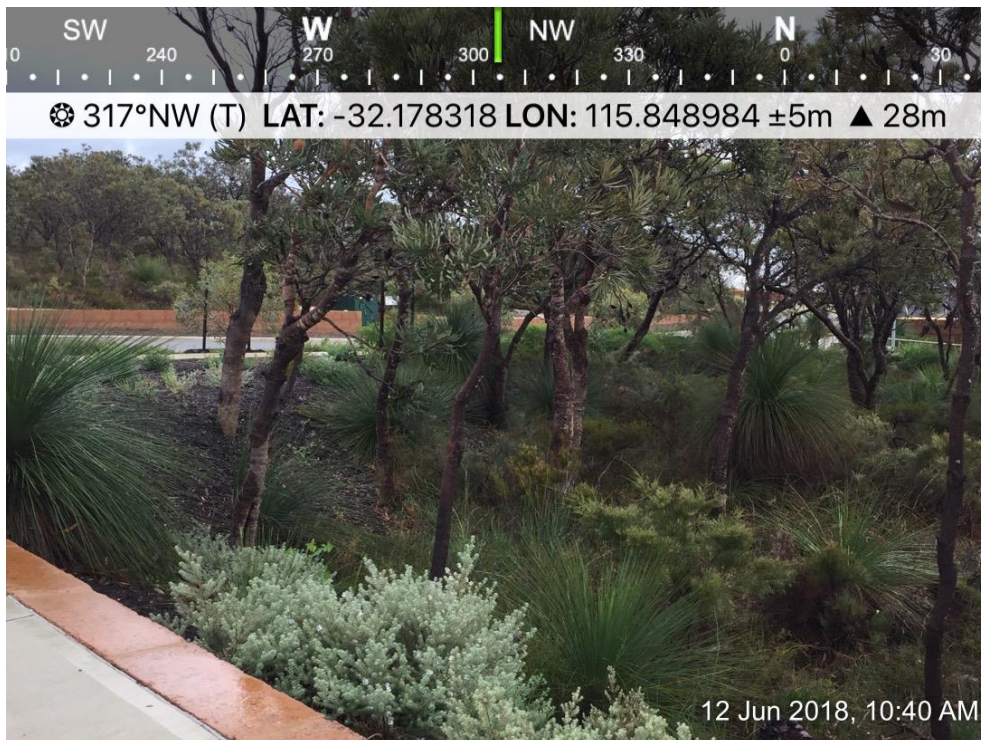
Plot 6:	Excluded – Low threat (Clause 2.2.3.2 [f])
Photo 6a:	Retained vegetation within POS maintained in accordance with the previous BMP (Strategen, 2015).

- The five individual POS areas (Plot 6) to the south of the subject lots comprise a combination of active POS (maintained turf and play areas) and retained native vegetation. Strategen is satisfied that the retained vegetation is being maintained in accordance with the previous BMP prepared to support the subdivision (Strategen, 2015). In this regard, the five POS areas have been excluded under Clause 2.2.3.2 (f).

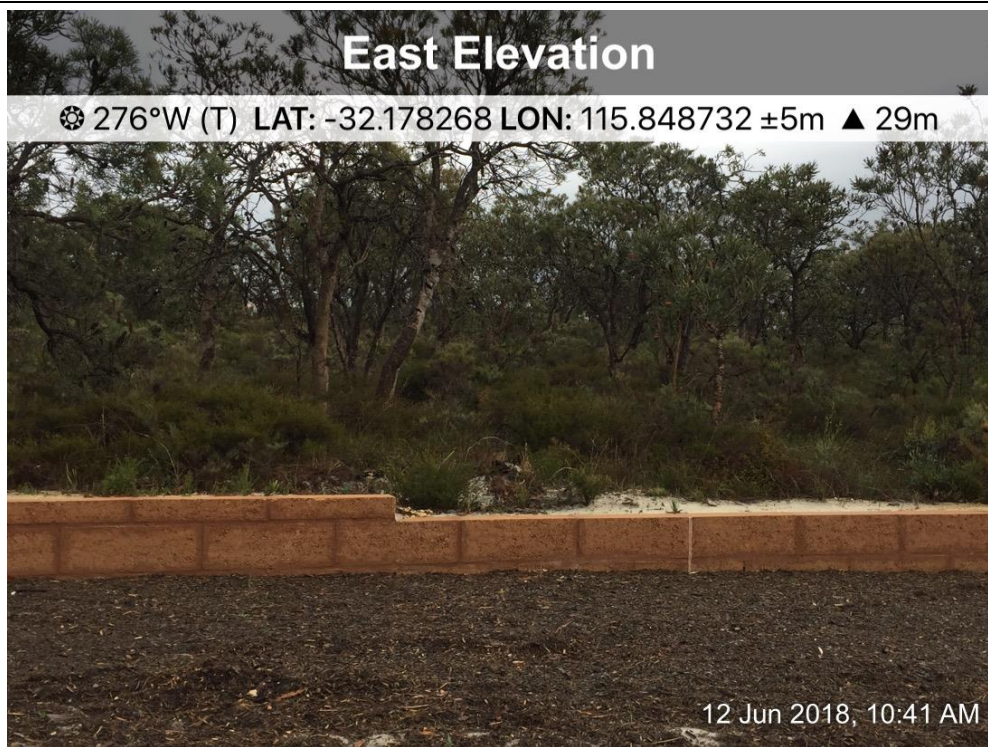
Plot 6:	Excluded – Low threat (Clause 2.2.3.2 [f])
Photo 6b:	Retained vegetation within POS maintained in accordance with the previous BMP (Strategen, 2015).

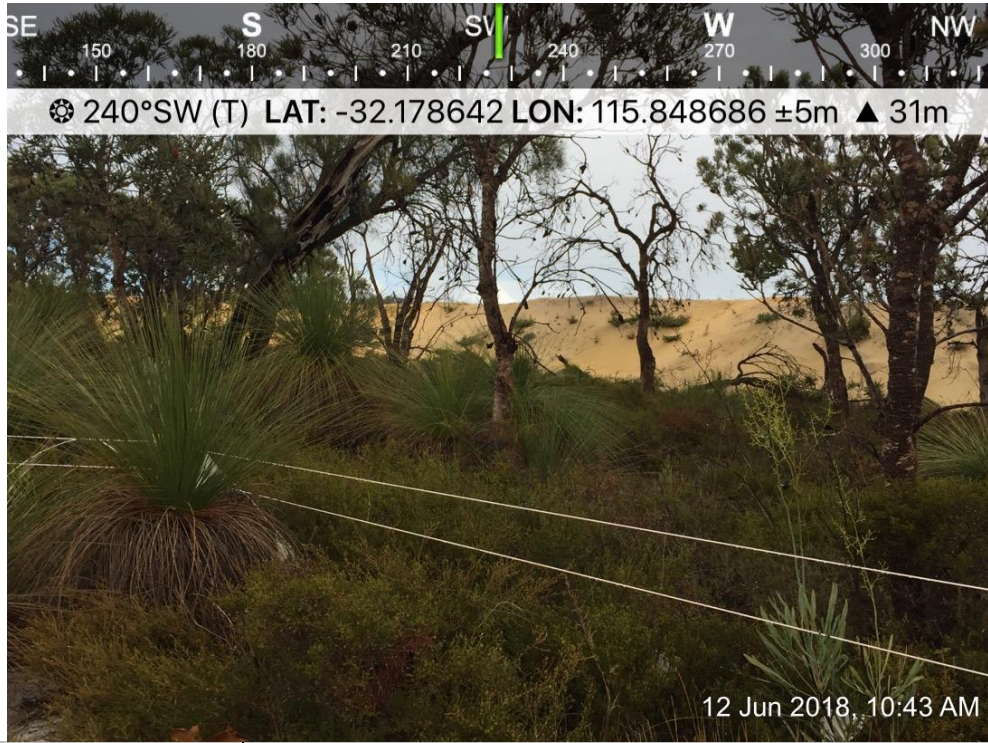
Plot 6:	Excluded – Low threat (Clause 2.2.3.2 [f])
Photo 6c:	Retained vegetation within POS maintained in accordance with the previous BMP (Strategen, 2015).

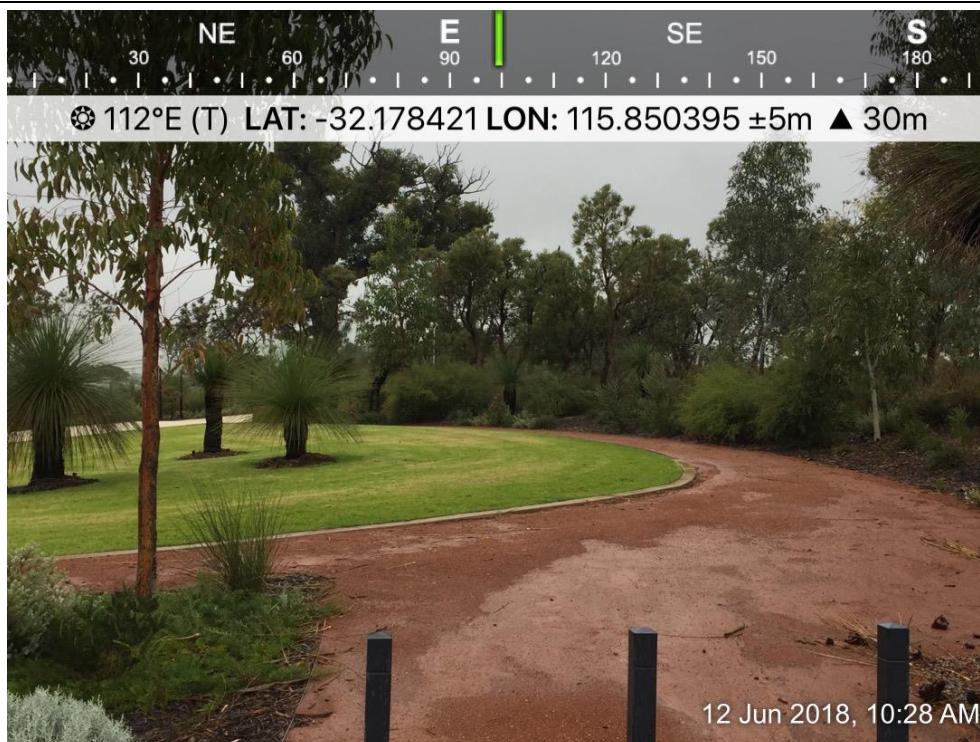
Plot 6:	Excluded – Low threat (Clause 2.2.3.2 [f])
Photo 6d:	Retained vegetation within POS maintained in accordance with the previous BMP (Strategen, 2015).

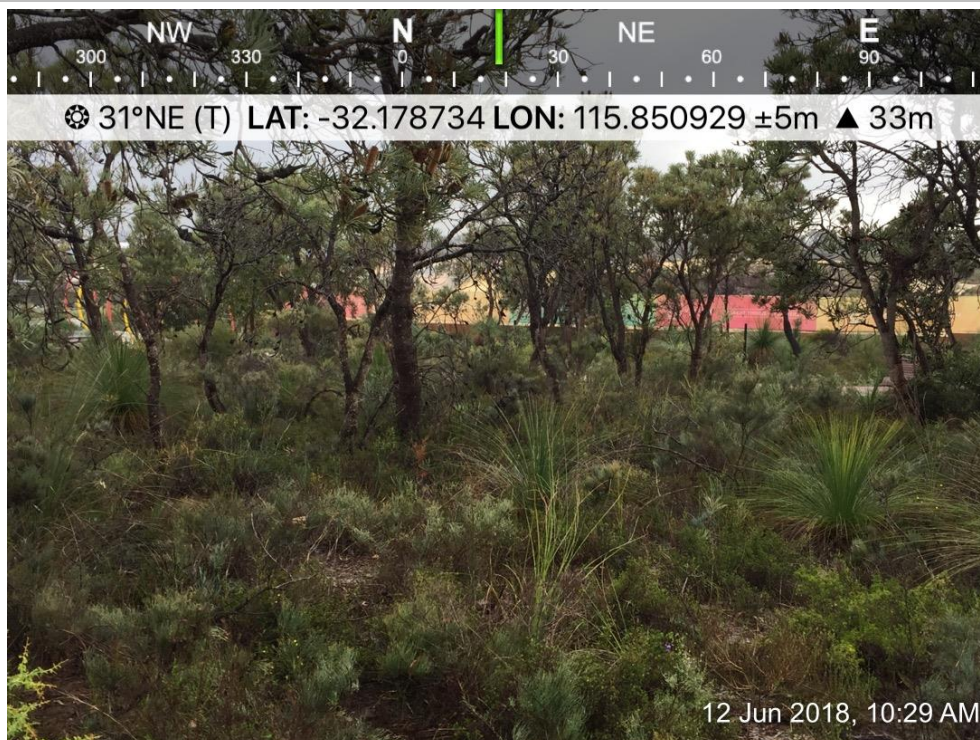
Plot 6:	Excluded – Low threat (Clause 2.2.3.2 [f])
Photo 6e:	Retained vegetation within POS maintained in accordance with the previous BMP (Strategen, 2015).

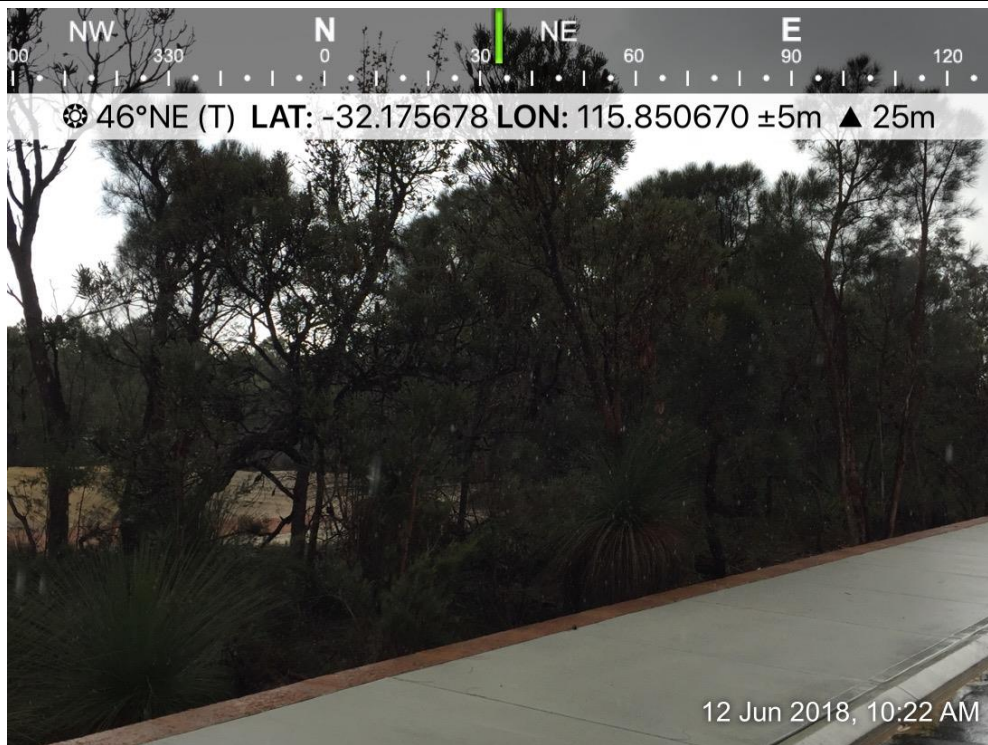
Plot 7:	Excluded – Clause 2.2.3.2 [c]
Photo 7a:	Retained vegetation within POS maintained in accordance with the previous BMP (Strategen, 2015) and excluded in accordance with Clause 2.2.3.2 (c) being vegetation less than 0.25 ha in area and not within 20 m of the proposed lots or other vegetation plots.

- The northern POS area (Plot 7), directly south of the cleared school site, is excluded in accordance with AS 3959 Clause 2.2.3.2 (c); multiple areas of vegetation less than 0.25 ha in area and not within 20 m of other areas of vegetation being classified or the proposed lots.
