Richard Noble AS 3959 Bushfire Attack Level (BAL) Assessment Report

Lot 285 Campana Rise, Hammond Park, WA

12 March 2020 56824/128,175 (Rev 0) JBS&G Australia Pty Ltd T/A Strategen-JBS&G

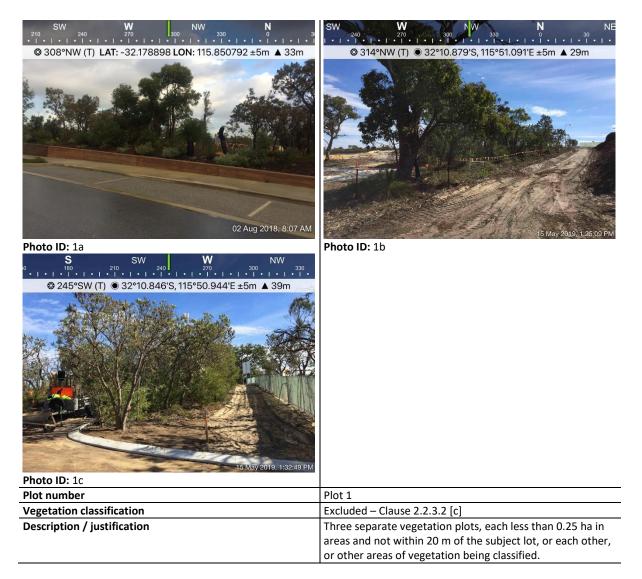
Photo ID: 2a			
Plot number Plot 2			
Vegetation classification Excluded – Clause 2.2.3.2 [d]			
<b>Description / justification</b> Plot comprises a single strip of vegetation less than 20 m width and not			
	20 m of the subject lot.
