Richard Noble
Bushfire Attack Level (BAL) Compliance Report

Stage 5 – Vivente Estate
Hammond Park

25 February 2020

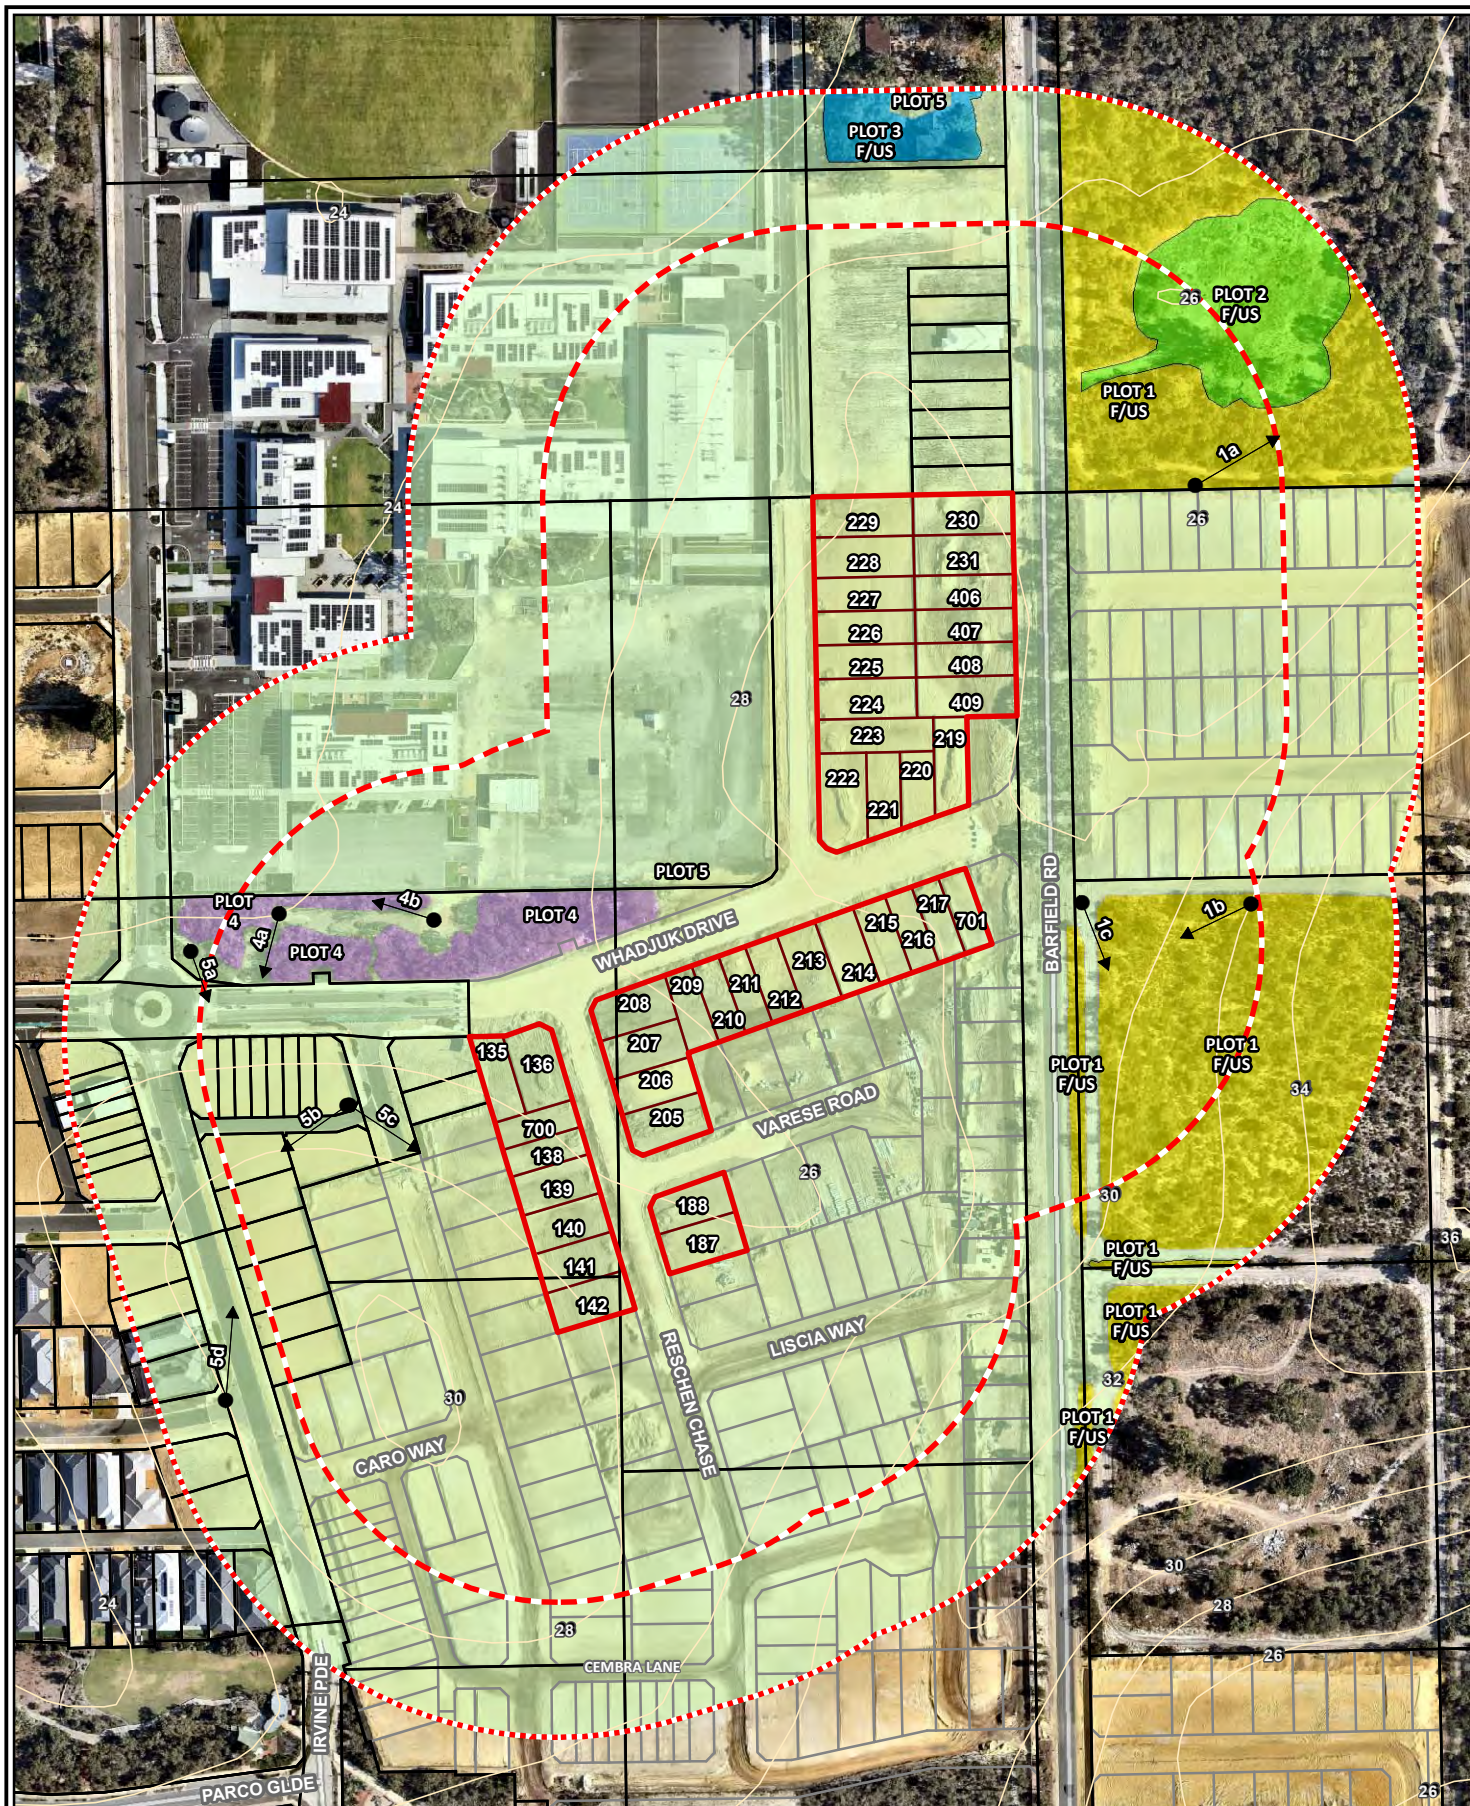
FIGURE 1

Site observations indicate that, apart from a small area of vegetation (i.e. Plot 3) that is greater than 100 m from the project area being reclassified from Class D Scrub to Class B Woodland, the vegetation classifications align with the post-development vegetation classifications determined by the endorsed Strategen (2019) BMP.

Site observations indicate that effective slope under the classified vegetation aligns with the effective slopes identified within the endorsed Strategen (2019) BMP.

Figure 1 illustrates the current vegetation classifications and exclusions observed during the inspection, which represent post-development conditions for the site. The vegetation classifications/exclusions and effective slope are summarised in Table 2.

VEGETATION CLASSIFICATION
AND EFFECTIVE SLOPE

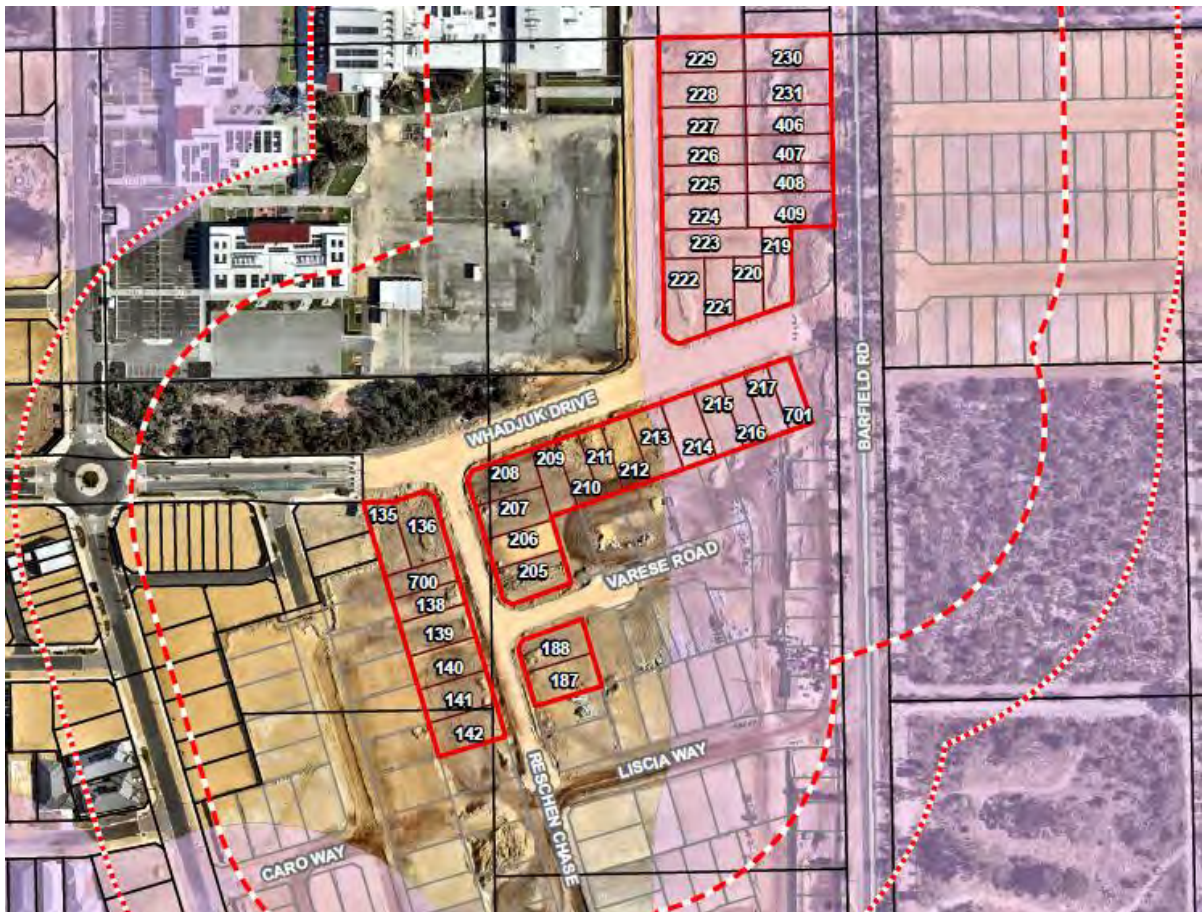
Plate 1 : Map of Bush Fire Prone Areas (DFES 2020)

18 of the lots within Stage 5 are not situated within a designated bushfire prone area (as per the state Map of Bush Fire Prone Areas; see Plate 1) and therefore do not trigger a formal requirement for bushfire consideration/BAL assessment at the building stage. As such, BAL certificates have not been provided for the below lots:

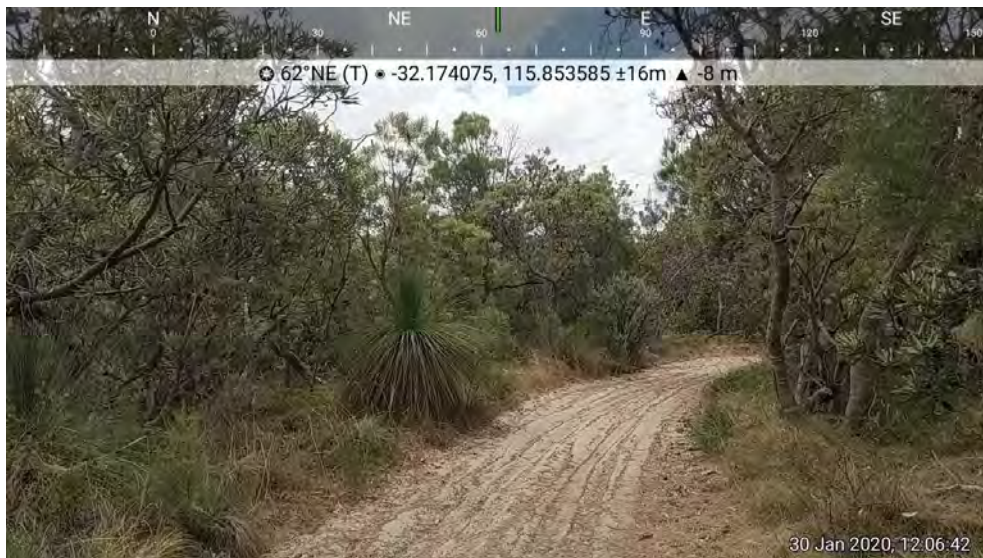
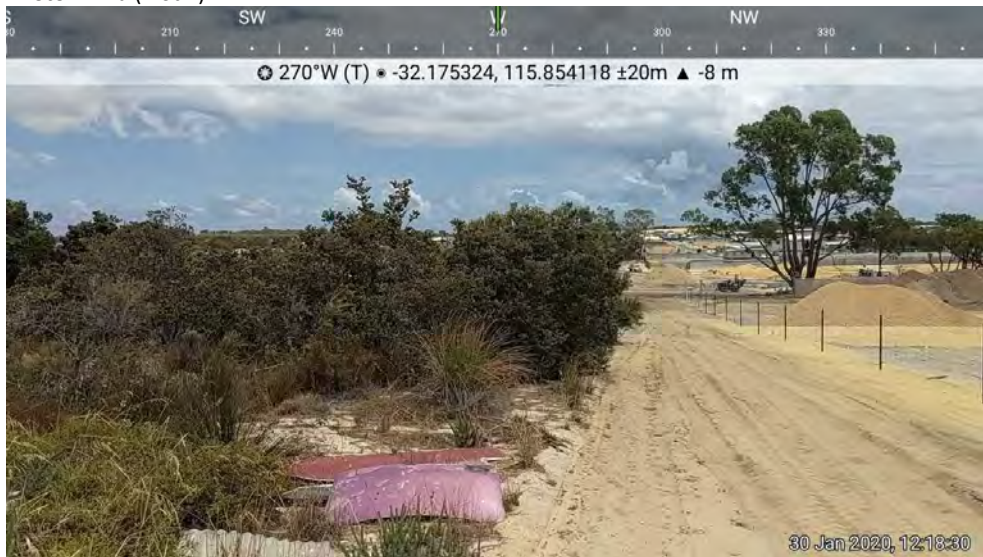
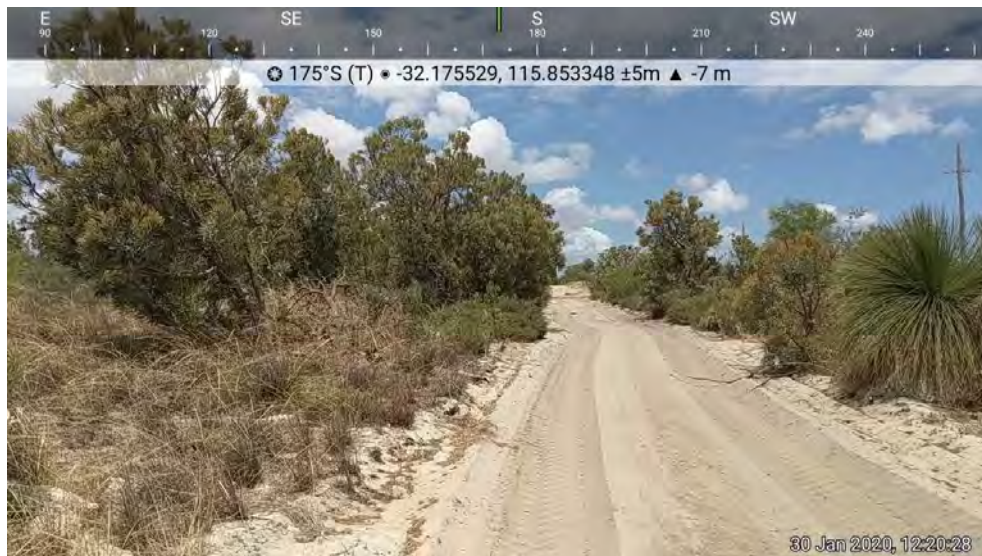
Photo ID: 1a (Plot 1)

Plot number	Plot 1
Vegetation classification	Class D Scrub
Description / justification	Vegetation dominated by low <i>Banksia</i> spp. and <i>Casuarina</i> spp. with a continuous horizontal and vertical structure, greater than 2 m high but less than 6 m high at maturity.

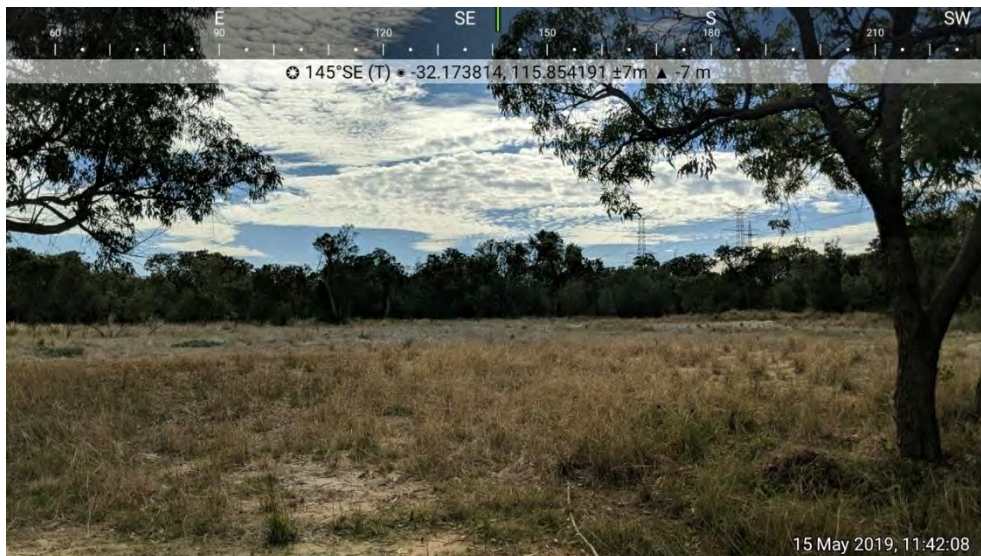
Photo ID: 2a (Plot 2)

Plot number	Plot 2
Vegetation classification	Class G Grassland
Description / justification	Grassland at maturity, greater than 100 mm in height

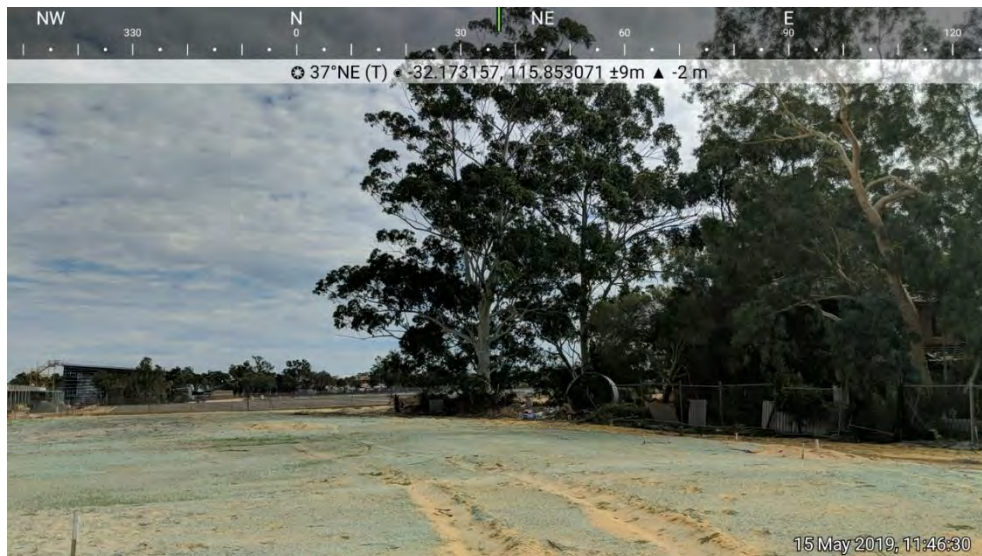
Photo ID: 3a (Plot 3, Background RHS)

Plot number	Plot 3
Vegetation classification	Class B Woodland
Description / justification	Trees 2-30 m at maturity, dominated by trees with a grassy understorey (lacks shrubby middle layer and deep surface litter)

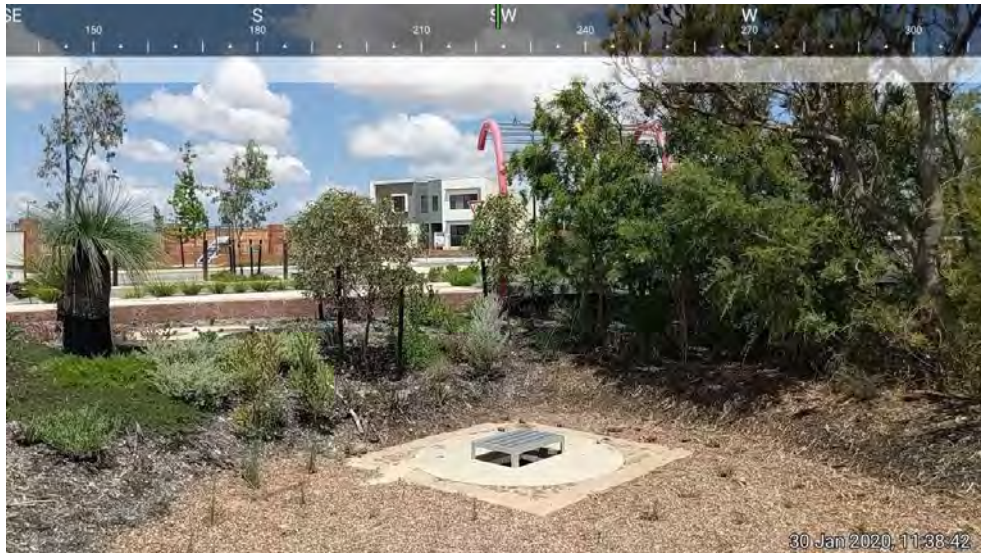
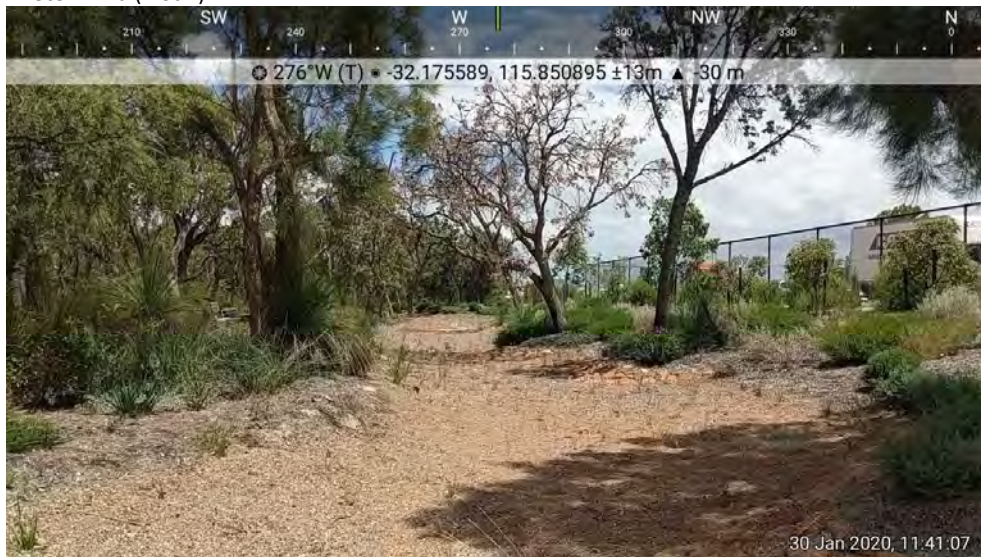
Photo ID: 4a (Plot 4)

Plot number	Plot 4
Vegetation classification	Excluded – Clause 2.2.3.2 [b]
Description / justification	A single area of vegetation less than 1 ha in size and not within 100 m of other classified vegetation.

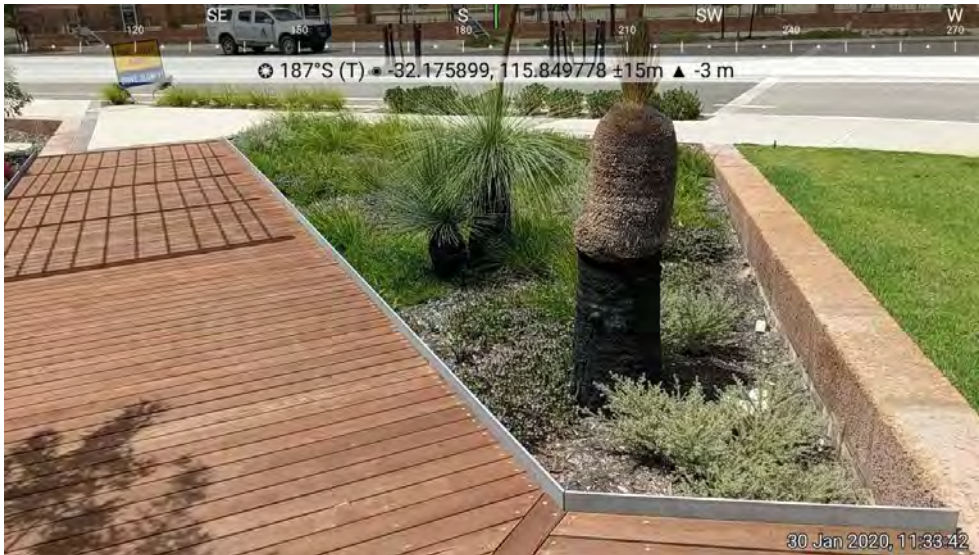
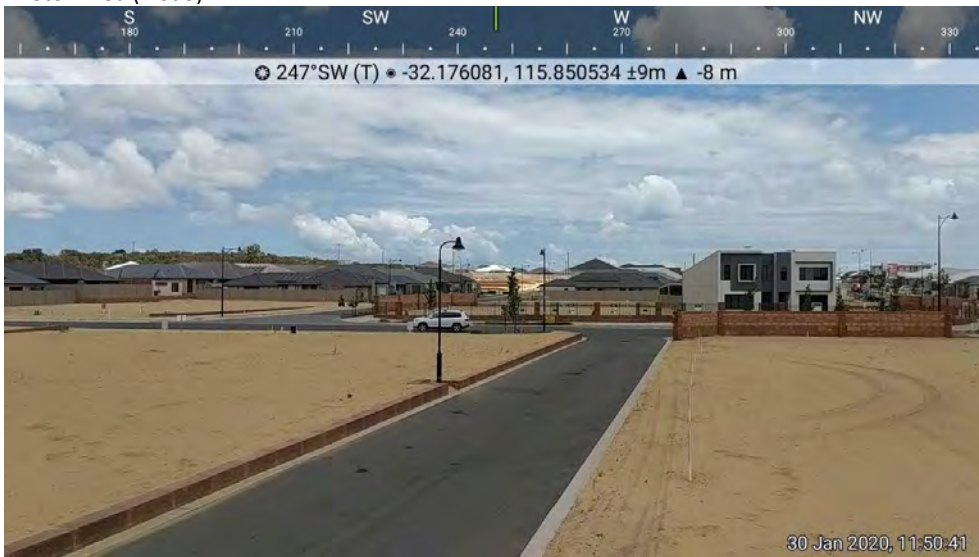
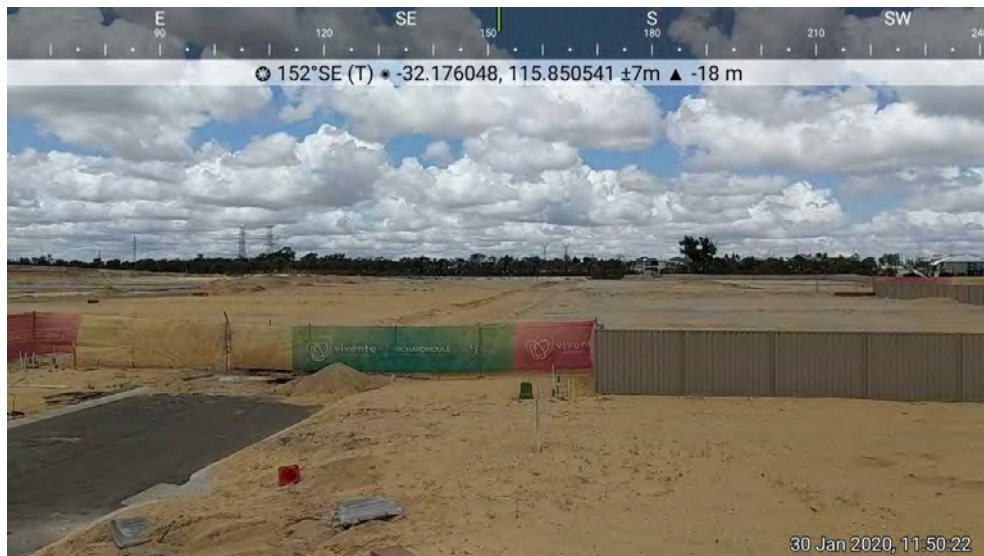
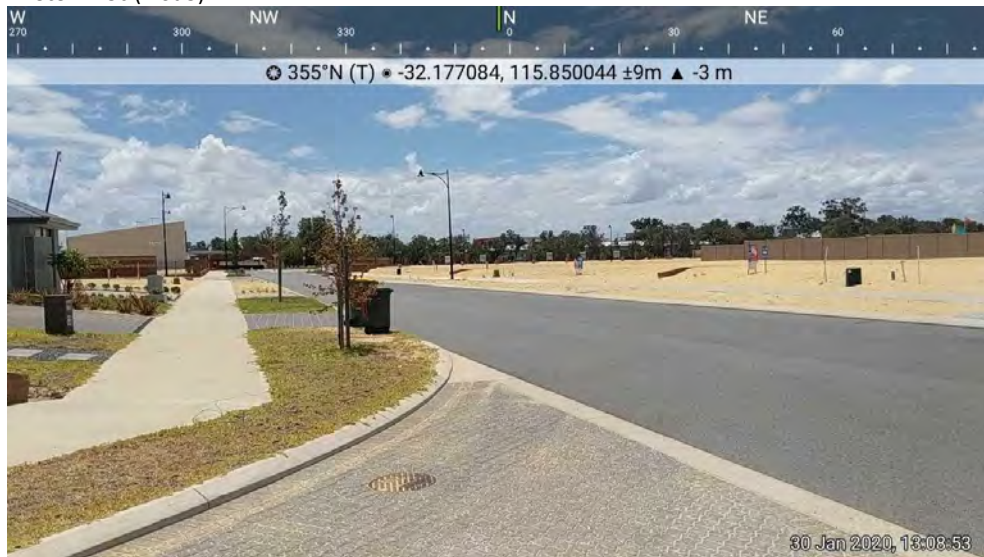
Photo ID: 5a (Plot 5)

Plot number	Plot 5
Vegetation classification	Excluded – Non-vegetated and Low threat (Clause 2.2.3.2 [e] and [f])
Description / justification	Low threat cultivated gardens and maintained lawns within surrounding properties and non-vegetated areas including roads, footpaths, driveways and building footprints
