Bushfire Attack Level (BAL) Compliance Report

Stage 8 Vivente, Hammond Park, WA

22 April 2021 60210/136,884 (Rev 0) JBS&G Australia Pty Ltd T/A Strategen-JBS&G

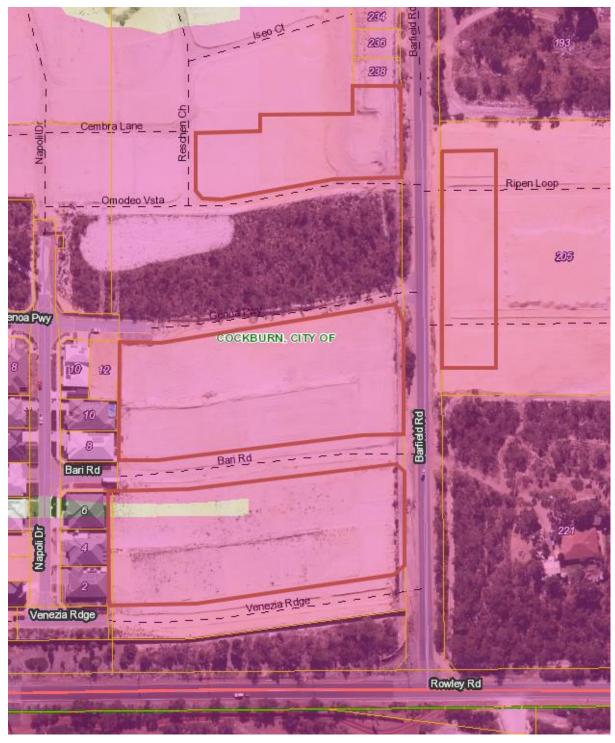
Plate 1: Map of Bush Fire Prone Areas (DFES 2019)

The majority of the project area is designated as bushfire prone on the Map of Bush Fire Prone Areas (DFES 2020, see Plate 1). As such, bushfire risk considerations and BAL assessment at the building stage are applicable to all proposed lots within Stage 8 (i.e. all 63 proposed lots).

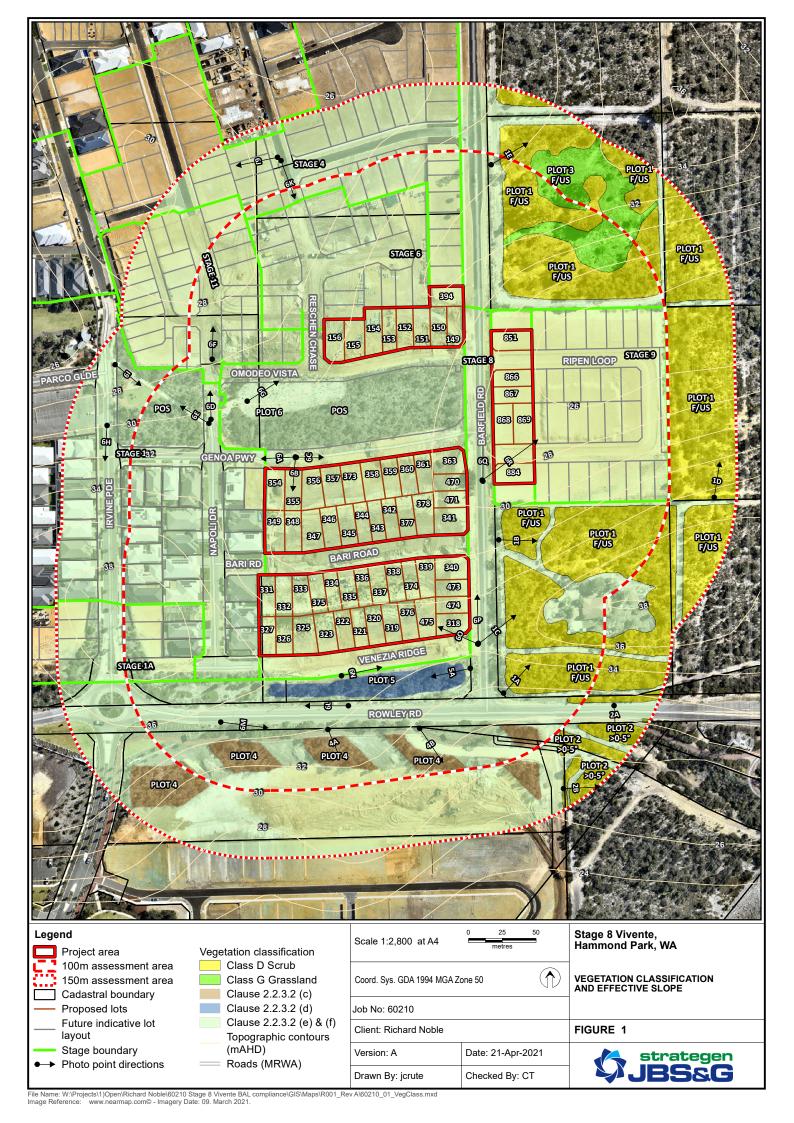
Strategen-JBS&G assessed classified vegetation and exclusions within the 150 m assessment area through on-ground verification on 21 January 2021 in accordance with AS 3959—2018 Construction of Buildings in Bushfire-Prone Areas (AS 3959; SA 2018) and the Visual Guide for Bushfire Risk Assessment in Western Australia (DoP 2016). Georeferenced site photos and a description of the vegetation classifications and exclusions are contained in Appendix B and depicted in Figure 1.

Strategen-JBS&G assessed effective slope under classified vegetation within the 150 m assessment area through on-ground verification on 21 January 2021 in accordance with AS 3959. Results were cross-referenced with DPIRD 2 m contour data and are depicted in Figure 1.

Figure 1 illustrates the current post-development vegetation classifications and exclusions observed during the inspection. The vegetation classifications/exclusions and effective slope are summarised in Table 2.

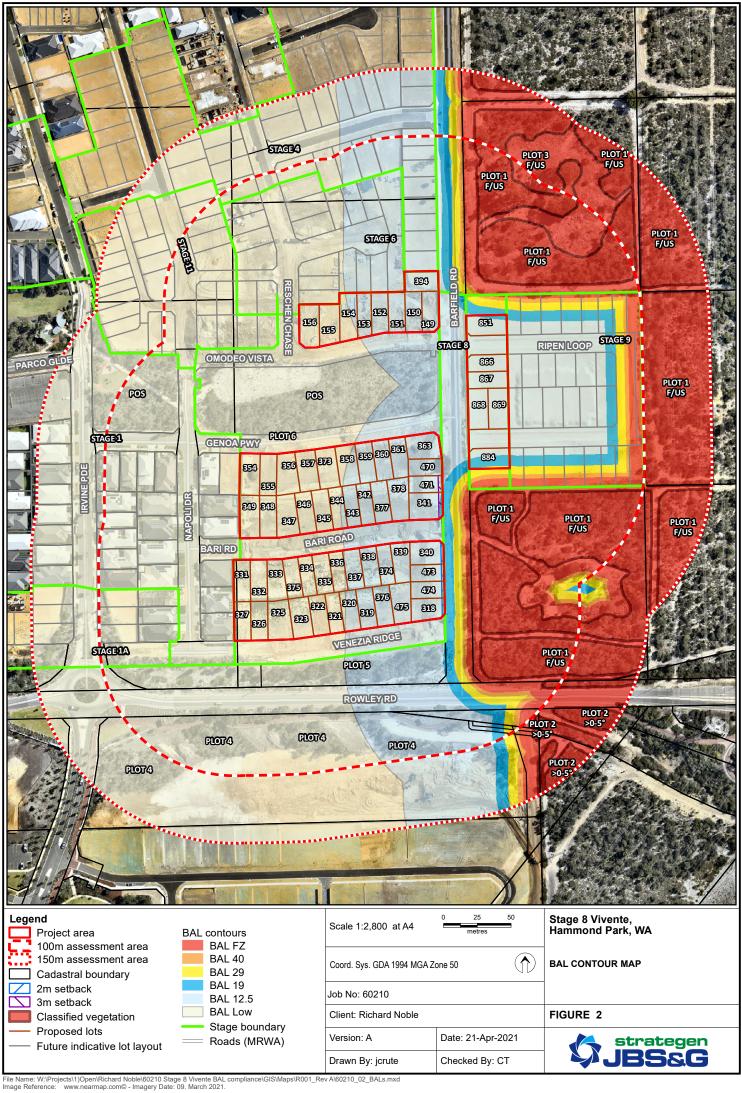
Strategen-JBS&G has undertaken a BAL contour assessment in accordance with Method 1 of AS 3959 for the project area (Figure 2). The Method 1 procedure incorporates the following factors:

The BAL contours are based on the current on-ground site conditions confirmed during site assessment and results are detailed in Table 3 and illustrated in Figure 2.

BAL certificates are provided in Appendix A in accordance with the BAL contour assessment results detailed in Table 3 and Figure 2.
