Richard Noble
Bushfire Attack Level (BAL) Compliance Report
Stage 4 Vivente, Hammond Park

30 July 2020
59211/131,251 (Rev 0)
JBS&G Australia Pty Ltd T/A Strategen-JBS&G

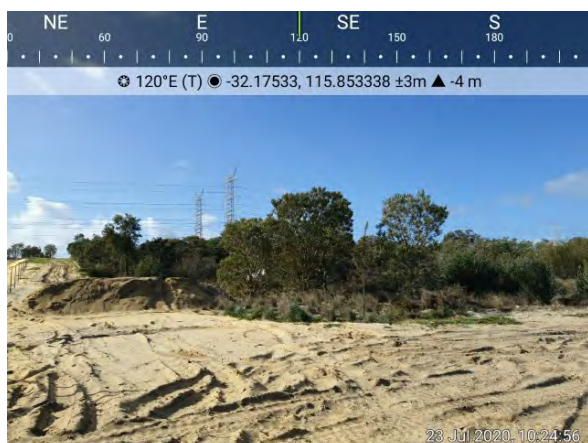
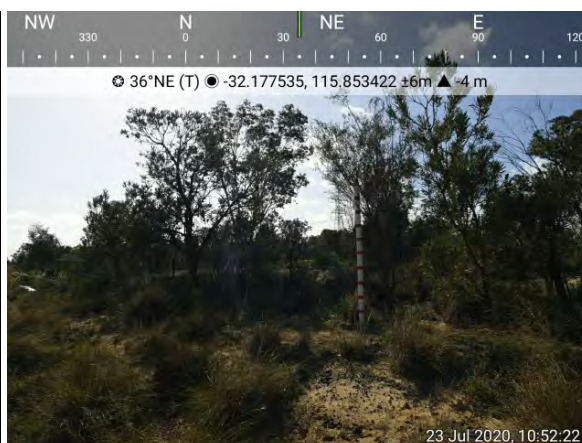
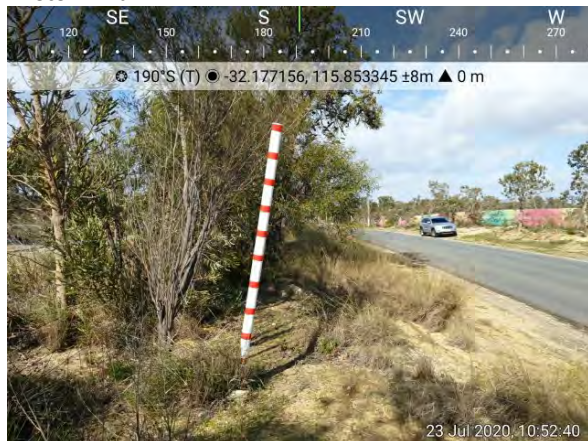
Plot number	Plot 1
Vegetation classification	Class D Scrub
Description / justification	Scrub vegetation predominantly 2-6 m in height with a continuous vertical fuel profile consisting predominantly of low banksias.

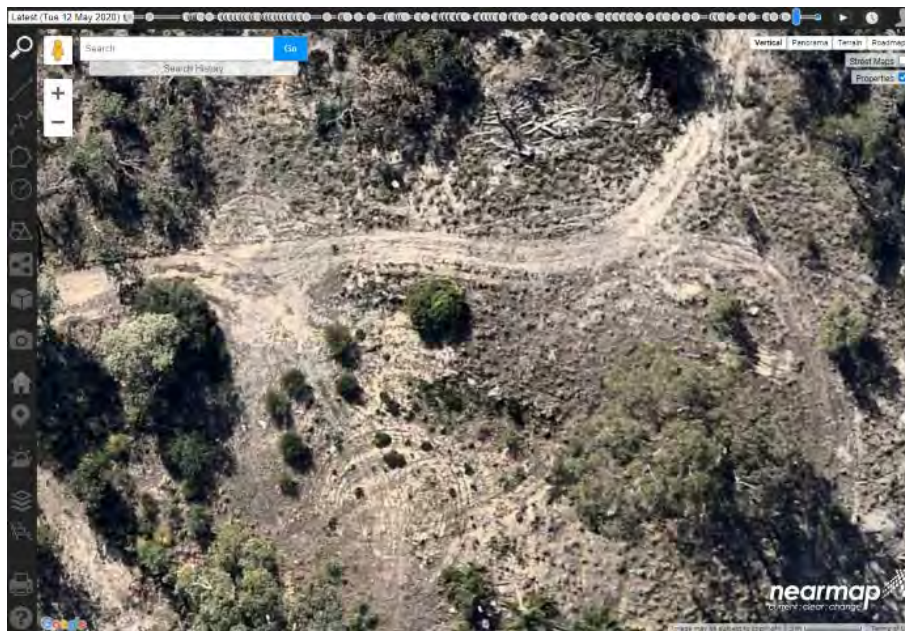
Nearmap aerial imagery (2020)

Plot number	Plot 2
Vegetation classification	Class G Grassland
Description / justification	Unmanaged grassland vegetation greater than 10 cm in height.

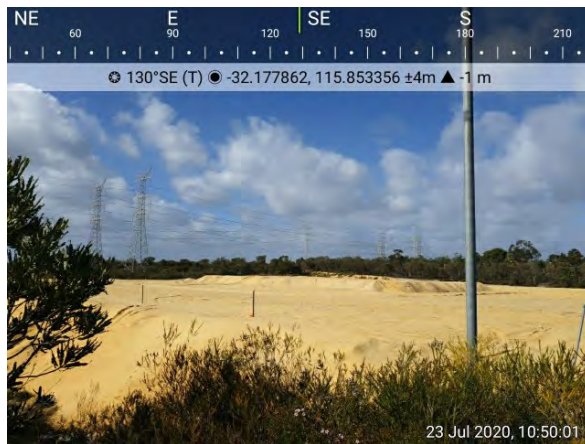
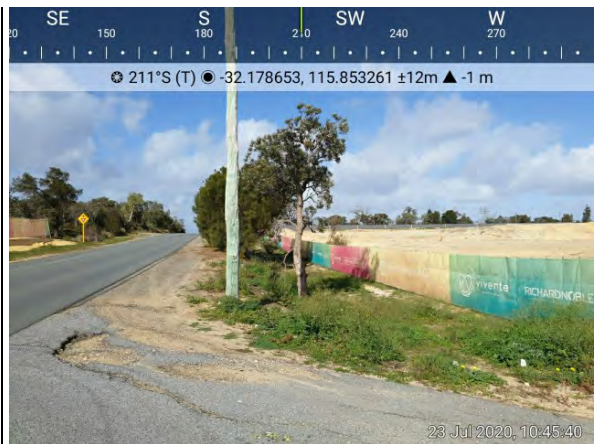
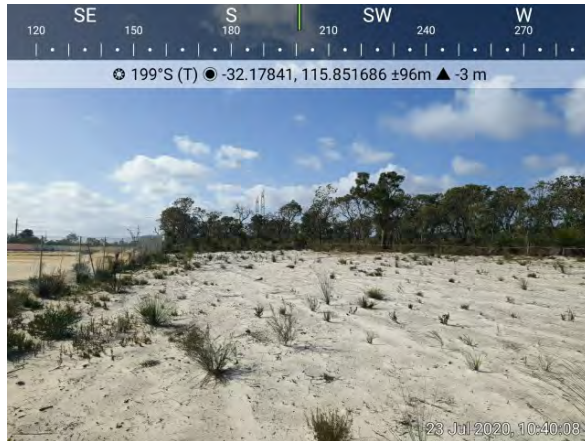
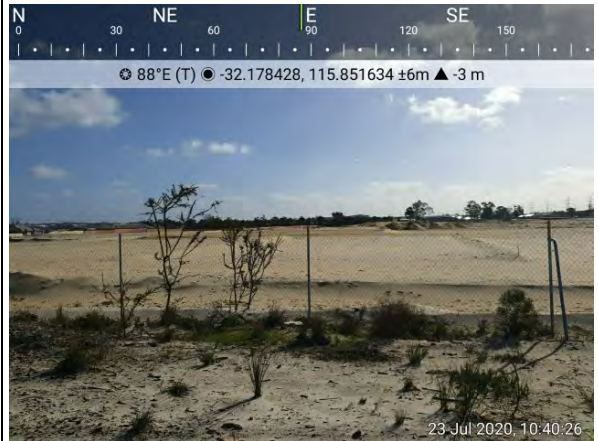
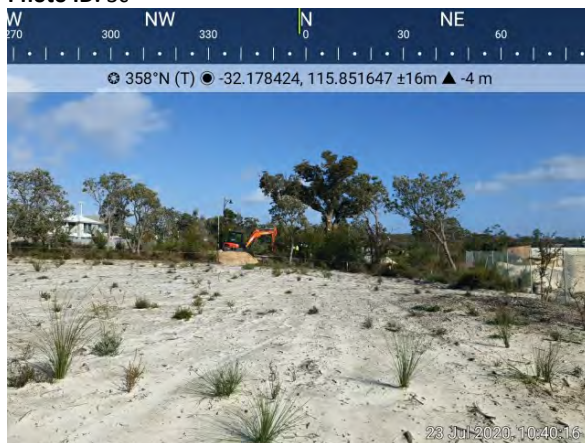
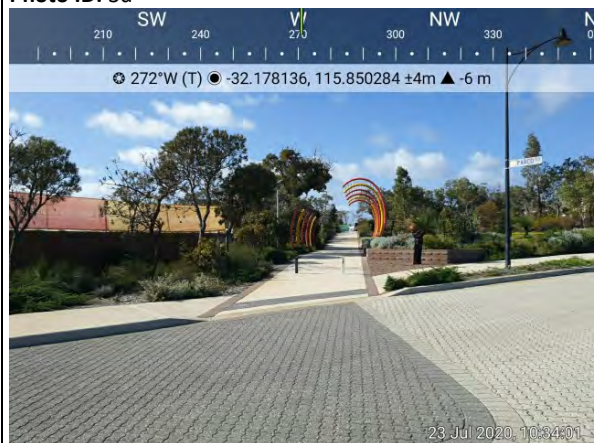
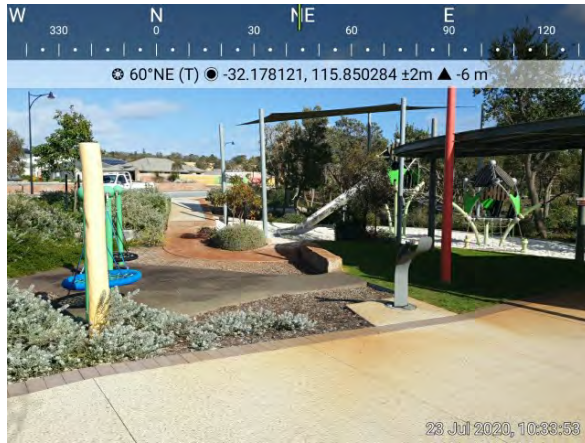
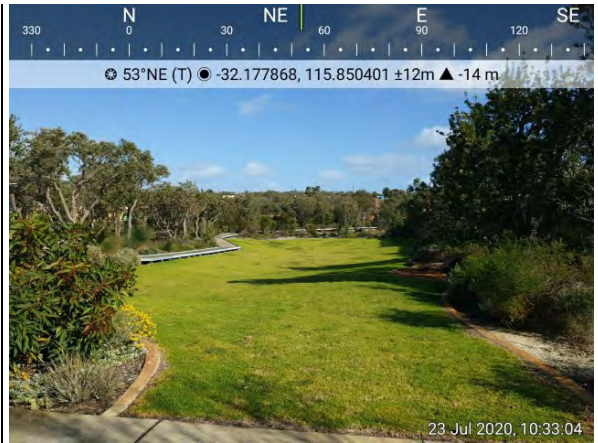
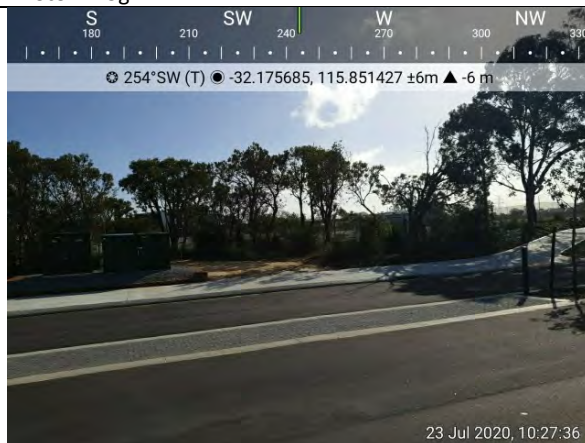
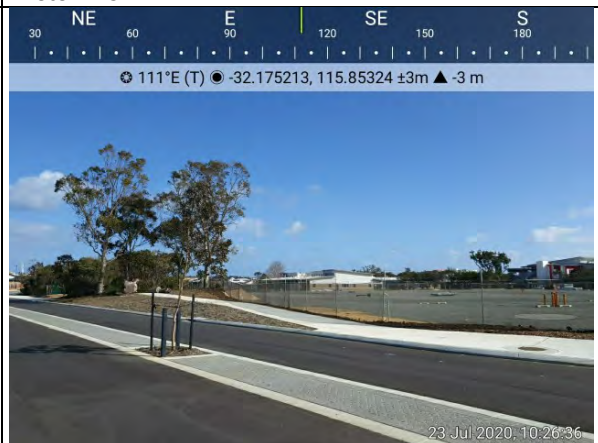
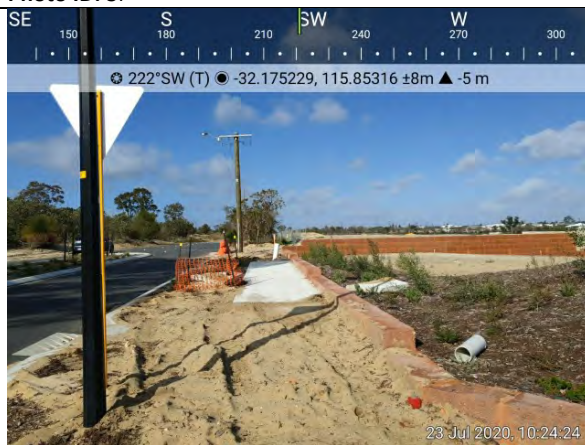
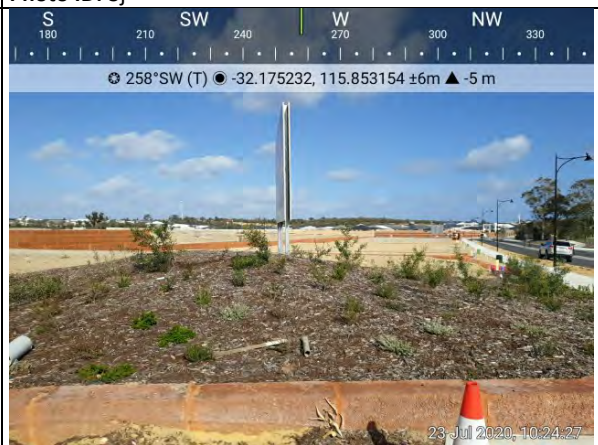
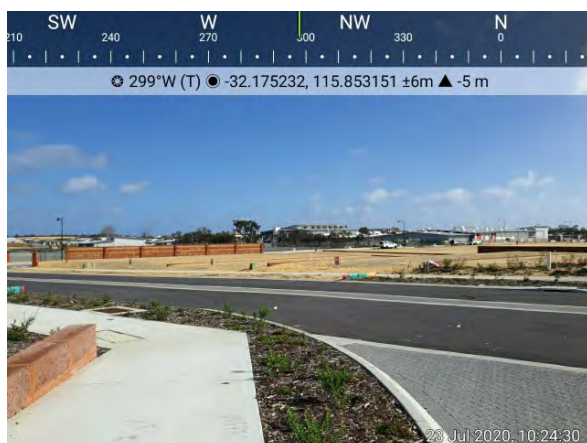
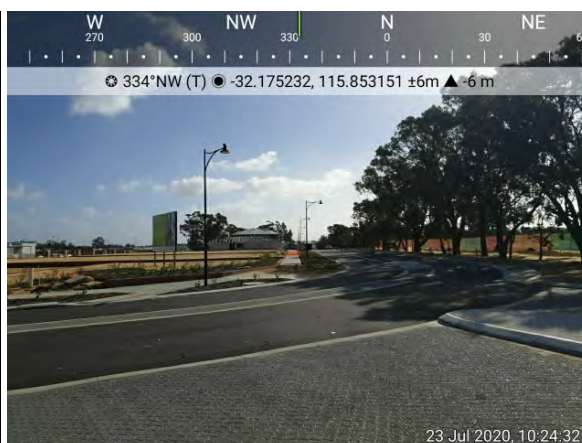
Vegetation classification
Excluded – Non-vegetated and Low threat (Clause 2.2.3.2 [e] and [f])

Description / justification
Non-vegetated areas (i.e. roads, buildings, cleared vacant lots, driveways, footpaths) and low threat managed vegetation (i.e. mowed grass, slashed staging buffers, managed gardens/POS, etc).
