Richard Noble Bushfire Attack Level (BAL) Compliance Report

20 lots within Stages 8 and 9 Vivente Estate Hammond Park, WA

7 October 2022 61728/147,549 (Rev 1) JBS&G Australia Pty Ltd T/A Strategen-JBS&G

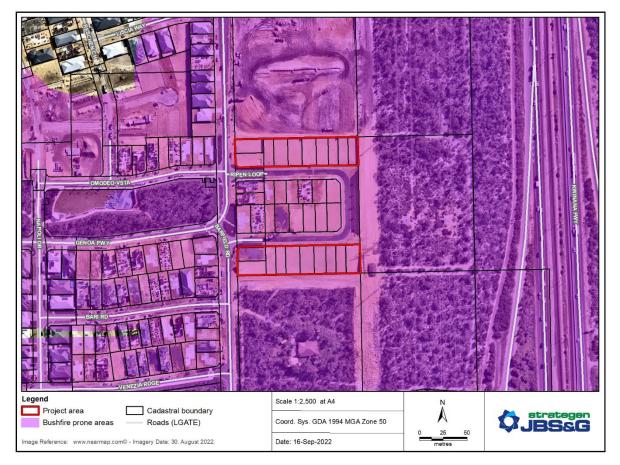
Plate 1: Map of Bush Fire Prone Areas (DFES 2021)

The project area is designated bushfire prone on the Map of Bush Fire Prone Areas (DFES 2021, see Plate 1). As such, bushfire risk considerations and BAL assessment are applicable to all proposed lots within the project area and are required to support future building permit applications.

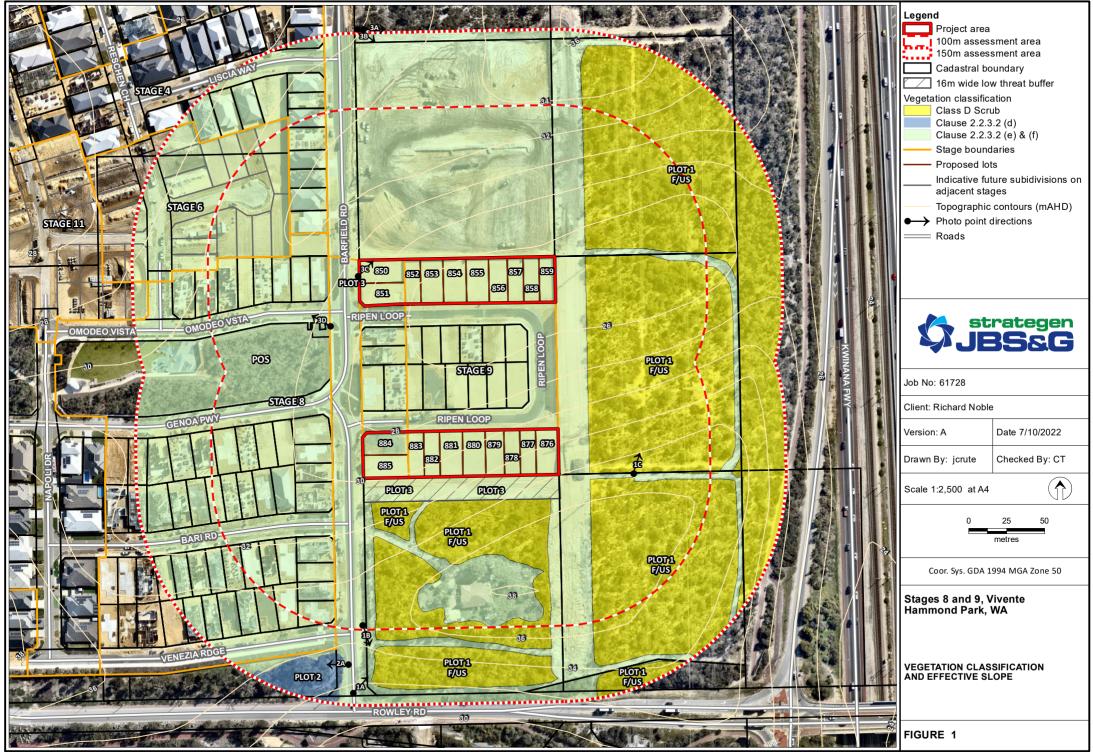
The predominant vegetation classification within the 150 m wide assessment area is Class D Scrub, which is identified to the east and south of the project area.

Site observations indicate that the vegetation classifications have evolved following ongoing clearing and earthworks throughout the estate, such that the extent of cleared, low threat land has expanded beyond that determined in previous BMPs and BAL reports (e.g. Strategen-JBS&G 2022). In particular, land clearing to the north of the project area has caused the previously classified Class D scrub vegetation and Class G grassland vegetation (as assessed in Strategen-JBS&G 2022) to become a non-vegetated/low threat area excluded under Clauses 2.2.3.2 (e) and (f).

The 20 m wide cleared firebreak to the east of the project area and 16 m wide cleared low threat staging buffer to the south of the project area continue to be maintained in a low threat state and are excluded under Clauses 2.2.3.2 (e) and (f).

The adjacent west POS cell has been excluded under Clause 2.2.3.2 (f) as low threat vegetation due to the fragmentation of the vegetation cells and lack of fuel carrying capacity within the vegetation, as previously adopted by the City and DFES under the approved BMPs for Vivente Estate.

Site observations indicate that effective slope under classified vegetation aligns with the effective slopes identified within the endorsed BMPs, with that being an effective slope of flat/upslope (i.e. 0 degrees).

Figure 1 illustrates the current vegetation classifications and exclusions observed during the latest site inspection. The vegetation classifications/exclusions and effective slope are summarised in Table 2.

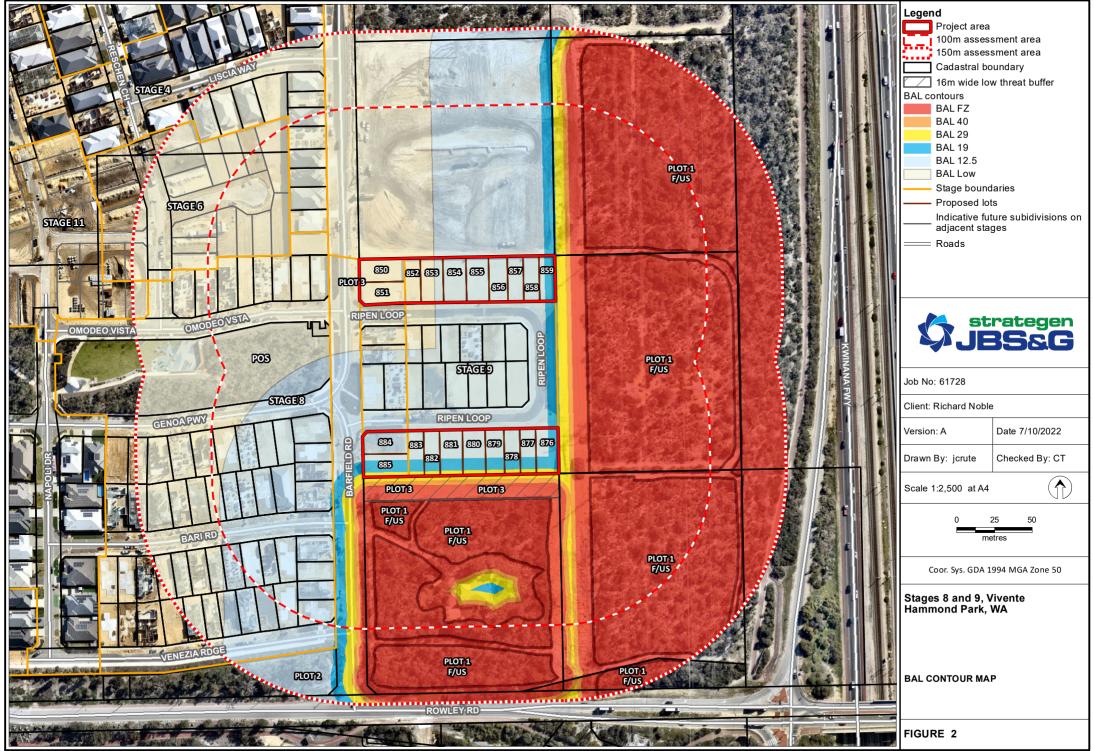
Strategen-JBS&G has undertaken a BAL contour assessment in accordance with Method 1 of AS 3959 for the project area (Figure 2). The Method 1 procedure incorporates the following factors:

The BAL contours are based on the current on-ground site conditions confirmed during site assessment and results are detailed in Table 3 and illustrated in Figure 2.

Should a lower BAL be realistically achievable through an appropriate building setback, then the landowner can refer to the recommended setbacks listed in Table 3. The lower BAL may be achieved if the recommended building setback is reflected on the building plan for that lot and a revised BAL certificate can be issued at that time.

Nine lots can potentially achieve a lower BAL if building setbacks are implemented, as set out in Table 3. Should it be determined through demonstration on individual building plans that compliance with the recommended building setbacks has been achieved and subsequently a lower BAL rating has been attained (as per Table 3), then the lower BAL rating should apply and be reflected in an updated BAL certificate prepared at that time.
