Richard Noble  
Bushfire Attack Level (BAL) Compliance Report  
Stages 9 and 12 Vivente, Hammond Park, WA

11 November 2021  
61728/140,797 (Rev 1)

JBS&G Australia Pty Ltd T/A Strategen-JBS&G

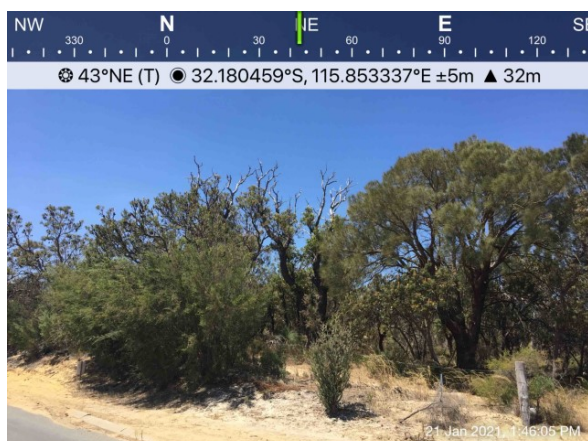
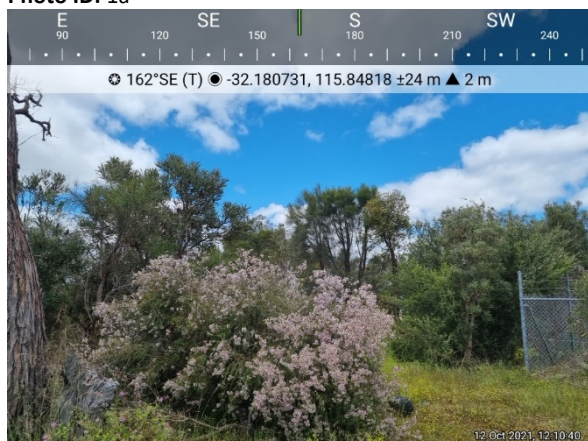
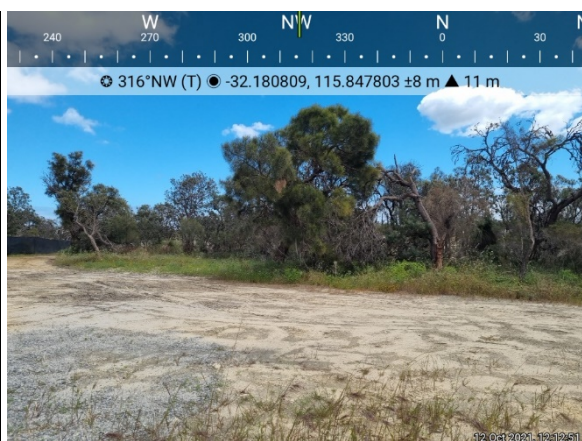
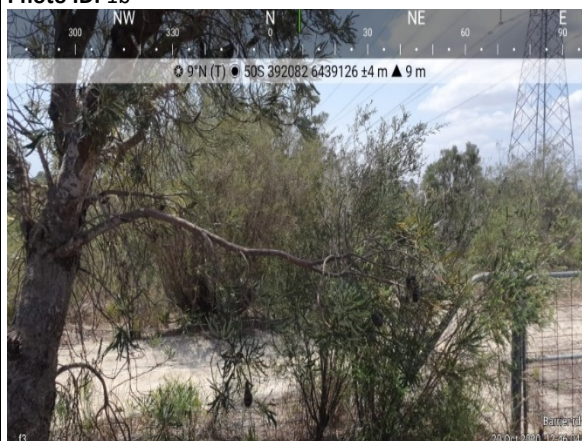
Plot number		Plot 1
Vegetation classification	Pre-development	Class D Scrub
	Post-development	Class D Scrub
Description / justification		Scrub vegetation predominantly 2–6 m in height with a continuous horizontal fuel profile consisting predominantly of banksia/sheoak

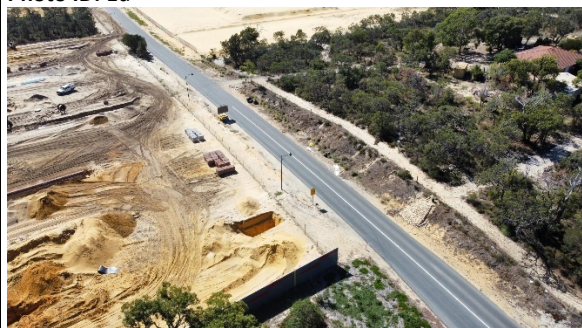
Photo ID: 1f

- new roadside clearing along the eastern verge of Barfield Road (refer to drone Photo 1f in Appendix B), which has reduced the level of Class D scrub along this interface compared to that previously mapped
- new vegetation clearing to the west of the project area opposite Frankland Avenue, which has reduced the level of Class D scrub along this interface compared to that previously mapped
- implementation of a 20 m wide cleared buffer to the east of the project area in accordance with clearing permit (CPS 7145/1), which has reduced the level of Class D scrub along this interface compared to that previously mapped.

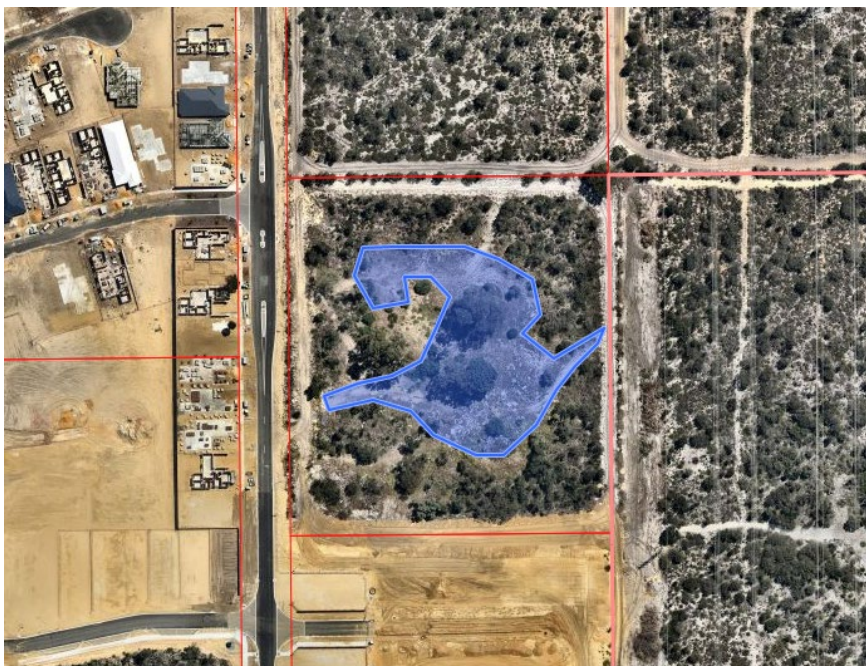
Photo ID: 2a (Nearmap imagery captured 24/10/21)

Plot number		Plot 2
Vegetation classification	Pre-development	Class G Grassland
	Post-development	Class G Grassland
Description / justification		Unmanaged grassland vegetation greater than 100 mm in height.

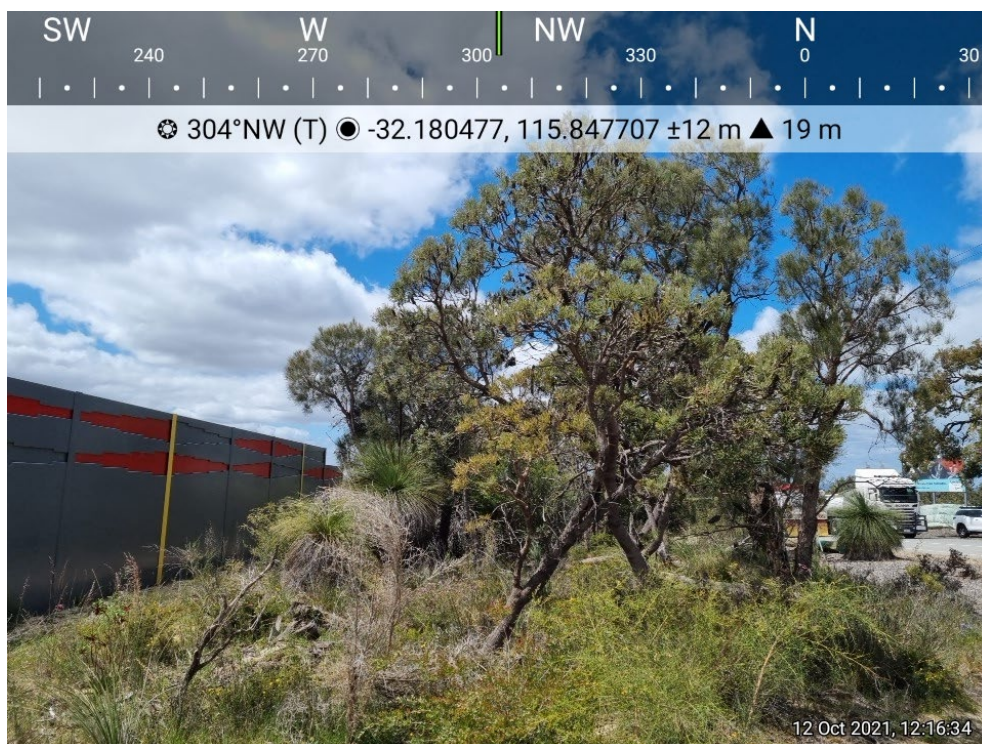
Plot number		Plot 4
Vegetation classification	Pre-development	Excluded – Clause 2.2.3.2 [d]
	Post-development	Excluded – Clause 2.2.3.2 [d]
Description / justification		Narrow strip of vegetation less than 20 m wide and not within 20 m of other areas of classified vegetation or the site, north of Rowley Road.

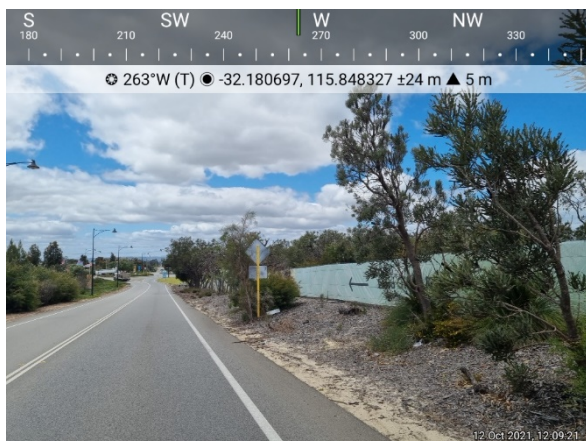
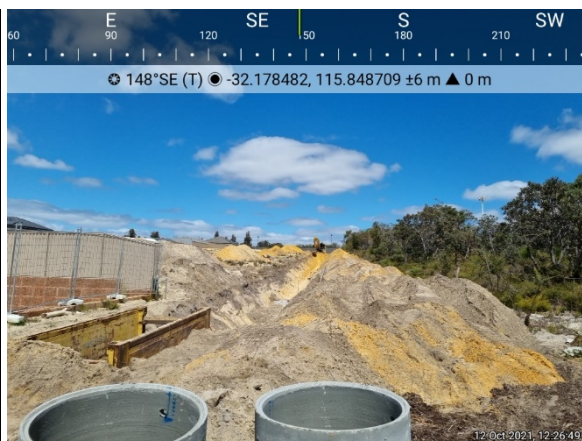
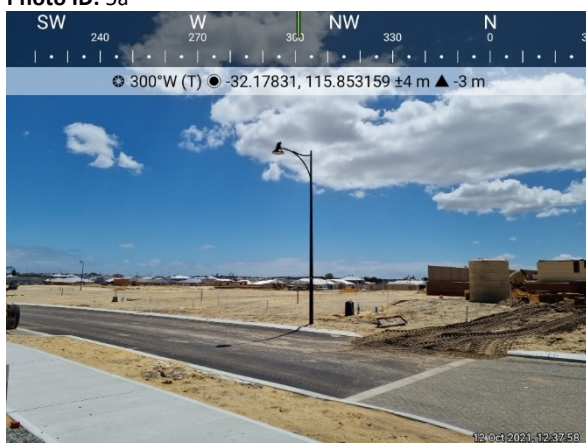
Plot number		Plot 5
Vegetation classification	Pre-development	Excluded – Non-vegetated and Low threat (Clause 2.2.3.2 [e] and [f])
	Post-development	Excluded – Non-vegetated and Low threat (Clause 2.2.3.2 [e] and [f])
Description / justification		Existing non-vegetated areas (i.e. roads, buildings, cleared vacant lots, driveways, footpaths) and low threat managed vegetation (i.e. mowed grass, slashed staging buffers, managed gardens/POS, etc).
