Richard Noble  
Bushfire Attack Level (BAL) Compliance Report  
20 lots within Stages 8 and 9 Vivente Estate  
Hammond Park, WA

14 February 2022  
61728/ 143,127 (Rev 0)

JBS&G Australia Pty Ltd T/A Strategen-JBS&G

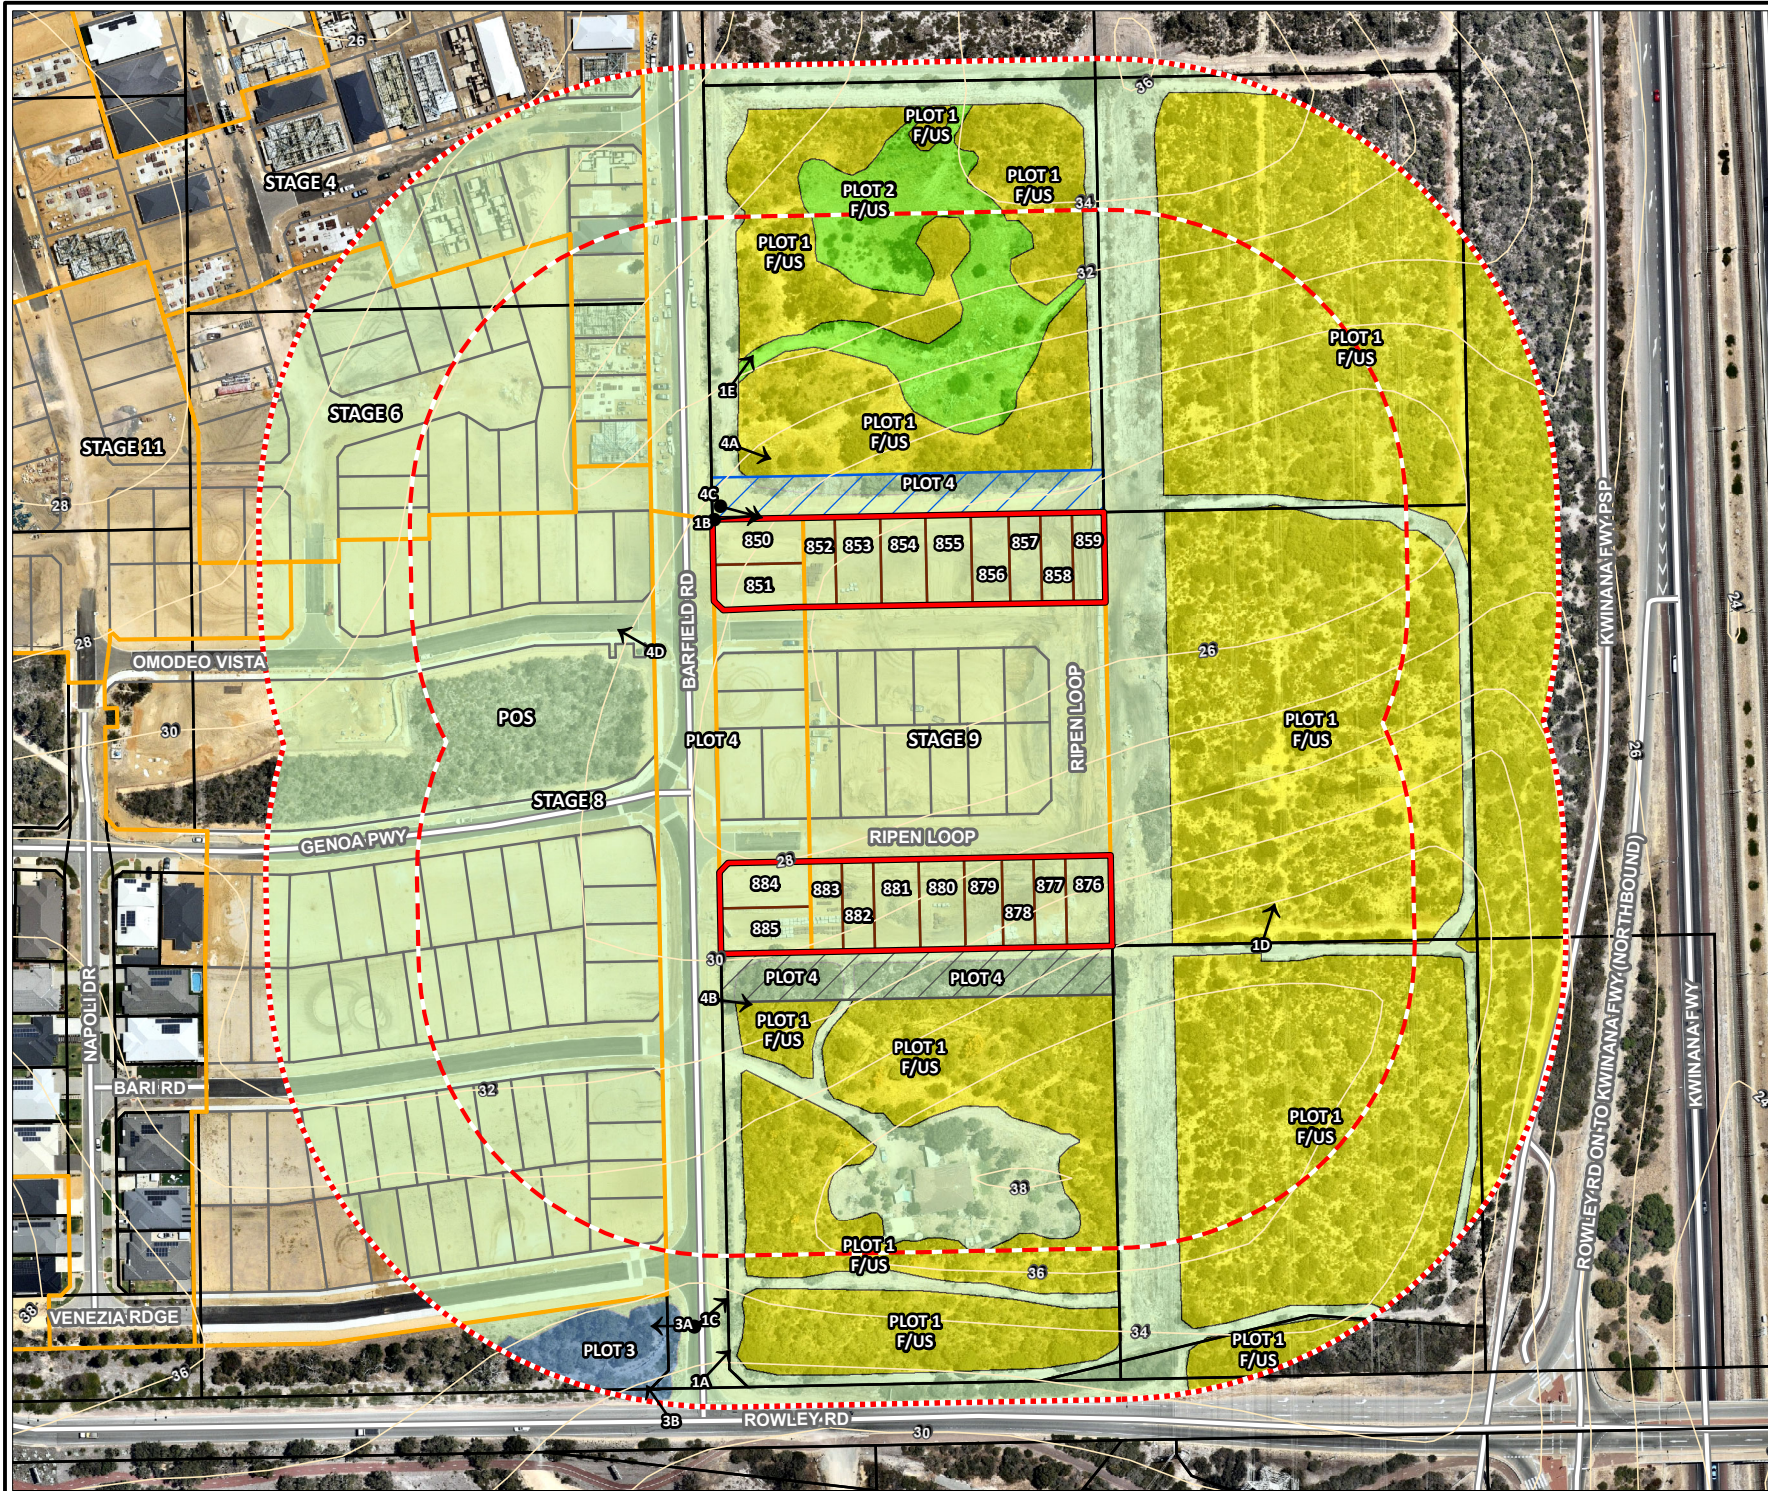
**FIGURE 1**

The predominant vegetation classification within the assessment area is Class D Scrub which is identified to the north, east and south of the project area. Class G Grassland is identified within a previously cleared area within the broader Class D Scrub to the north of Stage 9.

Site observations show that effective slope under the classified vegetation aligns with the effective slopes identified within the endorsed BMPs with that being an effective slope of flat/upslope (i.e. 0 degrees).

Figure 1 illustrates the current post-development vegetation classifications and exclusions observed during the inspection. The vegetation classifications/exclusions and effective slope are summarised in Table 2.

**VEGETATION CLASSIFICATION AND EFFECTIVE SLOPE**

Strategen-JBS&G assessed classified vegetation and exclusions within the 150 m assessment area through on-ground verification on 20 January 2022 in accordance with AS 3959—2018 *Construction of Buildings in Bushfire-Prone Areas* (AS 3959; SA 2018) and the *Visual Guide for Bushfire Risk Assessment in Western Australia* (DoP 2016). Georeferenced photos and a description of the vegetation classifications and exclusions are contained in Appendix B and depicted in Figure 1.

Strategen-JBS&G assessed effective slope under classified vegetation within the 150 m assessment area through on-ground verification on 20 January 2022 in accordance with AS 3959. Results were cross-referenced with DPIRD 2 m contour data and are depicted in Figure 1.

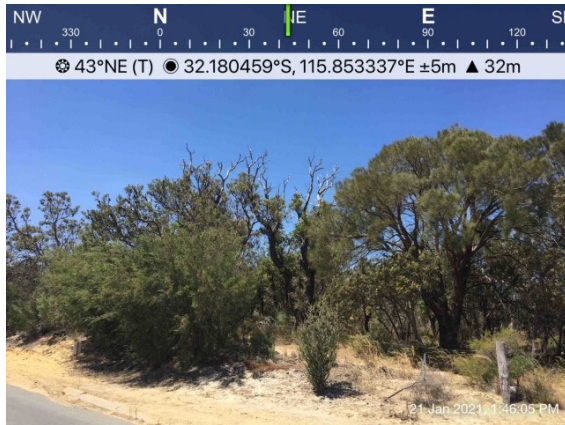
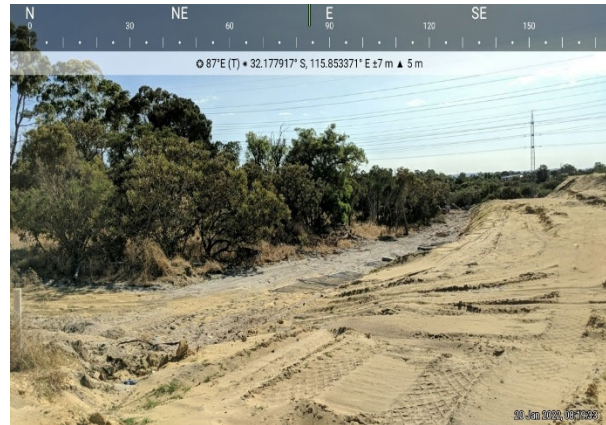
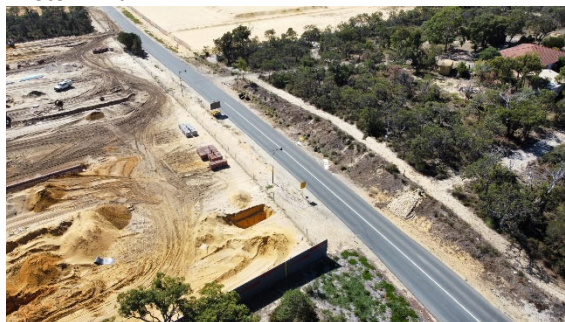
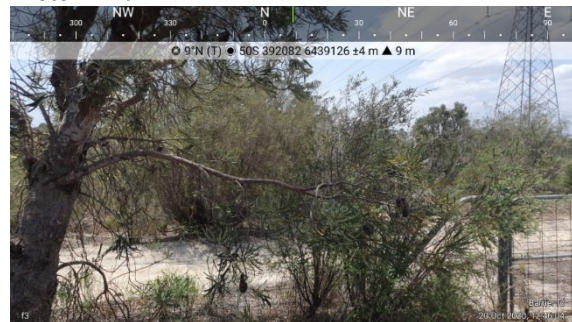
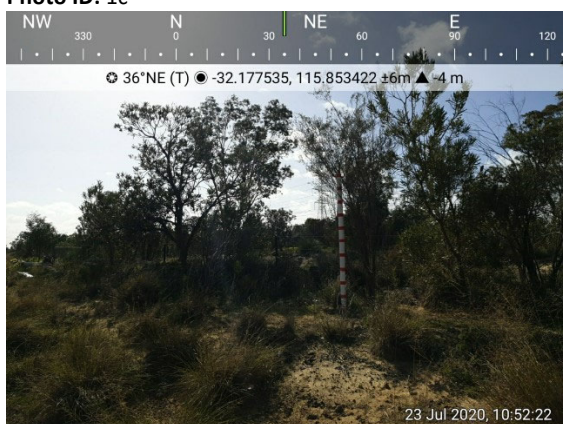
Photo ID: 1a

Plot number		Plot 1
Vegetation classification	Pre-development	Class D Scrub
	Post-development	Class D Scrub
Description / justification		Scrub vegetation predominantly 2–6 m in height with a continuous horizontal fuel profile consisting predominantly of banksia/sheoak

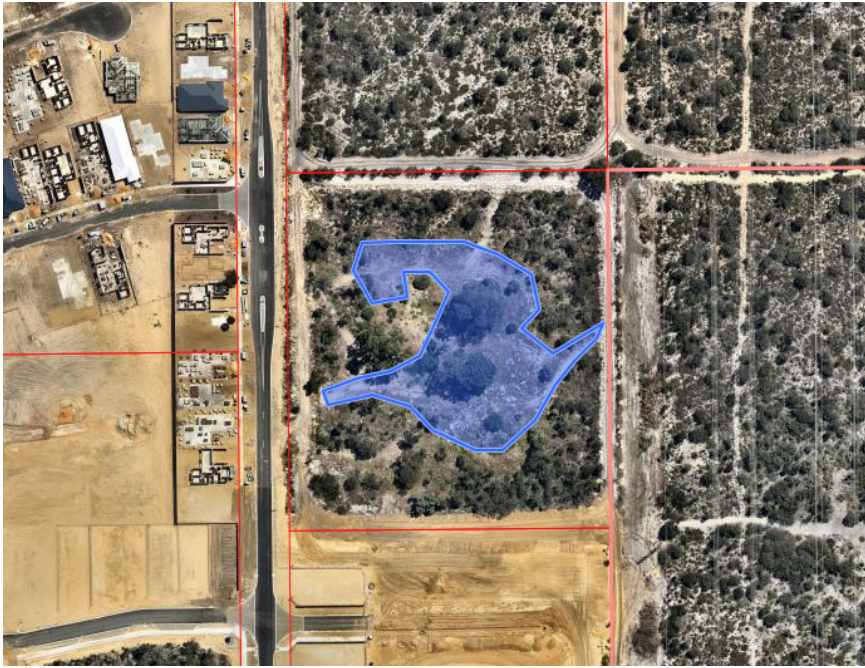
**Photo ID:** 2a (Nearmap imagery captured 24/10/21)

<b>Plot number</b>		Plot 2
<b>Vegetation classification</b>	<b>Pre-development</b>	Class G Grassland
	<b>Post-development</b>	Class G Grassland
<b>Description / justification</b>		Unmanaged grassland vegetation greater than 100 mm in height.

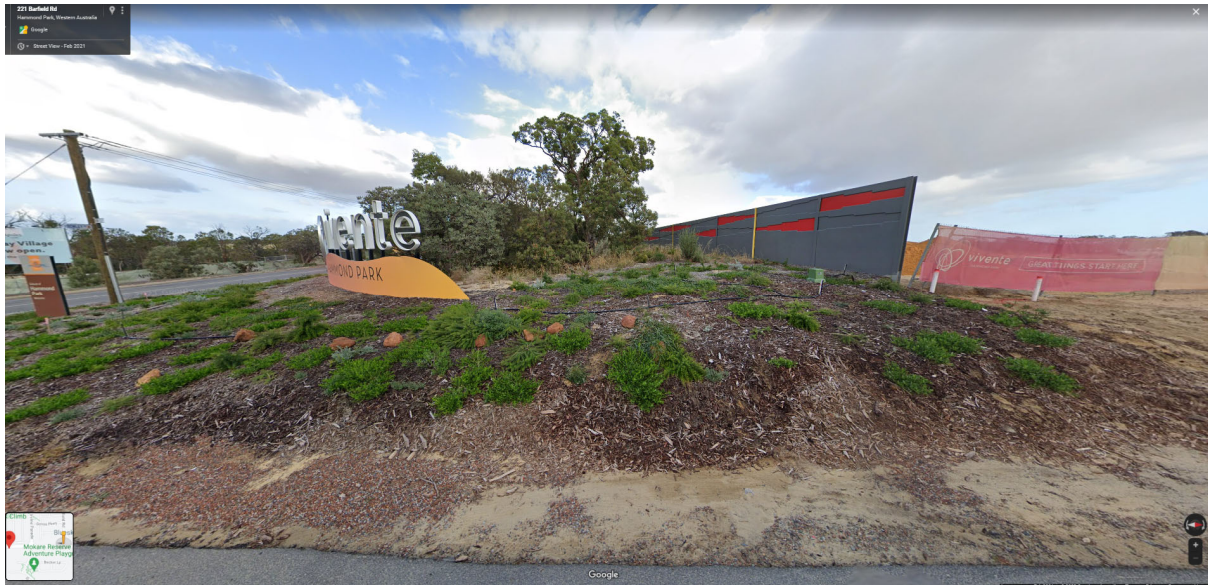
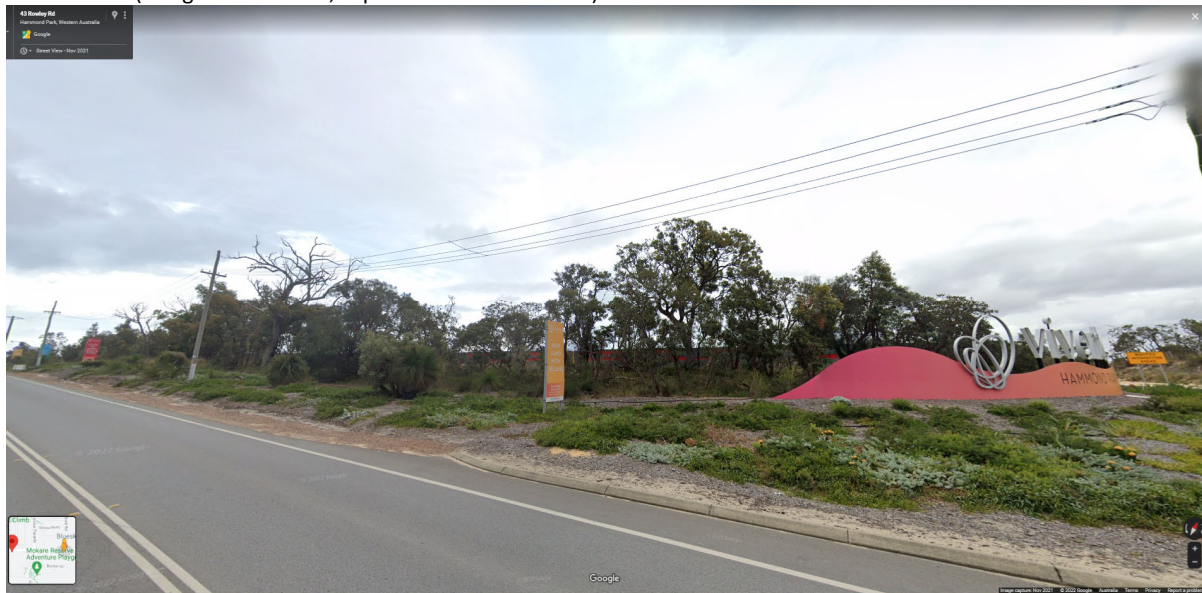
**Photo ID: 3a** (Google Street View, captured November 2021)

<b>Plot number</b>		Plot 3
<b>Vegetation classification</b>	<b>Pre-development</b>	Excluded – Clause 2.2.3.2 [d]
	<b>Post-development</b>	Excluded – Clause 2.2.3.2 [d]
<b>Description / justification</b>		Strips of vegetation less than 20m in width (regardless of length) and not within 20m of the site of each other or other areas of vegetation being classified vegetation.

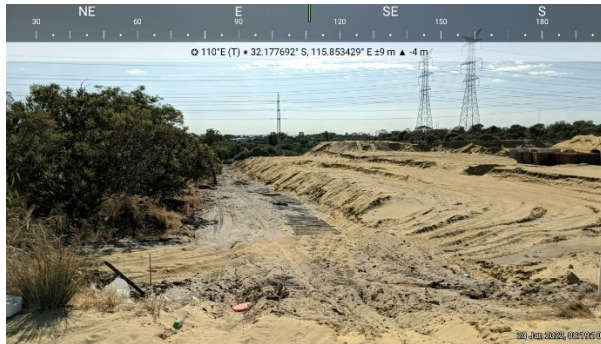
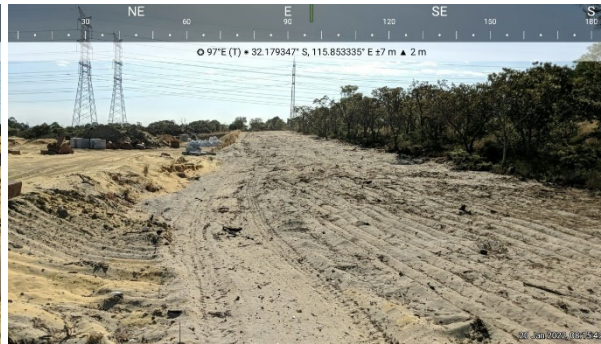
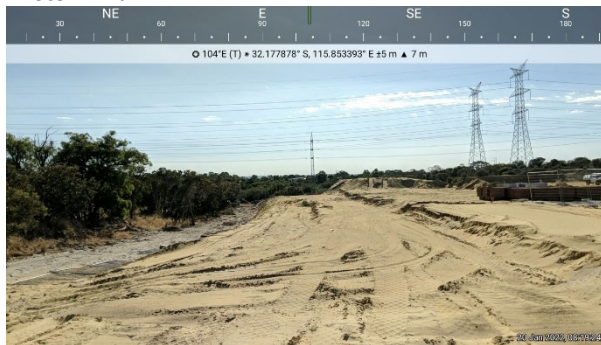
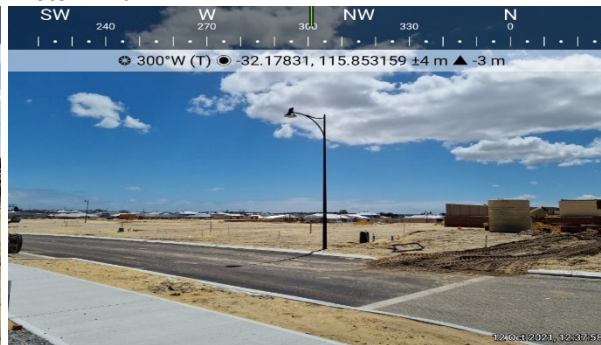
Photo ID: 4a

Plot number		Plot 4
Vegetation classification	Pre-development	Excluded – Non-vegetated and Low threat (Clause 2.2.3.2 [e] and [f])
	Post-development	Excluded – Non-vegetated and Low threat (Clause 2.2.3.2 [e] and [f])
Description / justification		Existing non-vegetated areas (i.e. roads, buildings, cleared vacant lots, driveways, footpaths) and low threat managed vegetation (i.e. mowed grass, slashed staging buffers, managed gardens/POS, etc). Includes central vegetated POS which has been assessed as low threat due to fragmentation and lack of fuel carrying capacity.
