Bushfire Attack Level (BAL) Compliance Report

20 lots within Stages 8 and 9 Vivente Estate

Hammond Park, WA

7 October 2022 61728/147,549 (Rev 1) JBS&G Australia Pty Ltd T/A Strategen-JBS&G

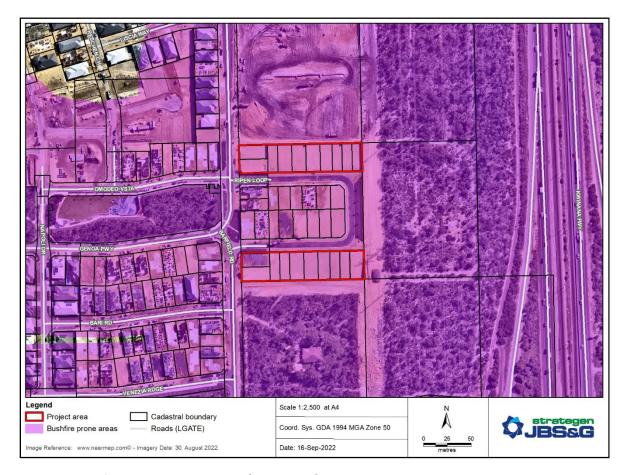
Plate 1: Map of Bush Fire Prone Areas (DFES 2021)

The project area is designated bushfire prone on the Map of Bush Fire Prone Areas (DFES 2021, see Plate 1). As such, bushfire risk considerations and BAL assessment are applicable to all proposed lots within the project area and are required to support future building permit applications.

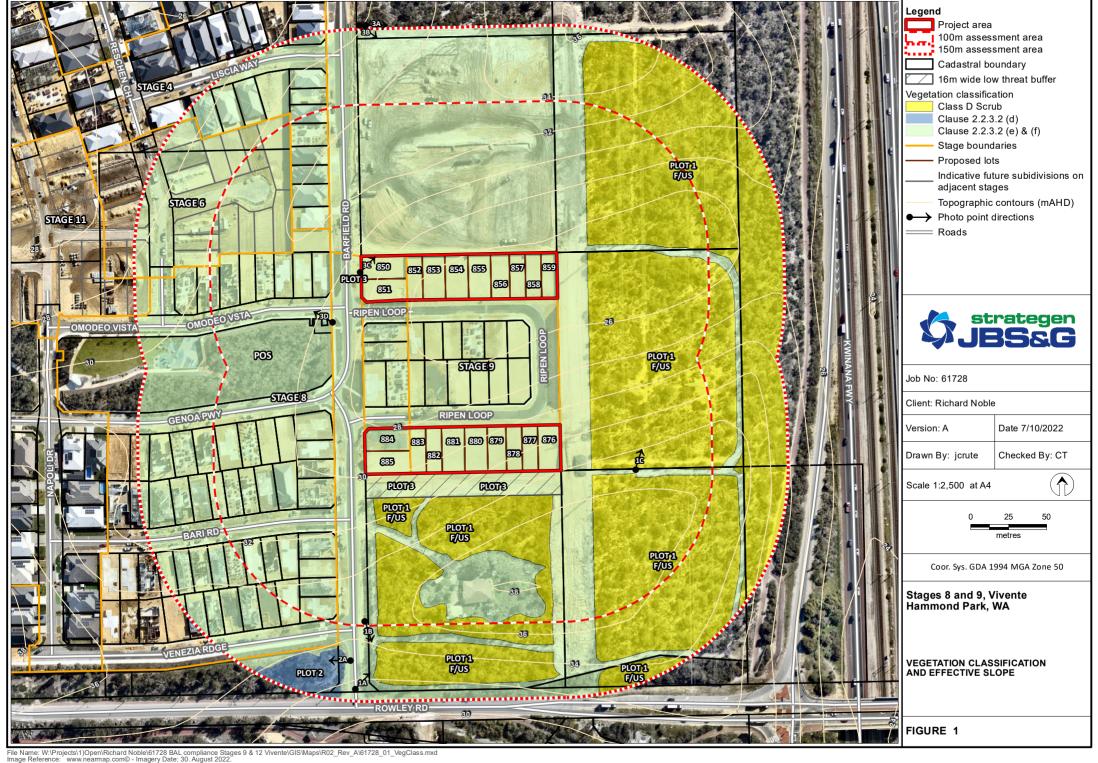
Strategen-JBS&G assessed classified vegetation and exclusions within the 150 m assessment area through on-ground verification on 12 October 2021 and reassessment on 7 September 2022 in accordance with AS 3959—2018 Construction of Buildings in Bushfire-Prone Areas (AS 3959; SA 2018) and the Visual Guide for Bushfire Risk Assessment in Western Australia (DoP 2016). Georeferenced photos and a description of the vegetation classifications and exclusions are contained in Appendix B and depicted in Figure 1.

The predominant vegetation classification within the 150 m wide assessment area is Class D Scrub, which is identified to the east and south of the project area.

Strategen-JBS&G assessed effective slope under classified vegetation within the 150 m assessment area through on-ground verification on 12 October 2021 and reassessment on 7 September 2022 in accordance with AS 3959. Results were cross-referenced with DPIRD 2 m contour data and are depicted in Figure 1.

Site observations indicate that effective slope under classified vegetation aligns with the effective slopes identified within the endorsed BMPs, with that being an effective slope of flat/upslope (i.e. 0 degrees).

Figure 1 illustrates the current vegetation classifications and exclusions observed during the latest site inspection. The vegetation classifications/exclusions and effective slope are summarised in Table 2.

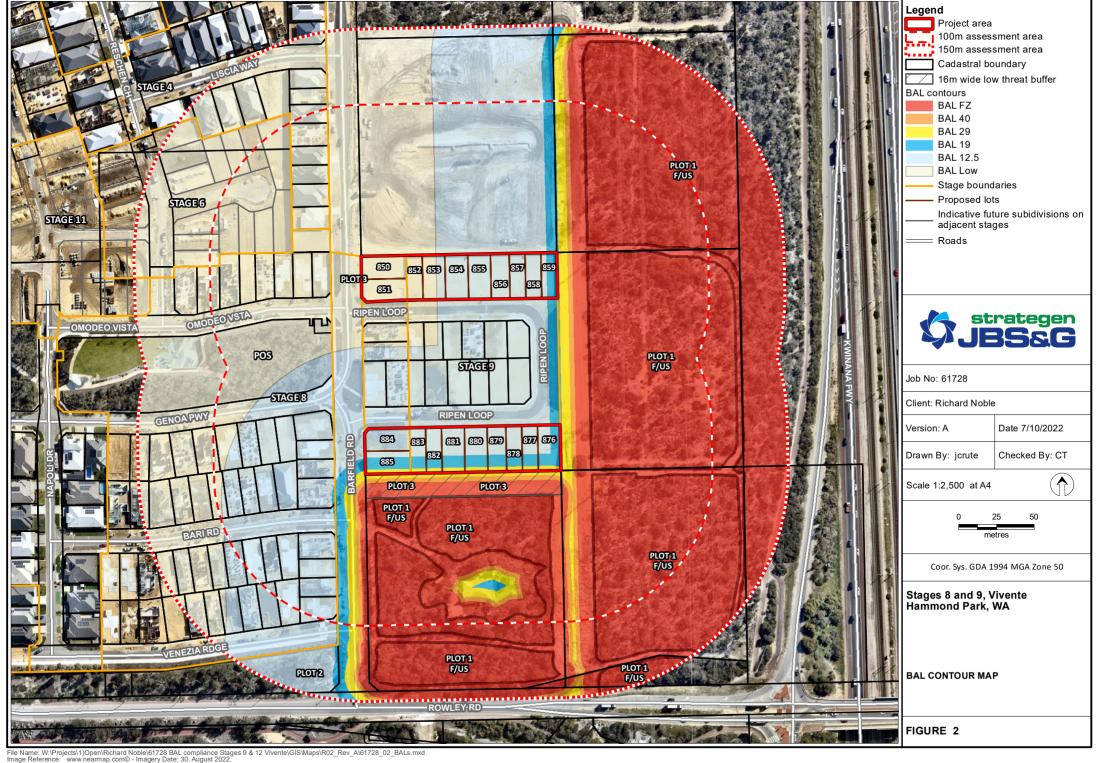
Strategen-JBS&G has undertaken a BAL contour assessment in accordance with Method 1 of AS 3959 for the project area (Figure 2). The Method 1 procedure incorporates the following factors:

The BAL contours are based on the current on-ground site conditions confirmed during site assessment and results are detailed in Table 3 and illustrated in Figure 2.

BAL certificates are provided in Appendix A in accordance with the BAL contour assessment results detailed in Table 3 and Figure 2.

Should a lower BAL be realistically achievable through an appropriate building setback, then the landowner can refer to the recommended setbacks listed in Table 3. The lower BAL may be achieved if the recommended building setback is reflected on the building plan for that lot and a revised BAL certificate can be issued at that time.

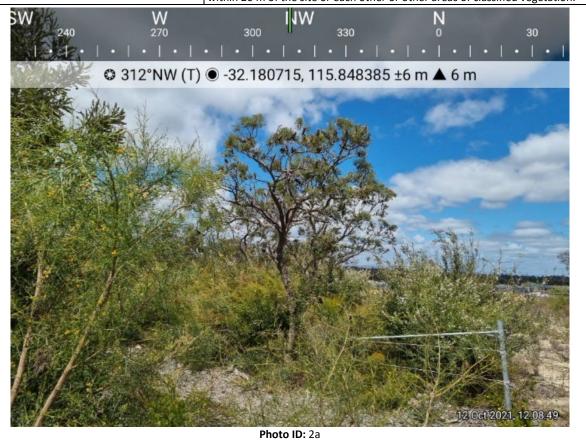
Plot 2				
Vegetation classification	Excluded – Clause 2.2.3.2 [d]			
Description / justification	Strips of vegetation less than 20 m in width (regardless of length) and not within 20 m of the site or each other or other areas of classified vegetation.
